Dorman 521-947 Rear Driver Side Lower Rearward Lateral Arm Instruction Manual

Model: 521-947 | Brand: Dorman

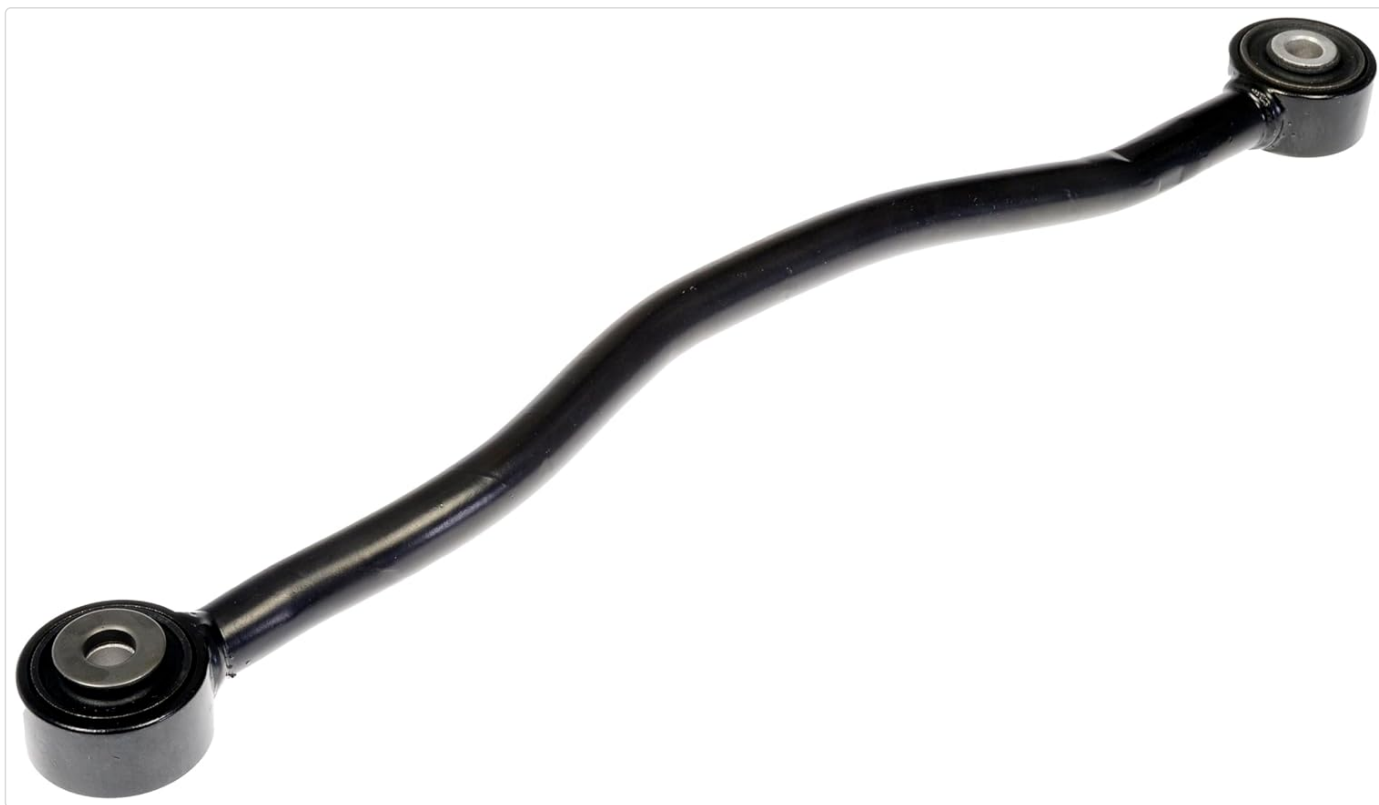
Figure 2.1: Dorman 521-947 Rear Driver Side Lower Rearward Lateral Arm, full view. This image shows the overall shape and design of the lateral arm, including the mounting points at each end.

The Dorman 521-947 is a rear driver side lower rearward lateral arm designed for precise fitment and function in compatible vehicles. It is a critical component of the vehicle's suspension system, contributing to wheel alignment and stability.

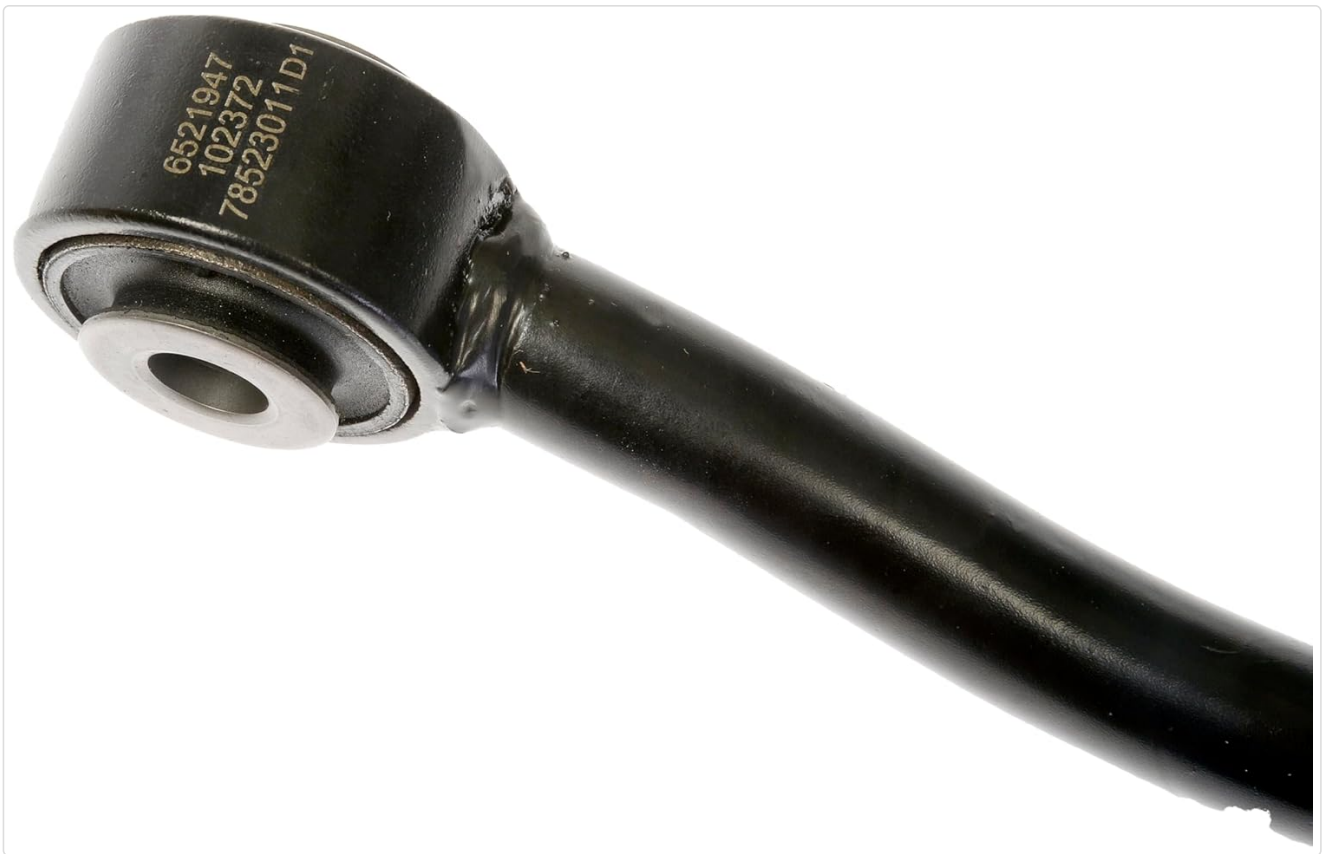
Figure 4.1: Side view of the Dorman 521-947 lateral arm, showing its curved profile and mounting points. This view helps in identifying the component's orientation.

Identify the rear driver side lower rearward lateral arm. It connects the wheel hub assembly to the vehicle's chassis.
