# ATI Performance Products TH400 Direct Drum User Manual

Model: 405722

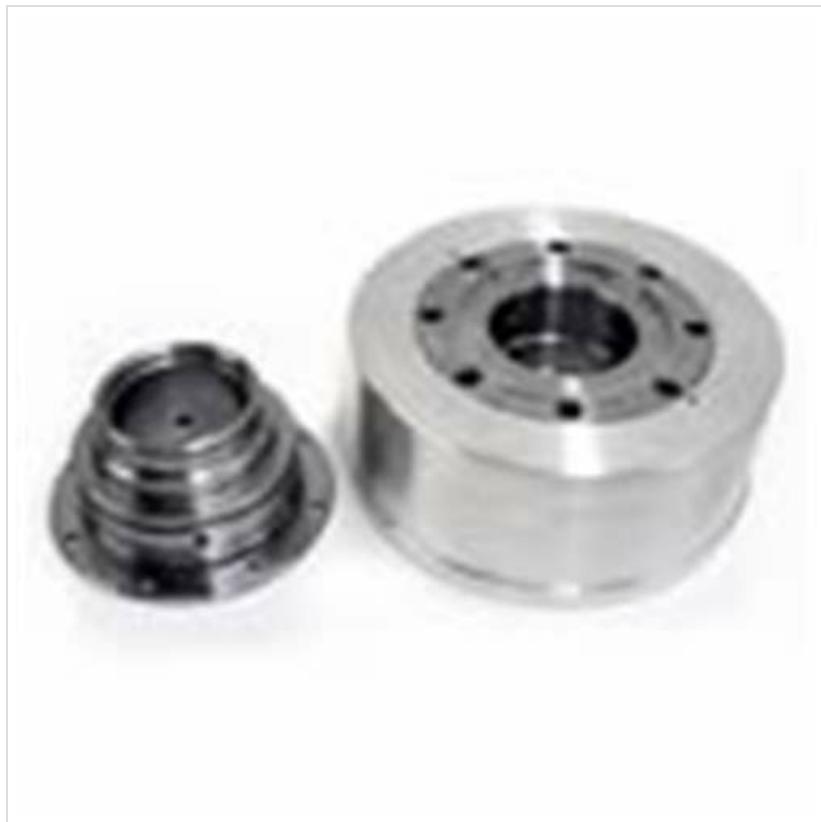
Image 1.1: The ATI Performance Products TH400 Direct Drum (right) shown alongside a smaller, related component (left). Both parts are metallic and appear to be precision-machined for automotive transmission applications.

The ATI TH400 Direct Drum is constructed from treated T-6 aircraft aluminum, a material chosen for its superior strength and heat dissipation properties. This design eliminates the need for traditional steel bushings and sleeves, which can expand under high temperatures and potentially lead to transmission failure. By integrating Torrington bearings, the drum is engineered to significantly extend clutch life and contribute to lower elapsed times (ET) in performance applications.
