Dorman 54245 Engine Coolant Cap User Manual

Model: 54245 | Brand: Dorman

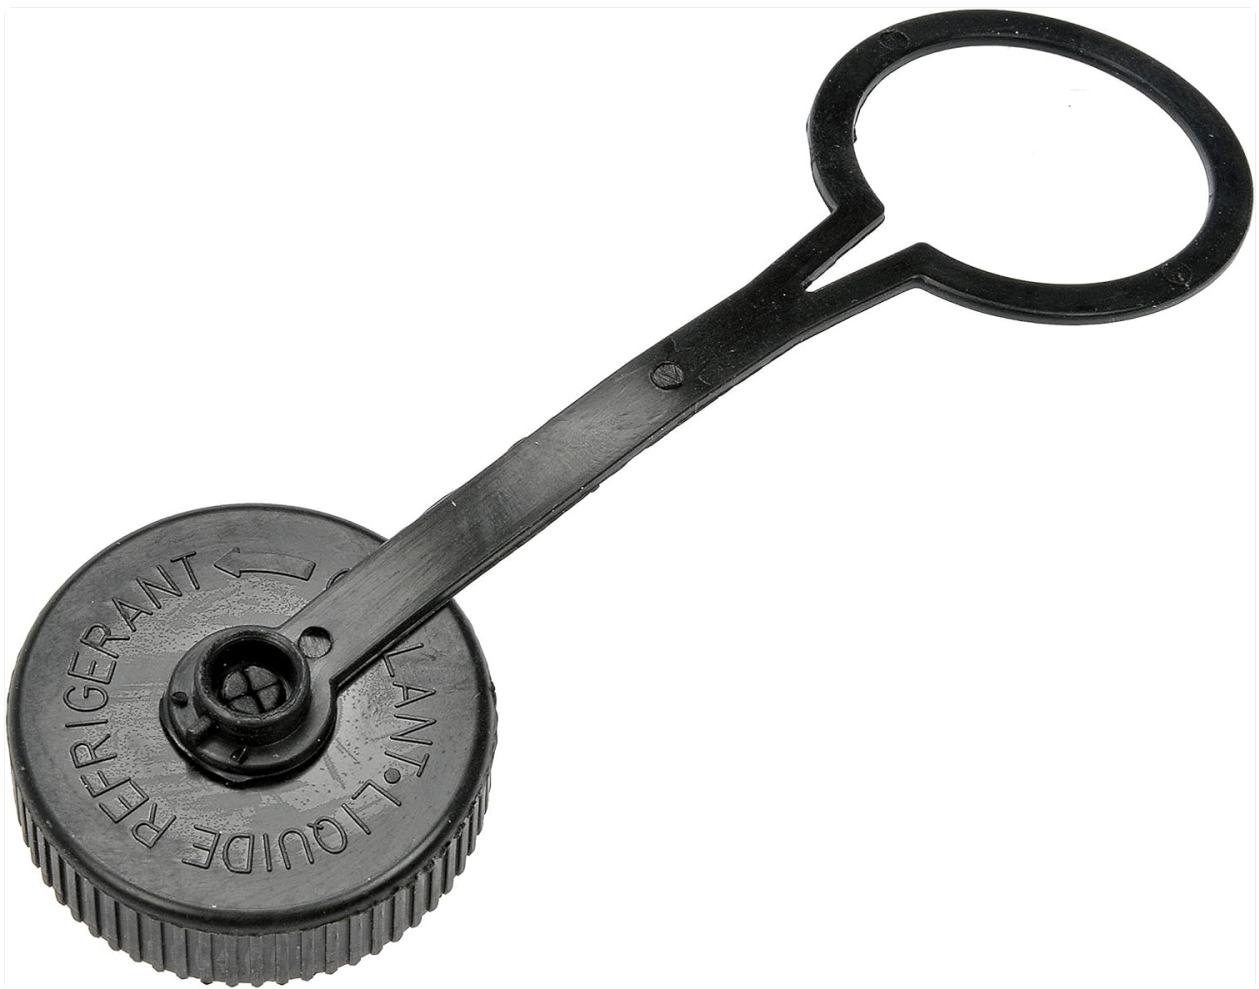
Image 1: Top view of the Dorman 54245 Engine Coolant Cap. This image shows the cap with its attached tether and ring, displaying the "REFRIGERANT" and "ANTI-LIQUIDE" markings.

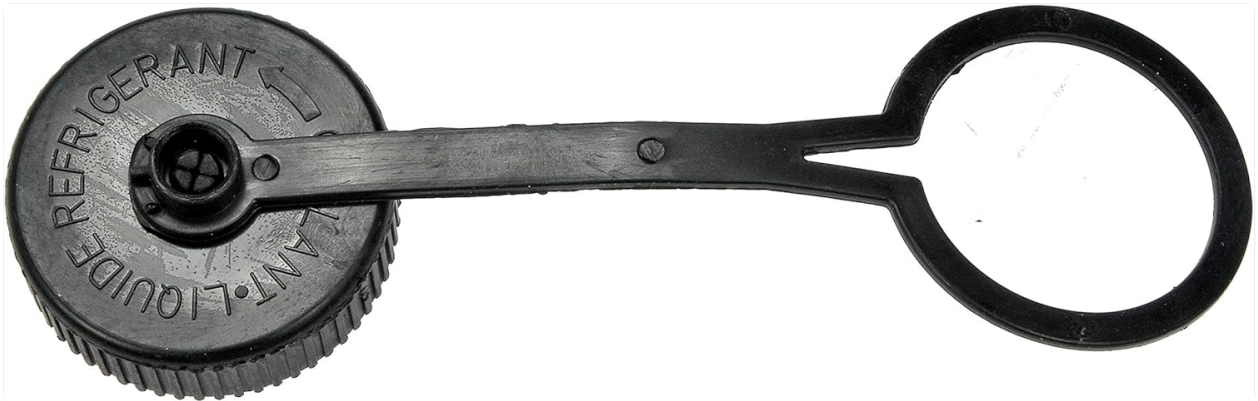
Image 2: Side view of the Dorman 54245 Engine Coolant Cap, showing the cap with its extended tether. This view highlights the design of the cap and its attachment mechanism.
