› **BRANDT Dryer Condenser Rear Seal - Model 57X0666 Instruction Manual**

BRANDT Dryer Condenser Rear Seal - Model 57X0666 Instruction Manual

Essential Guide for Installation and Maintenance

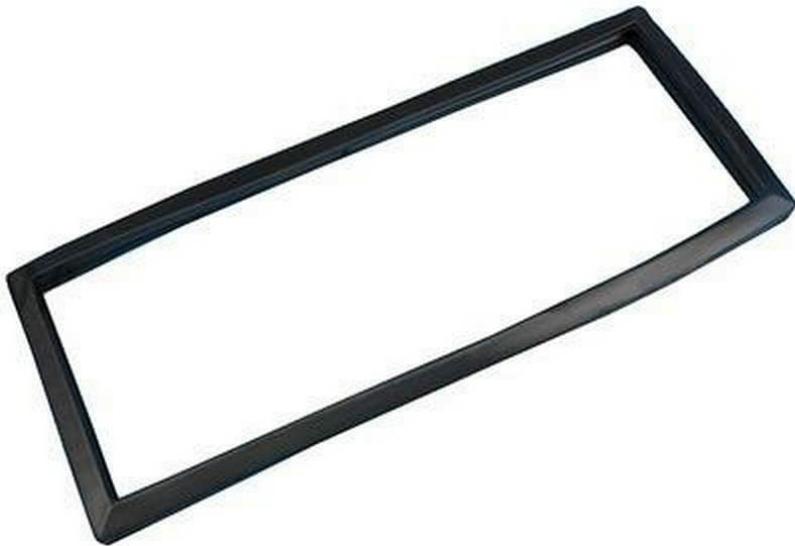
Image: The BRANDT Dryer Condenser Rear Seal, model 57X0666. This image displays the rubber seal component, which is designed to fit at the rear of the dryer's condenser unit.

- Install New Seal:** Position the new BRANDT 57X0666 rear seal onto the condenser unit or the dryer's sealing surface. Ensure it is seated evenly and securely around the entire perimeter. The seal should fit snugly without kinks or twists.

The condenser rear seal plays a vital role in the functionality of a condenser dryer. Its primary purpose is to create an airtight seal between the removable condenser unit and the dryer's internal air circulation system. This seal prevents humid air, extracted from the clothes during the drying process, from escaping into the surrounding environment. Instead, the humid air is directed through the condenser, where moisture is removed and collected, ensuring efficient drying and preventing condensation buildup in the laundry area.
