Philips HQ8100 Series

Philips Shaver Head Motor Drive Shaft Axis Replacement Manual

For HQ8100 Series Electric Shavers

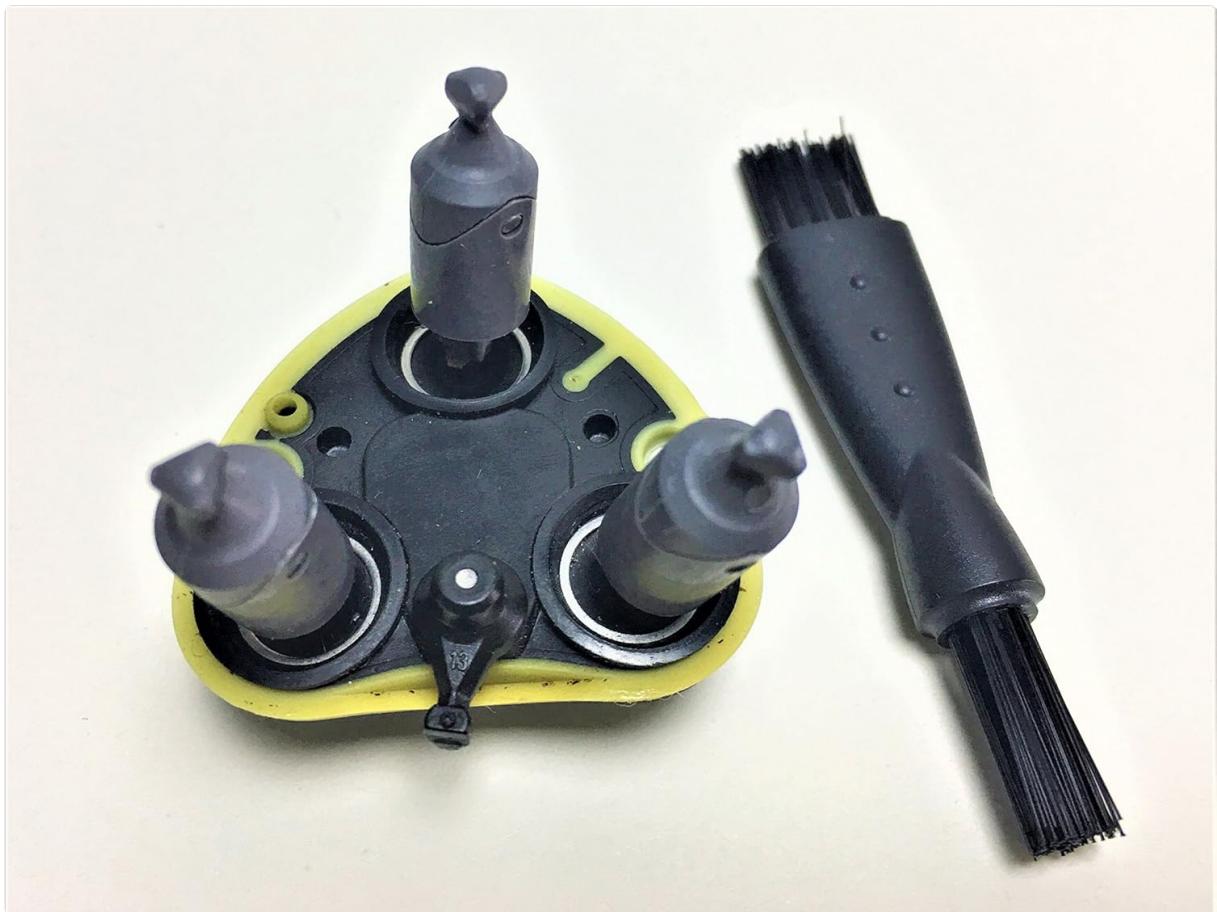
Figure 1: Top view of the Shaver Head Motor Drive Shaft Axis assembly, showing the three individual drive shafts and the included cleaning brush.

4. **Remove Old Part:** Carefully remove the old or damaged drive shaft axis. Be mindful of any small springs or clips.
5. **Install New Drive Shaft:** Position the new Shaver Head Motor Drive Shaft Axis (as shown in Figure 1 and Figure 2) into the shaver head assembly. Ensure that the gears align correctly with the shaver's motor drive and that the shafts properly engage with the cutting elements.

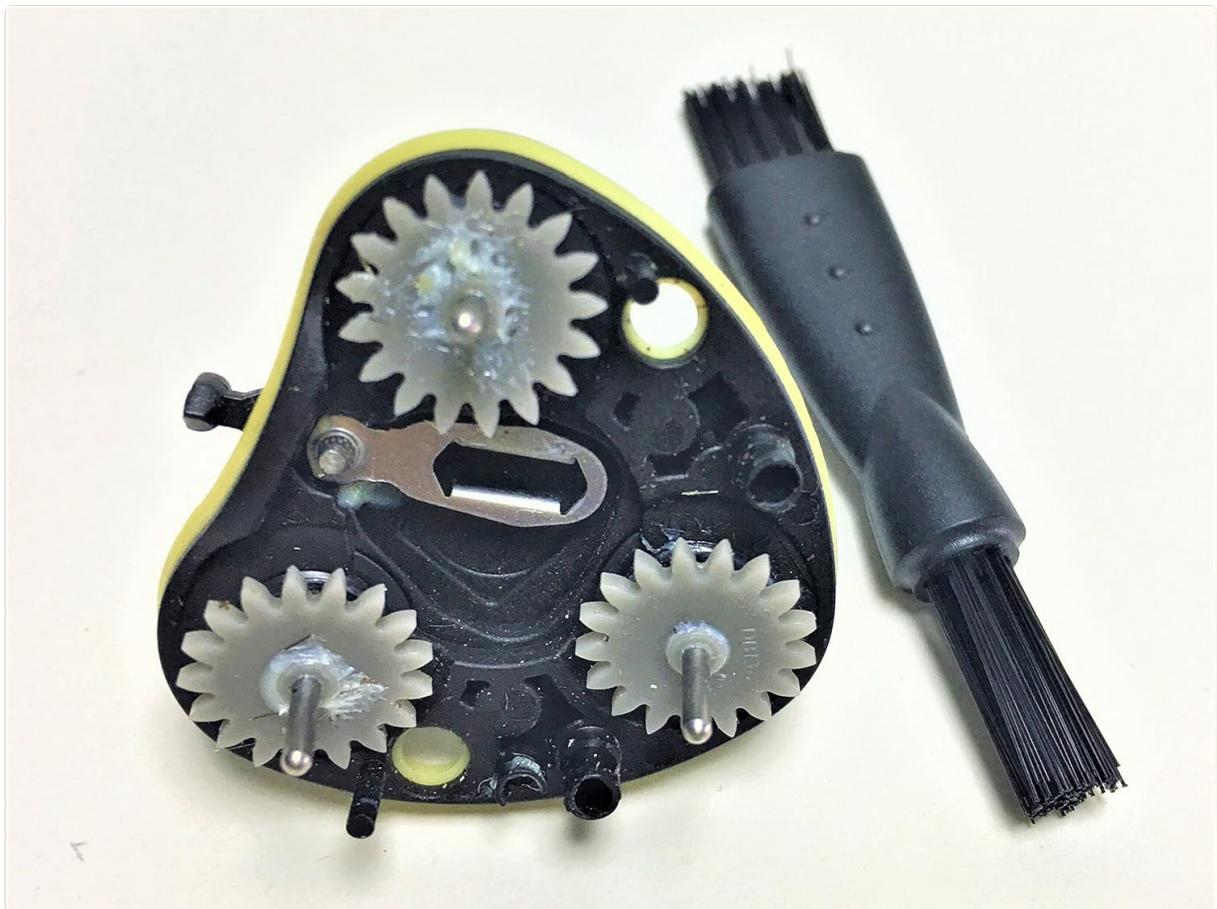
Figure 2: Underside view of the Shaver Head Motor Drive Shaft Axis assembly, illustrating the gear mechanism that connects to the shaver's motor, alongside the cleaning brush.
