› HD Switch RH Steering Linkage Ball Joint End Instruction Manual for Cub Cadet and MTD Models

HD Switch RH Steering Linkage Ball Joint End Instruction Manual

For Cub Cadet and MTD Models 923-0448A, 723-0448A

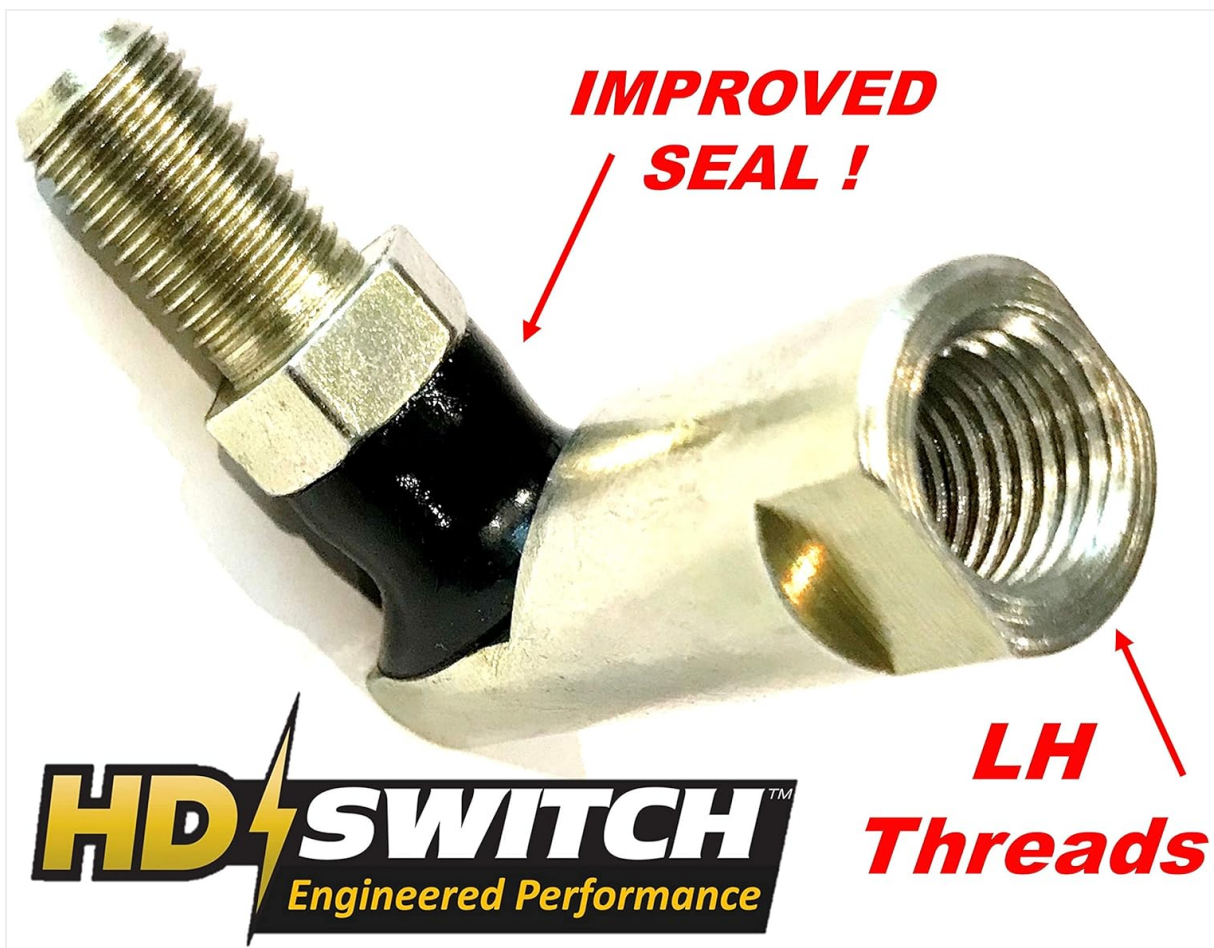
Figure 1: Overview of the HD Switch RH Steering Linkage Ball Joint End. This image displays the complete ball joint end, highlighting its threaded shaft and housing.

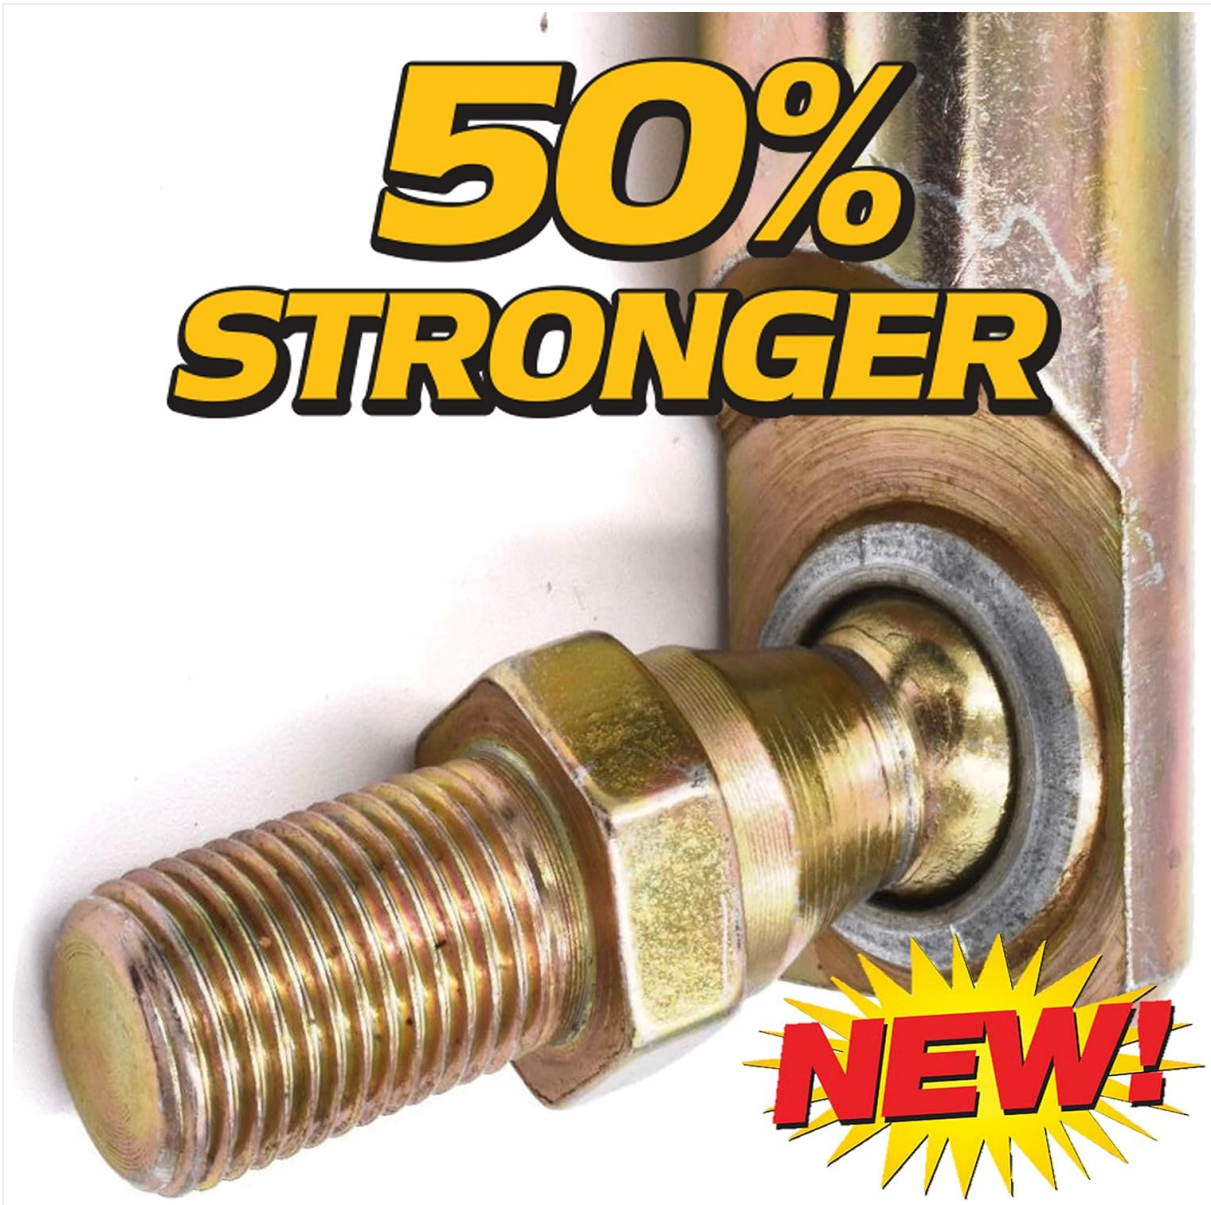
Figure 2: Detail of the ball joint's crimped construction, engineered for increased strength and durability.

- **Part Type:** RH Steering Linkage Ball Joint End
- **Replaces OEM Part Numbers:** Cub Cadet, MTD 923-0448A, 723-0448A
- **Thread Size:** 3/8"-24
- **Construction:** Crimped, 50% stronger design
- **Material:** 4130 Alloy Steel (Chromoly)
- **Corrosion Protection:** Zinc Yellow Coating
- **Brand:** HD Switch
