Exmark 121-5765-FBA

Exmark / Toro 30" Genuine OEM PTO Belt Part# 121-5765 Instruction Manual

Brand: Exmark | **Model:** 121-5765-FBA

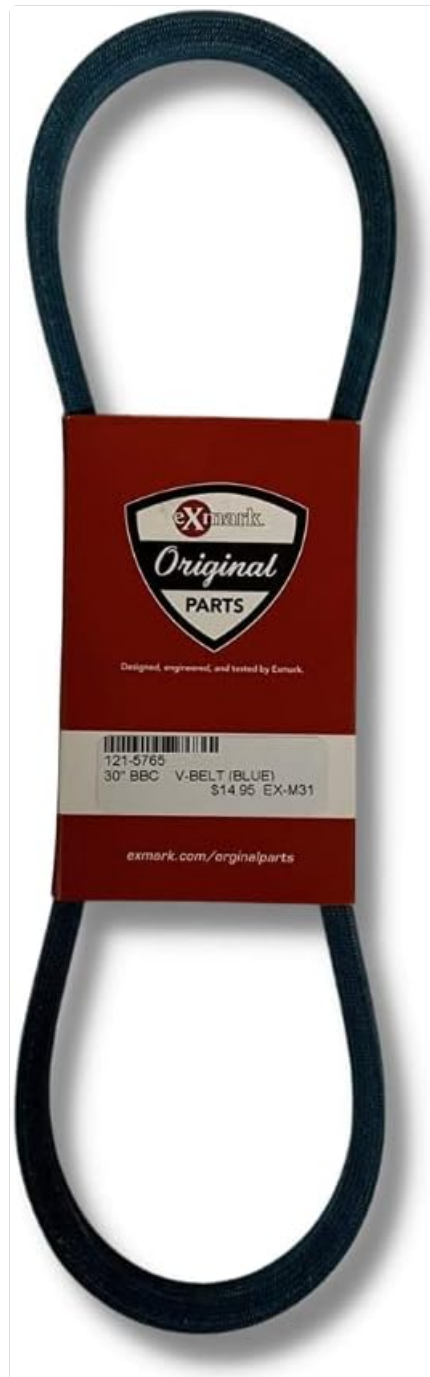
Image: The Exmark / Toro 30" Genuine OEM PTO Belt (Part# 121-5765) in its packaging, showcasing its blue color and official branding.

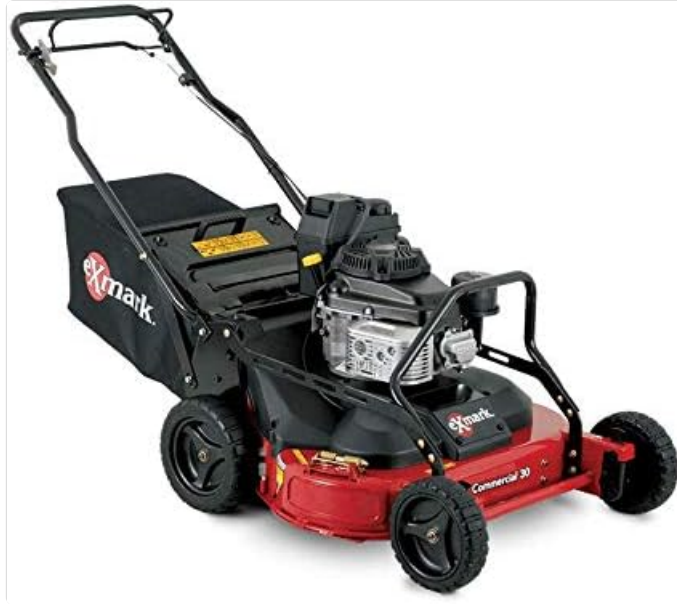
Image: An Exmark Commercial 30" walk-behind mower, illustrating the general type of equipment this belt is used with.

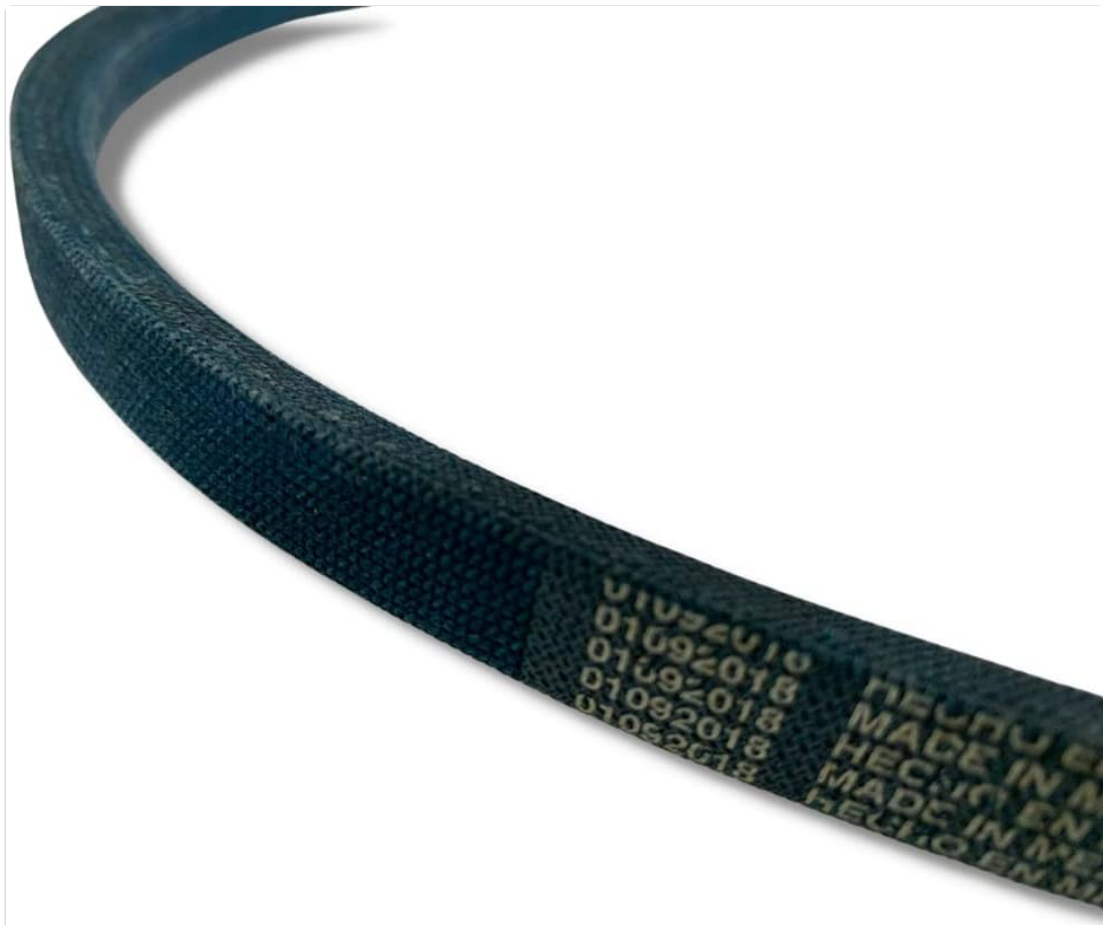
Image: A close-up view of the PTO belt, showing its texture and construction. This image can help in identifying the correct belt type.

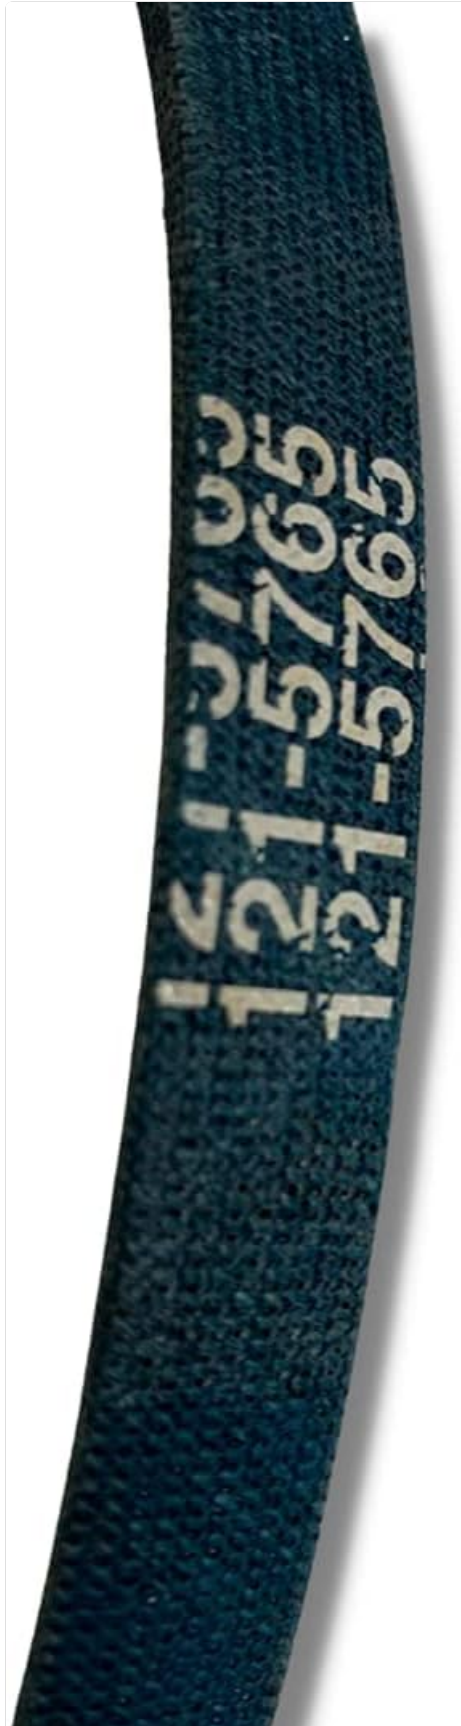
Image: A detailed view of the new PTO belt, clearly showing the part number "121-5765" printed on its surface.

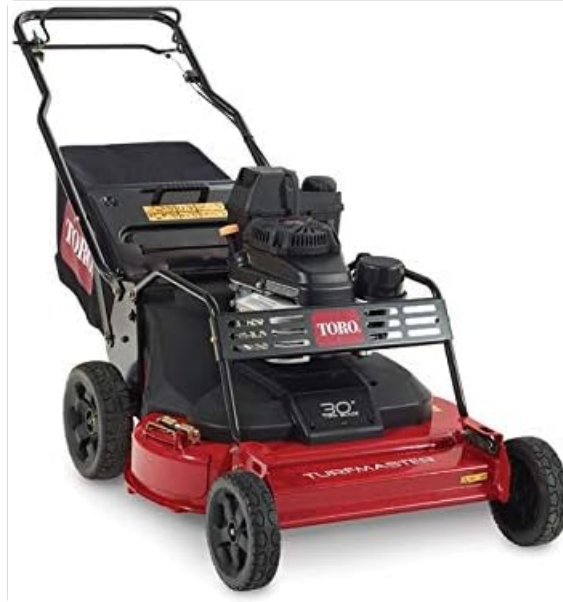
Image: A Toro TimeMaster 30" walk-behind mower, another compatible model for this PTO belt.
