# Dorman TI91140XL Front Inner Steering Tie Rod End User Manual

Brand: Dorman | Model: TI91140XL

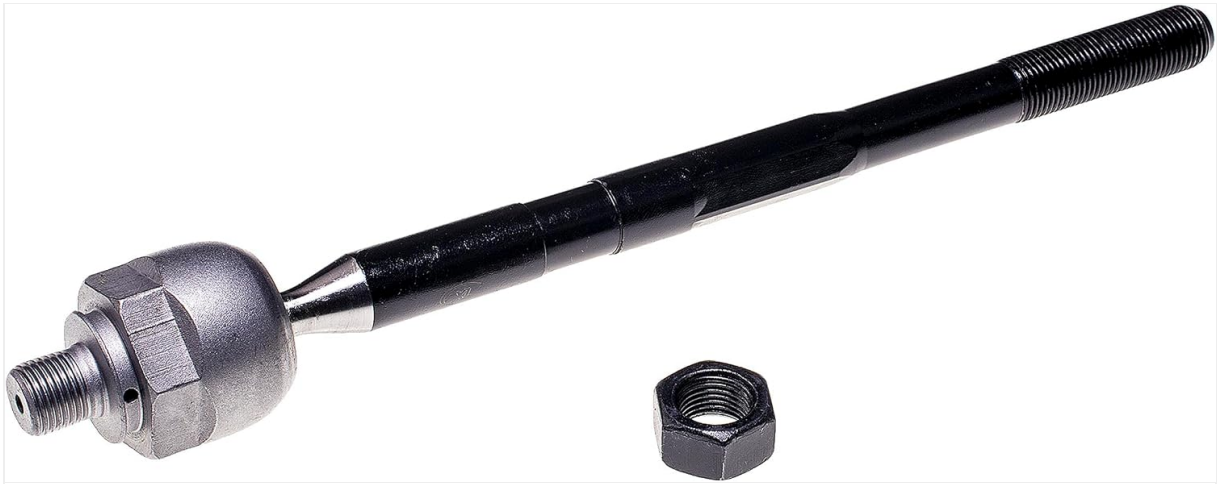
Image 1: The Dorman TI91140XL Front Inner Steering Tie Rod End, showing the main component and accompanying nut.

This Dorman TI91140XL Front Inner Steering Tie Rod End is engineered for smooth performance and superior durability. It features a hardened stud, highly polished ball, a maintenance-free polymer bearing, I.C.E. synthetic grease, and premium corrosion resistance. This component is designed to replace the original tie rod end in compatible Hummer H3 (2006-2010) and Hummer H3T (2009-2010) models, restoring factory handling and feel.

- **Extended-life construction:** Built with features to deliver smooth performance and extended durability for demanding drivers.
- **Superior ball stud:** Features a hardened ArmourGrade stud with a highly polished EverSmooth ball.
- **Low-friction bearing:** Utilizes an UltraFlow normalized forged housing with I.C.E. synthetic grease and a low-friction polymer bearing.
- **Premium corrosion resistance:** Equipped with WeatherShield external coating to resist corrosion.
- **Ensured fit:** Designed for direct fitment in specified vehicle applications.

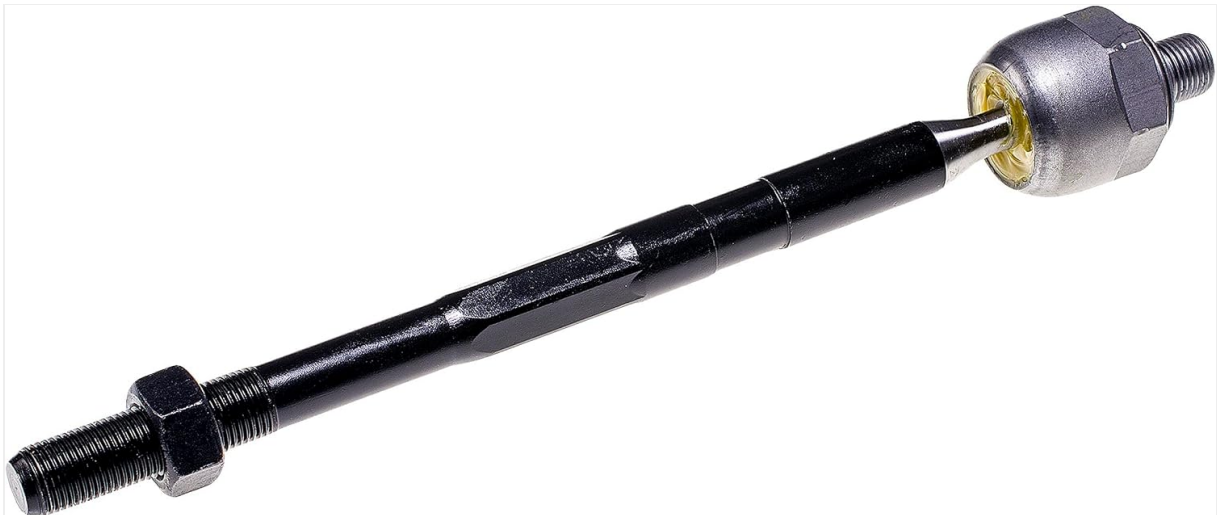
Image 2: An angled view of the Dorman TI91140XL Front Inner Steering Tie Rod End, highlighting its construction and the included nut.

- 1 x Dorman TI91140XL Front Inner Steering Tie Rod
- 1 x Nut
