# AMP PB5600 Plastic Snap-On Isolator Shift Bushing Instruction Manual

For NV5600, NV3500, NV3550, and TR3650 Transmissions

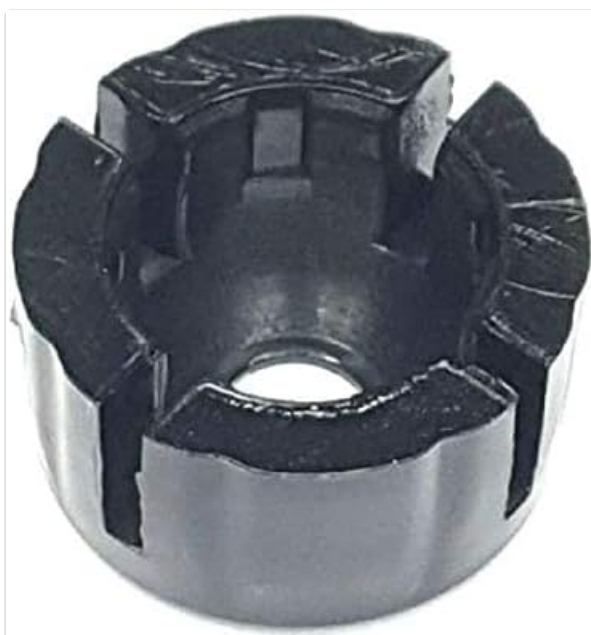
**Figure 1:** Top view of the AMP PB5600 plastic snap-on isolator shift bushing, showing its circular shape and internal structure.

The AMP PB5600 is a plastic snap-on isolator shift bushing designed to replace worn or damaged bushings in manual transmission shifter mechanisms. This component is crucial for maintaining precise and smooth gear engagement. It is compatible with NV5600, NV3500, NV3550, and TR3650 manual transmissions.

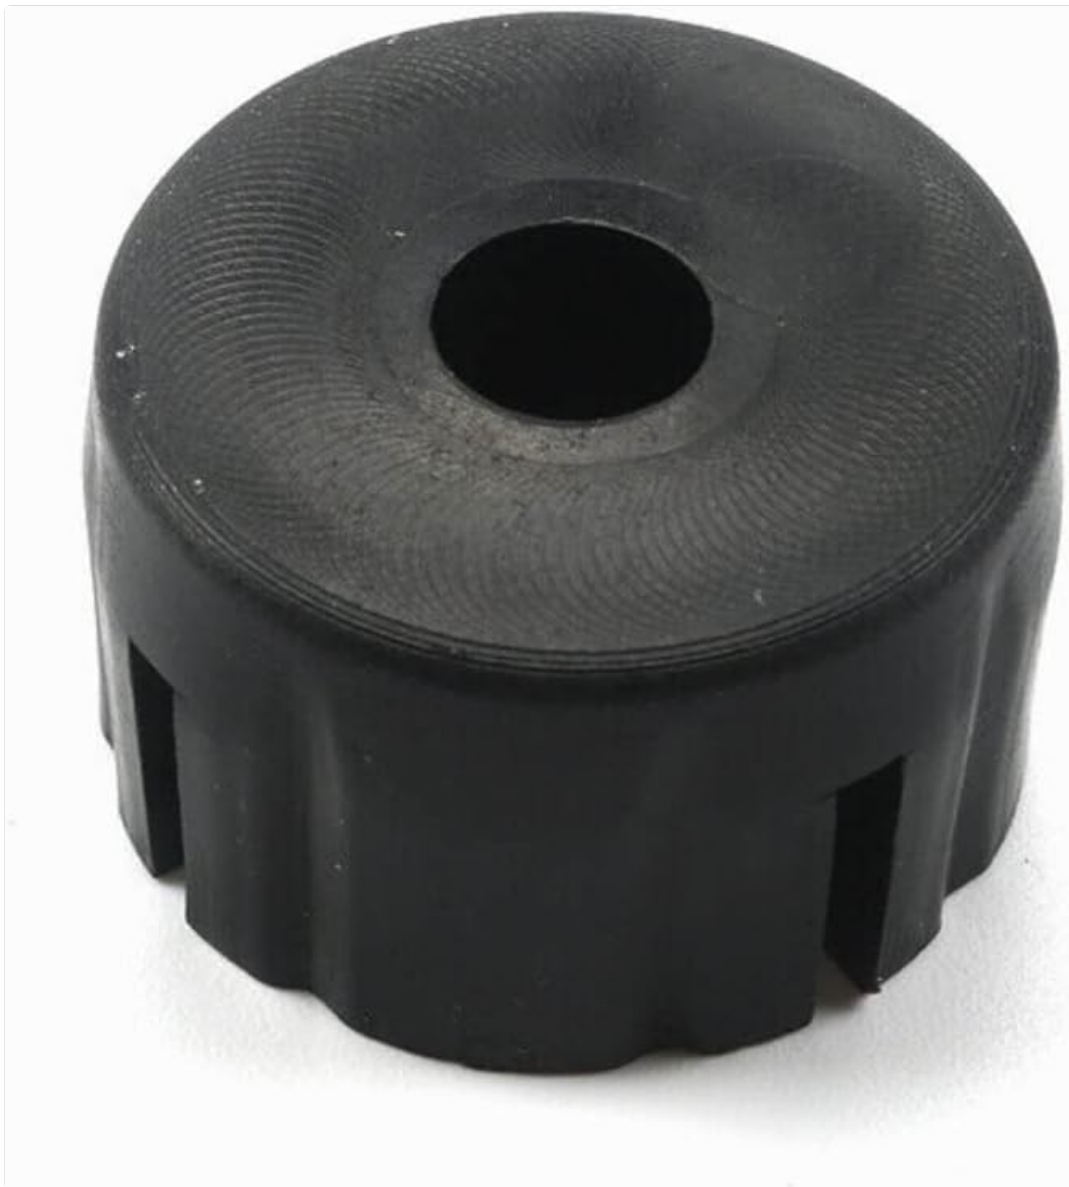
**Figure 2:** Side view of the AMP PB5600 bushing, illustrating its snap-on design and overall profile.

4. **Clean the Area:** Clean any debris, old grease, or worn material from the shifter lever and the housing where the new bushing will be installed.
5. **Install the New Bushing:** Position the AMP PB5600 bushing onto the shifter lever. Apply firm, even pressure to snap the new bushing into place. Ensure it is fully seated and properly oriented. The snap-on design should allow for a secure fit without excessive force.

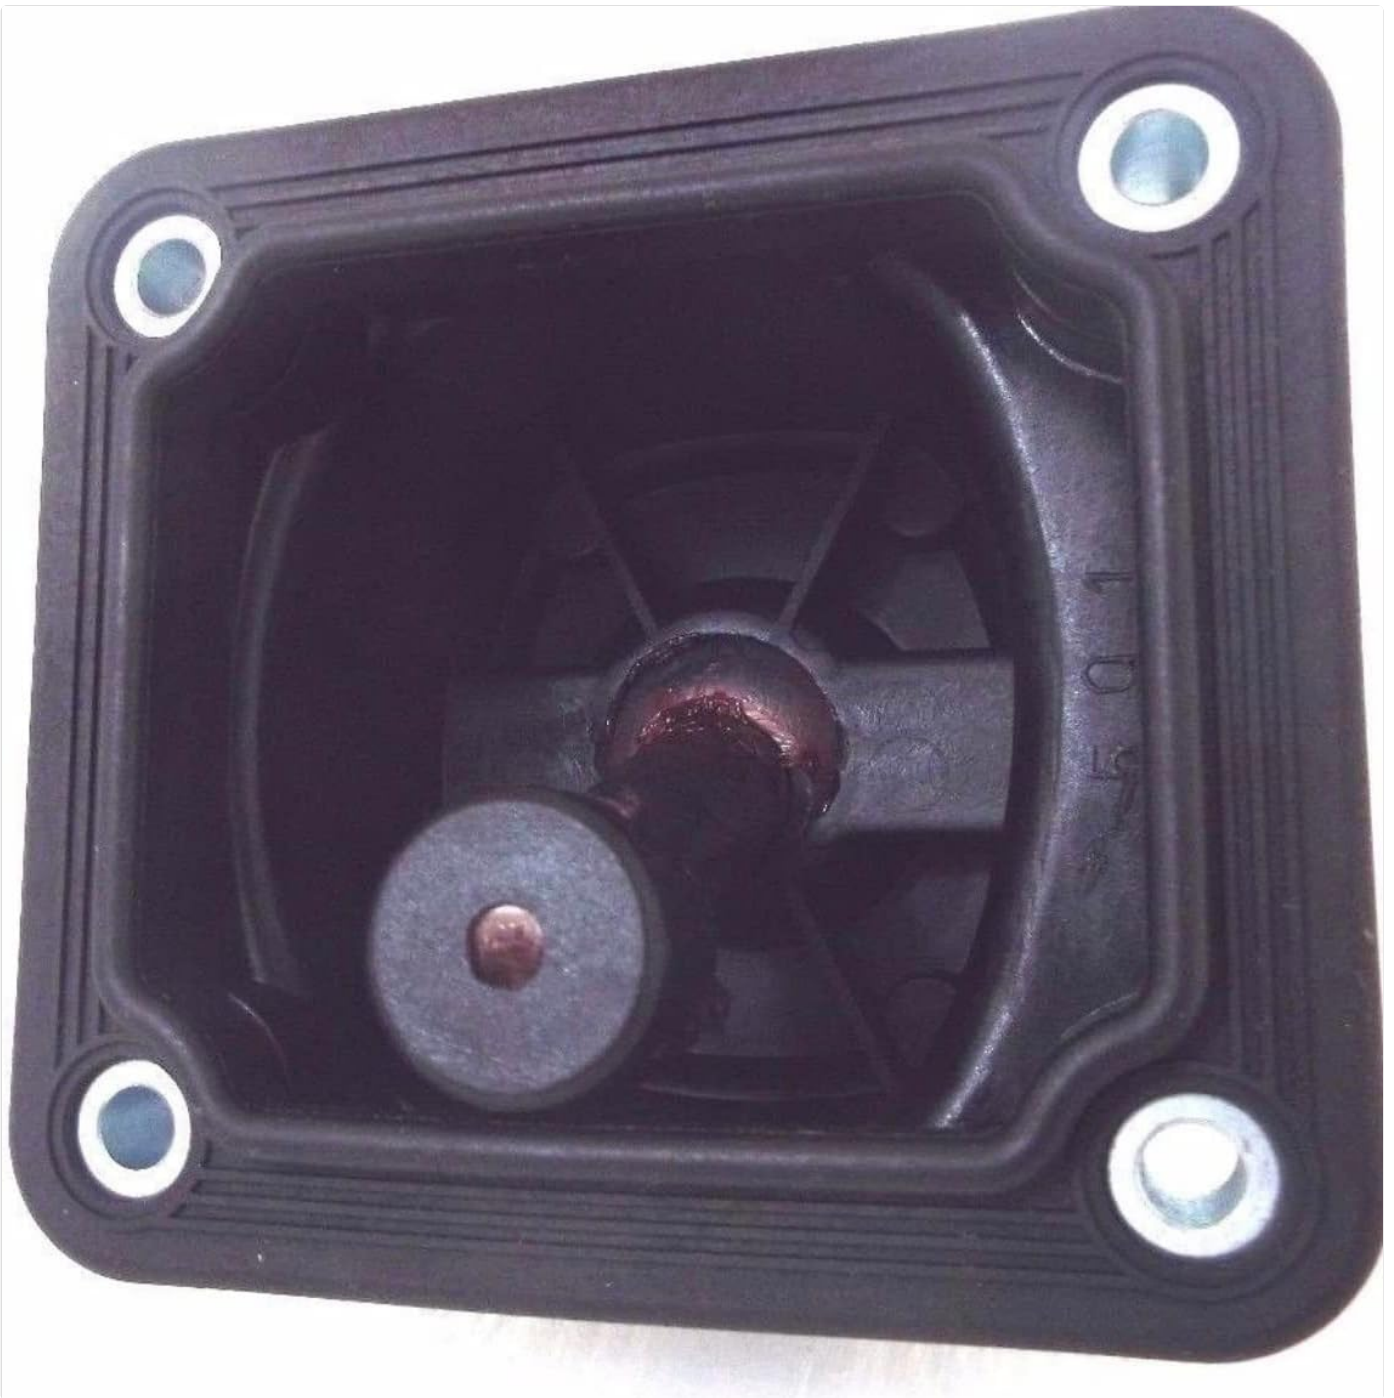
**Figure 3:** An example of a shifter assembly, indicating the general location where the isolator shift bushing is typically installed to connect the shifter lever to the transmission linkage.

2. **Locate the Old Bushing:** Identify the existing isolator shift bushing within the shifter mechanism. It is typically located at the base of the shifter lever where it connects to the transmission linkage.
