ZDTOPA G13B G4DG Cylinder Head Gasket MD066163 User Manual

Model: MD066163

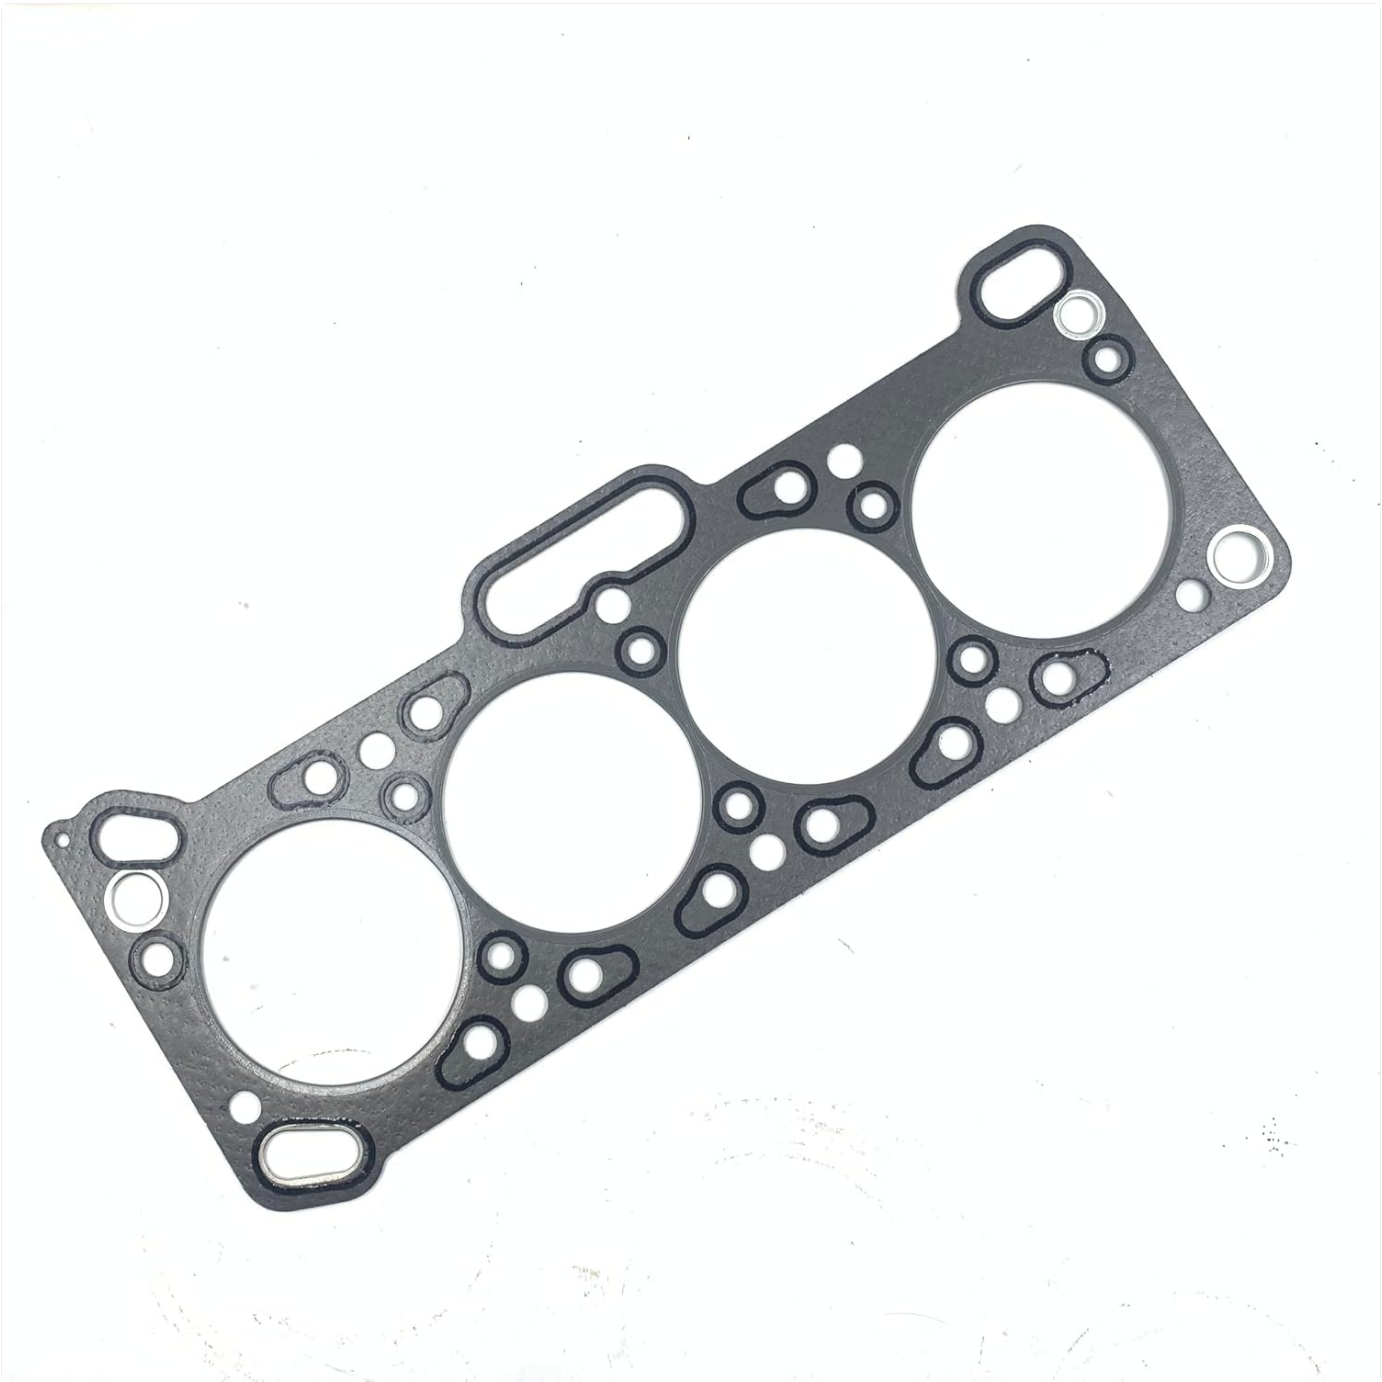
Image: The ZDTPA G13B G4DG Cylinder Head Gasket, showing its overall shape and design. This gasket is crucial for sealing the engine's combustion chambers and fluid passages.

The ZDTOPA G13B G4DG Cylinder Head Gasket, part number MD066163, is designed to provide a critical seal between the engine block and cylinder head. This component is vital for maintaining proper engine compression and preventing leakage of coolant or engine oil. It is constructed from graphite or similar materials, ensuring resistance to corrosion, heat, and oil, which are essential for engine longevity and performance.

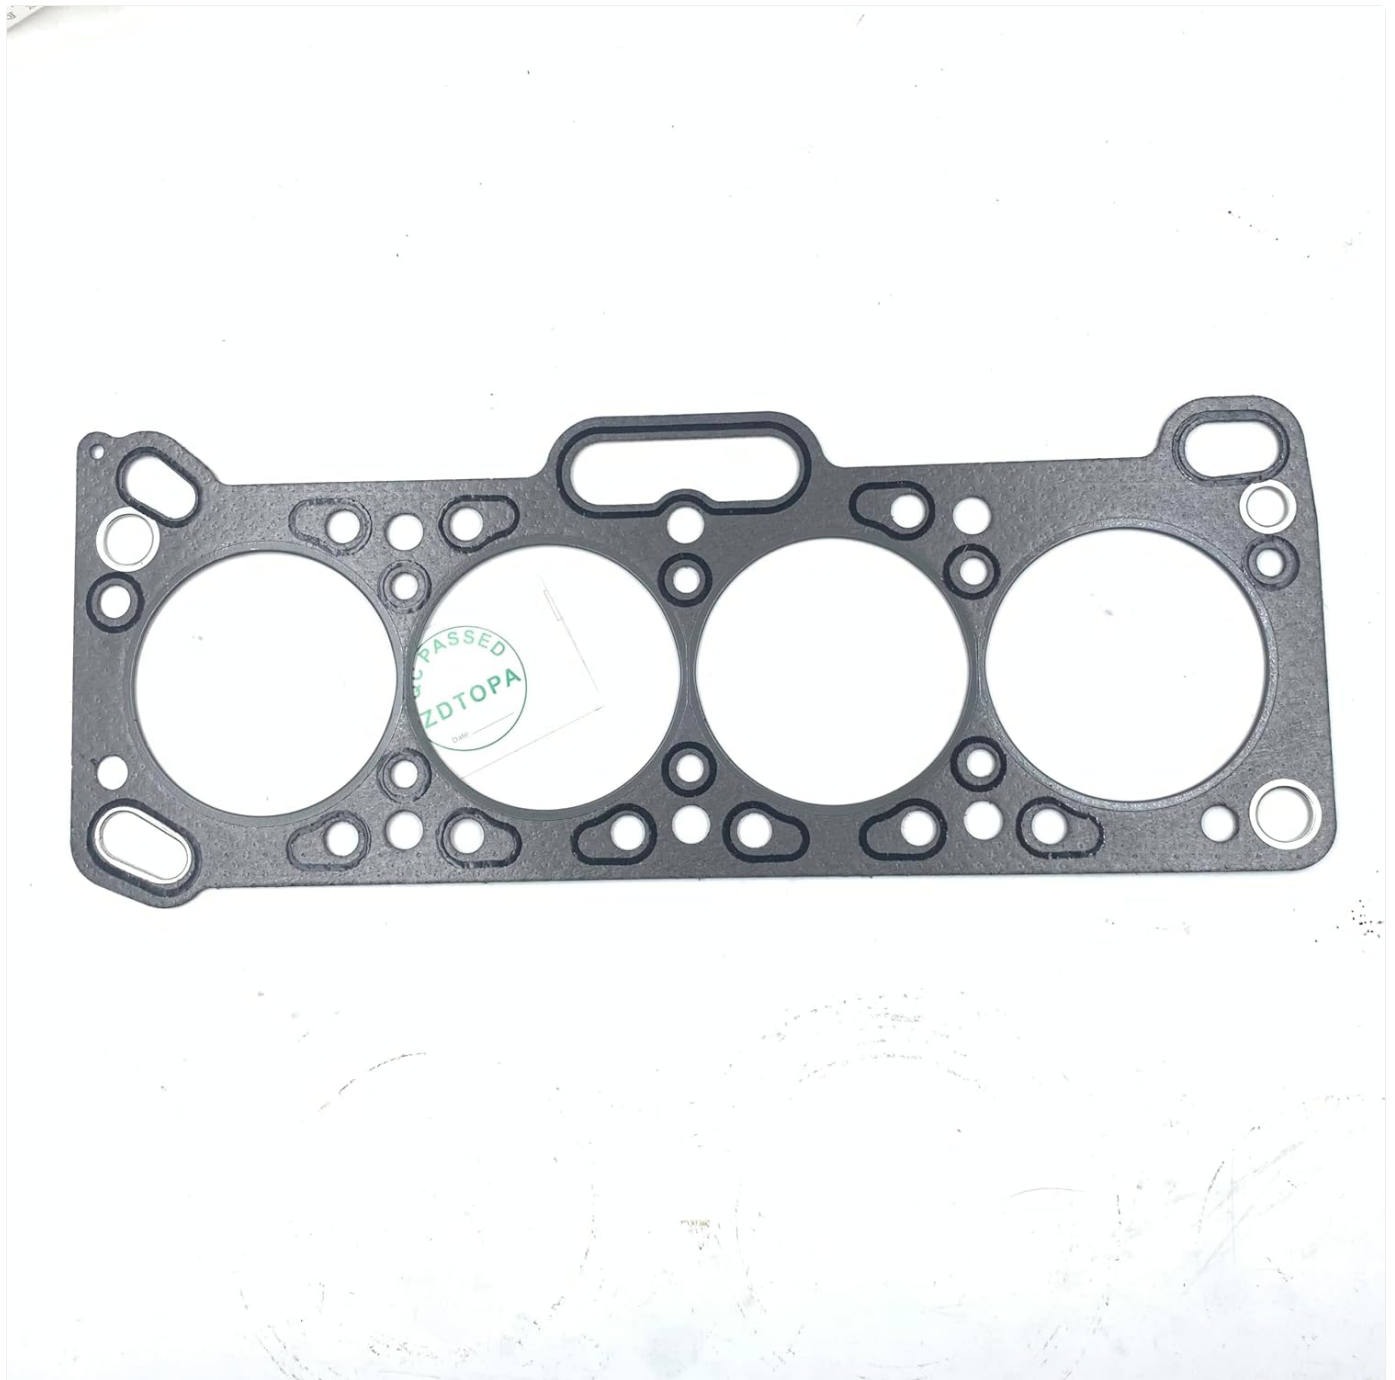
Image: A view of the ZDTOPA cylinder head gasket, possibly showing a quality control stamp or branding. This angle highlights the precision cutouts for bolts and fluid passages.

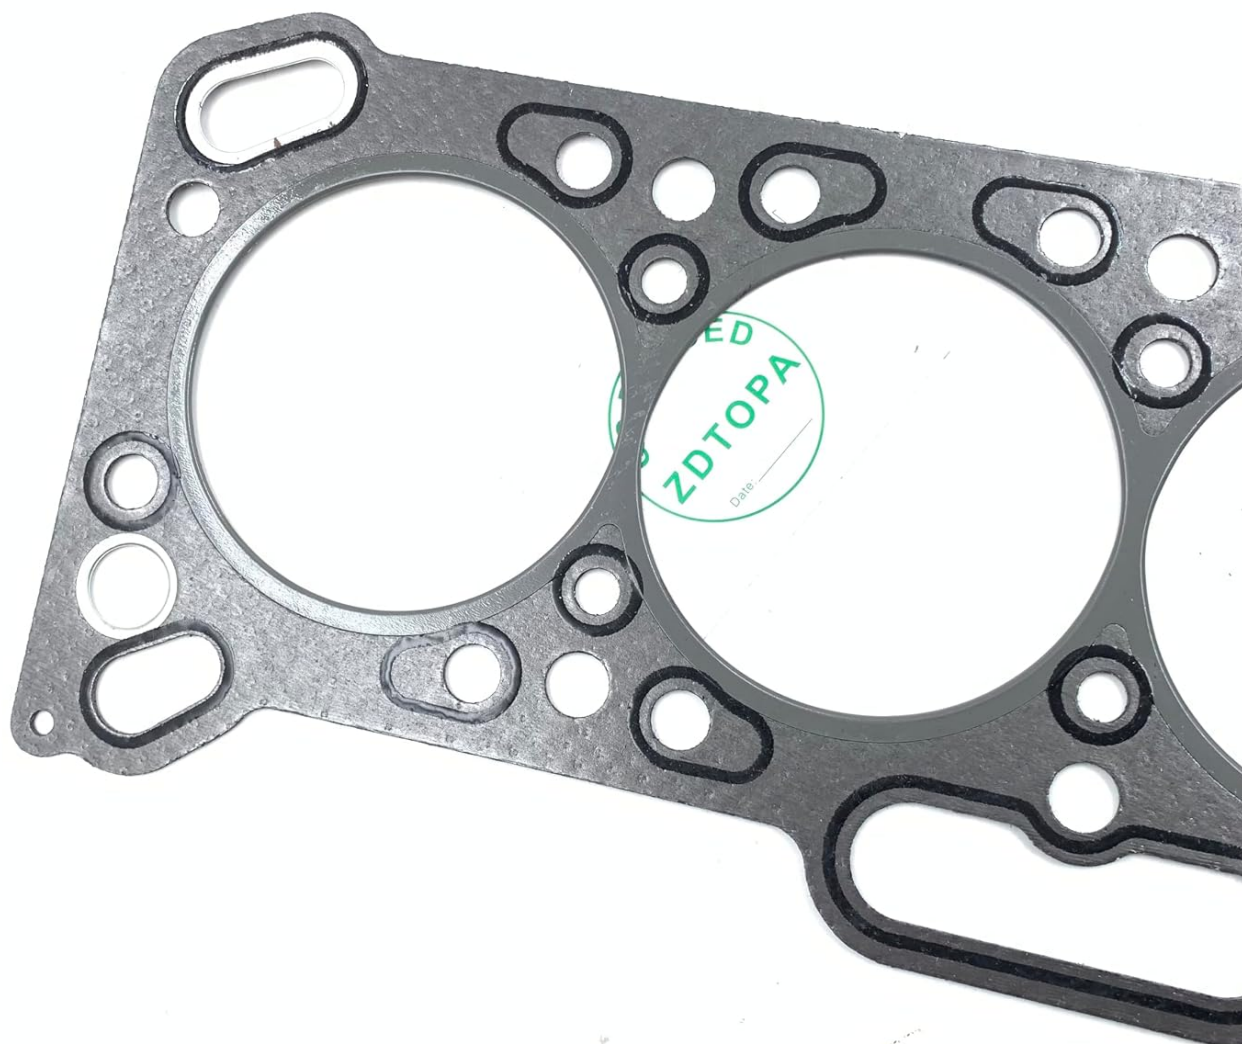
Image: A detailed close-up of the gasket material and construction, highlighting the sealing rings and fluid passages. This view emphasizes the quality and precision of the component.
