› Cutex Upper Cover Gasket #118-00505 for Juki MO-2300, MO-2400, MO-2500 Series Overlock Instruction Manual

Cutex Upper Cover Gasket #118-00505 Instruction Manual

For Juki MO-2300, MO-2400, MO-2500 Series Industrial Overlock Sewing Machines

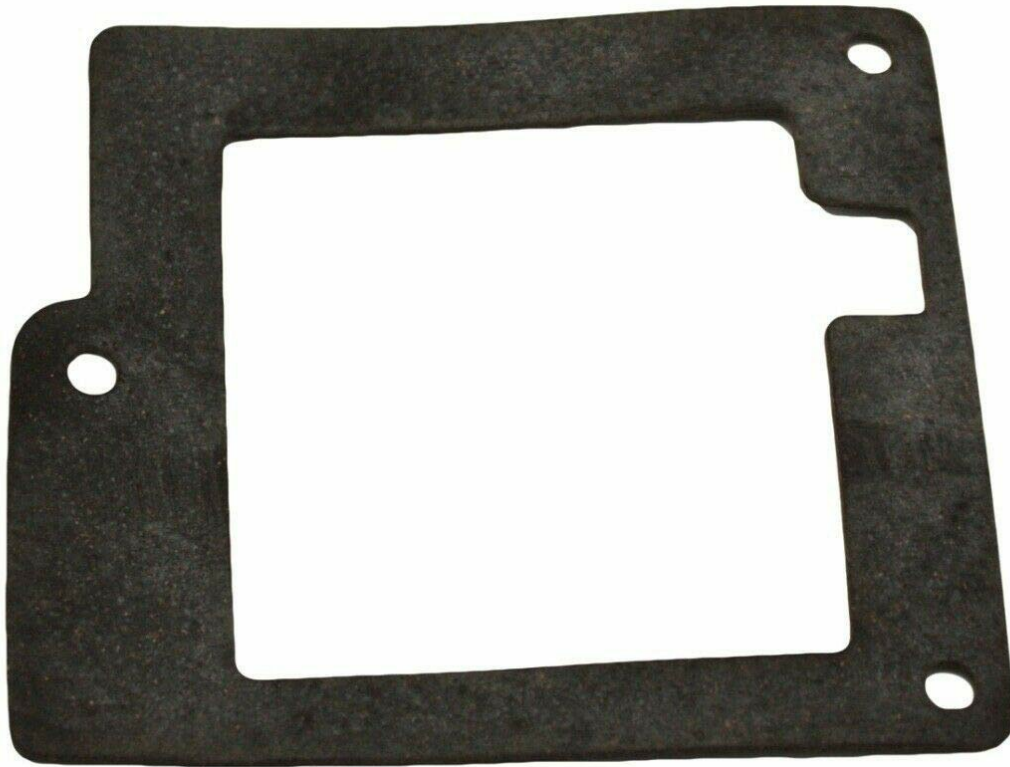
An image showing the Cutex Upper Cover Gasket, part number 118-00505. The gasket is dark gray, rectangular with a large central cutout, and features three small circular holes for mounting screws, one on the left side and two on the right side, one at the top right corner and one at the bottom right corner. It has specific cutouts to fit the contours of the upper cover of compatible Juki overlock machines.

4. **Position New Gasket:** Align the new Cutex Upper Cover Gasket (Part #118-00505) with the contours and screw holes of the upper cover. Ensure it sits flush and evenly without any kinks or twists.
