Mintu MTW6700TQ0

Mintu Washer Bearing Kit Instruction Manual

For Kenmore Elite Oasis and Maytag Bravos Washers

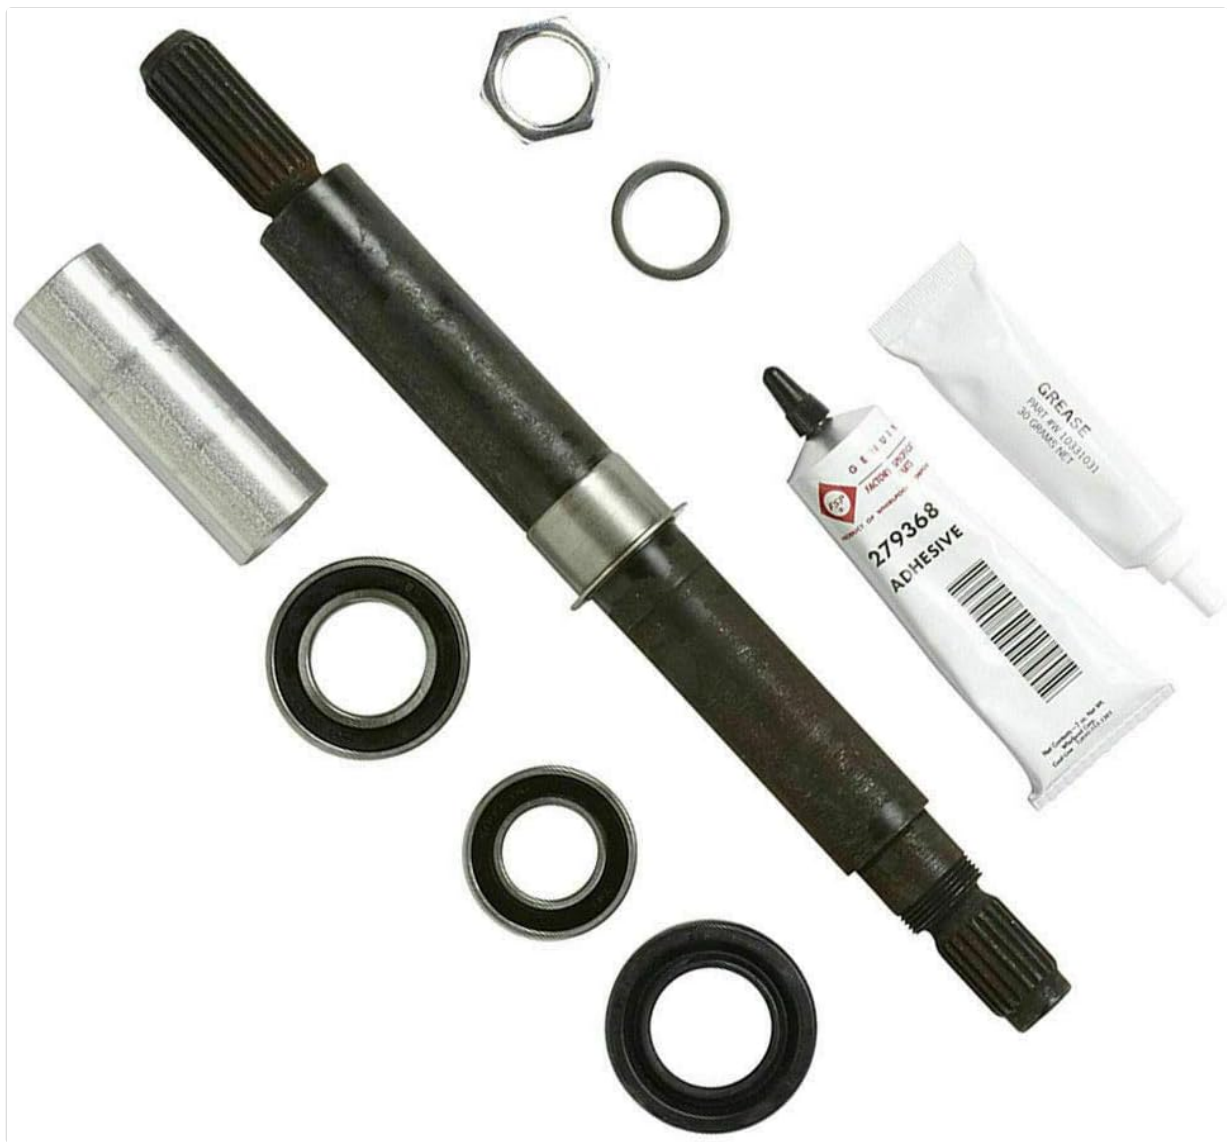
Image 1: Overview of the Mintu Washer Bearing Kit components. This image displays the main shaft, two bearings, a tub seal, a retaining nut, a metal sleeve, a tube of grease, and a tube of adhesive, all essential for the washer repair.

- **Brand:** Mintu
- **Part Number/Model:** MTW6700TQ0 (representative model for kit compatibility)
- **Compatible Washer Brands:** Kenmore, Maytag, Whirlpool (refer to product description for specific model numbers)
- **Included Components:** Main shaft, 2 bearings, 1 tub seal, retaining nut, metal sleeve, grease, adhesive.
- **Material:** Stainless steel (for certain components)
- **UPC:** 017015800648

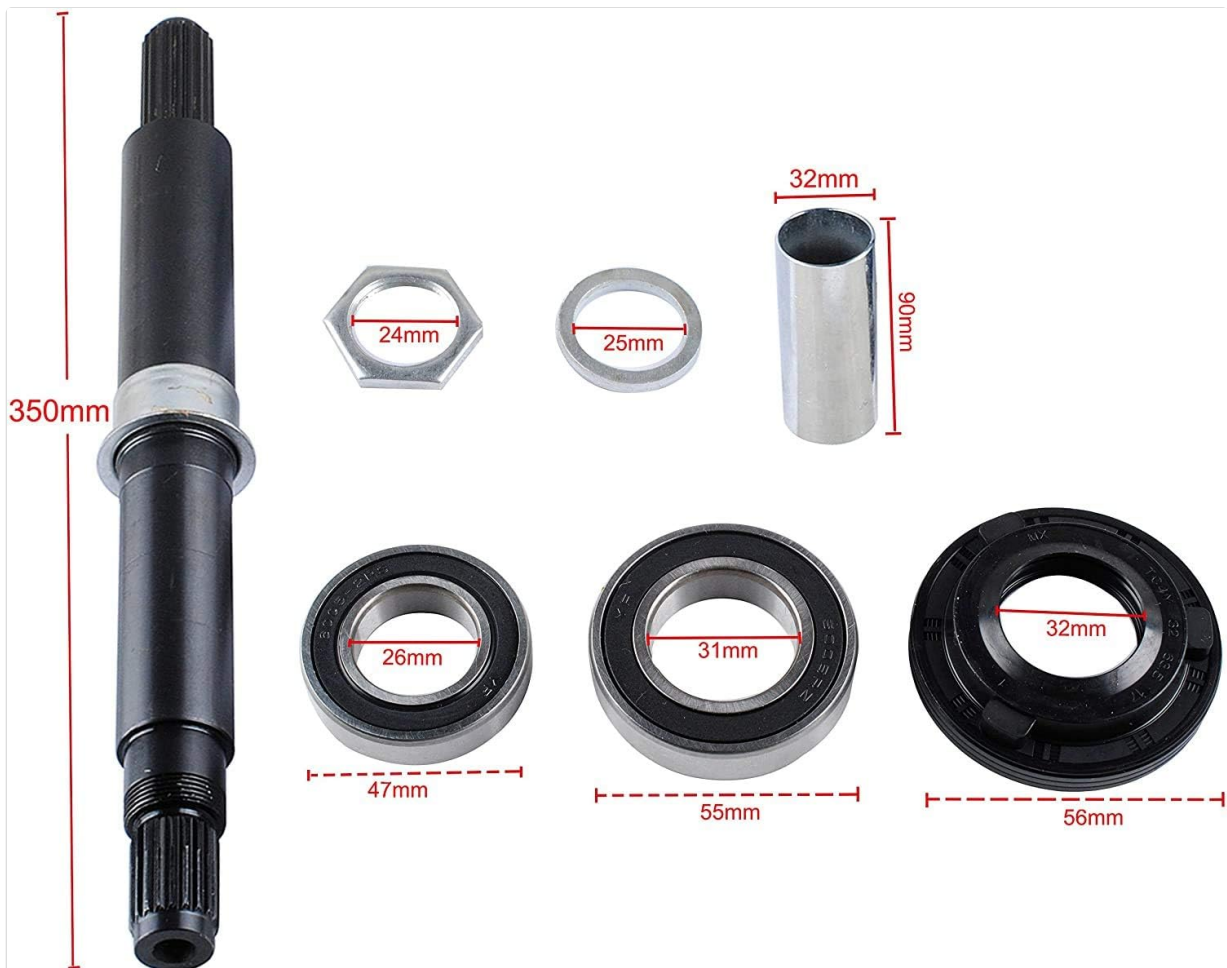
Image 2: Detailed dimensions of the Mintu Washer Bearing Kit components. This image provides measurements for the shaft (350mm length), nut (24mm), washer (25mm), sleeve (32mm diameter, 90mm length), bearings (26mm inner, 47mm outer; 31mm inner, 55mm outer), and seal (32mm inner, 56mm outer), aiding in component identification and compatibility verification.
