› NICHE Rear CV Axle Boot Kit for Polaris RZR 4 900 1000 - Instruction Manual

NICHE Rear CV Axle Boot Kit

INSTRUCTION MANUAL

Model: 519-KCV2228B

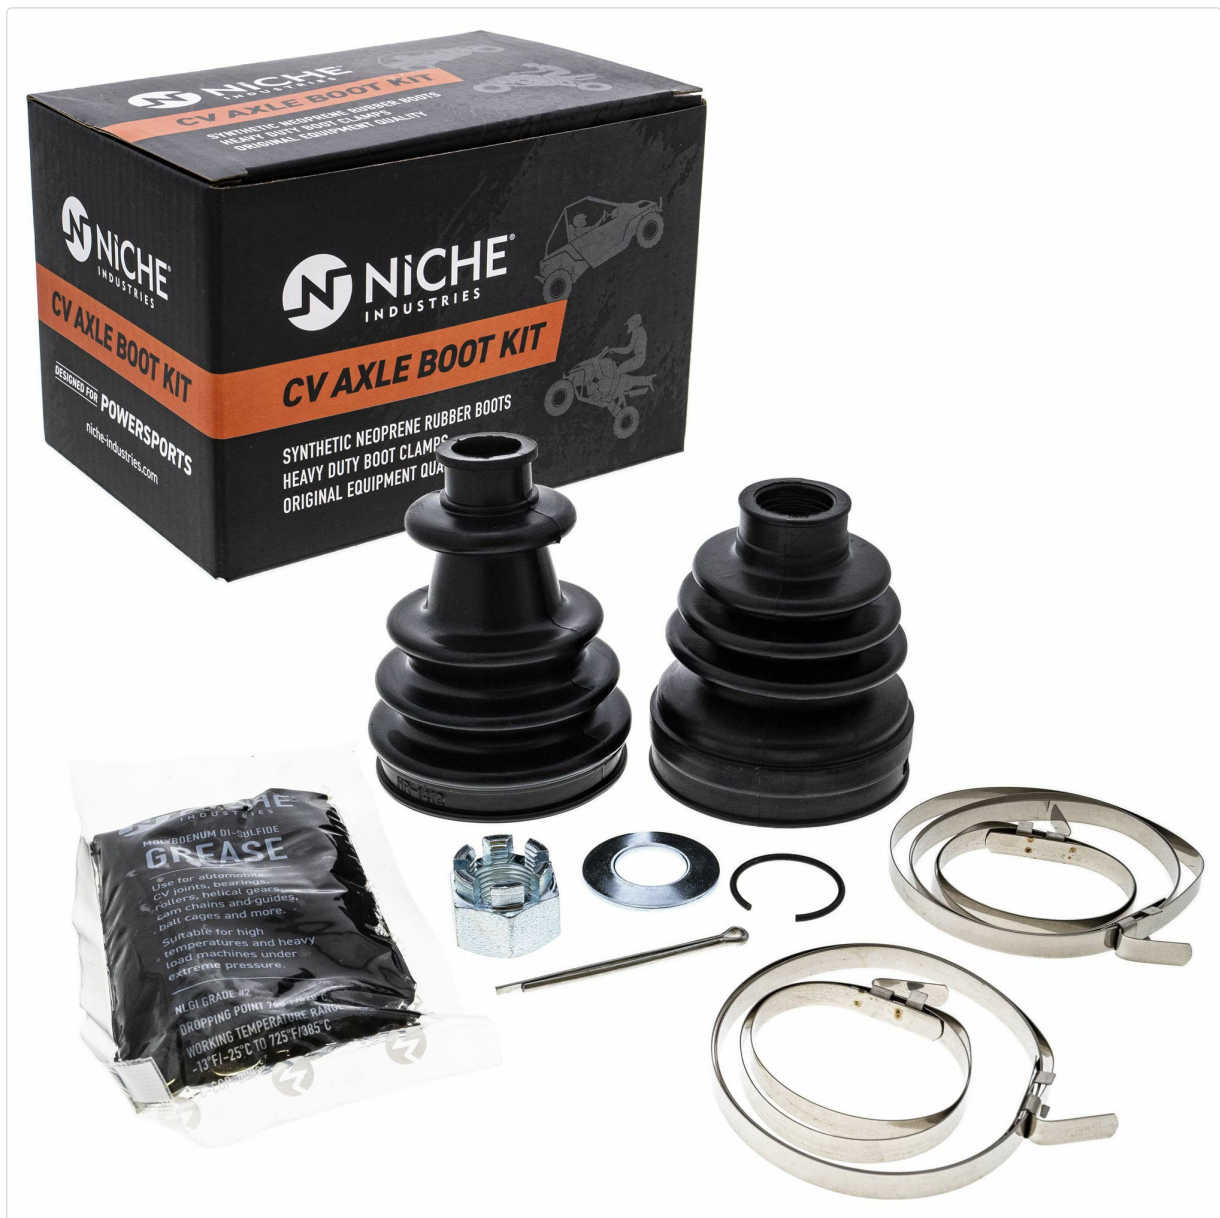
Image 2.1: Complete NICHE Rear CV Axle Boot Kit, showing boots, clamps, grease, and hardware.

- CV Axle Boot(s)
- Boot Clamp(s)
- Grease Packet (Molybdenum Di-Sulfide Grease)
- Associated Hardware (e.g., nut, washer, cotter pin, if applicable)

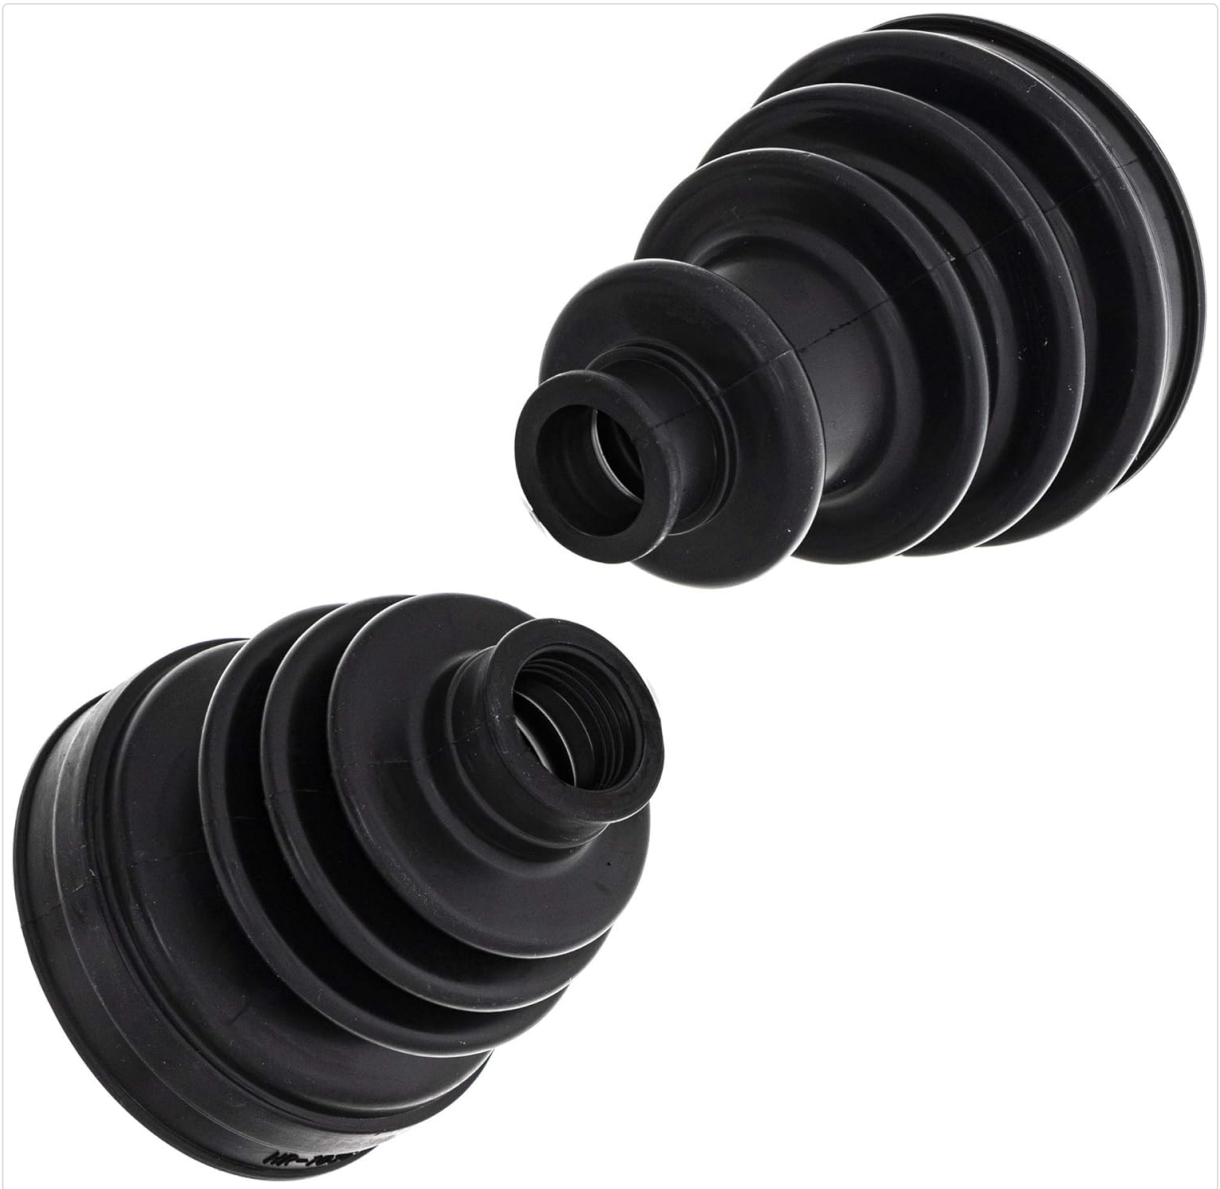
Image 3.1: Two NICHE CV axle boots, made from durable Neoprene Polychloroprene rubber.

- **Material:** Durable Neoprene Polychloroprene rubber for boots, heavy-duty stainless steel for clamps.
- **Grease:** Molybdenum Di-Sulfide grease, suitable for high temperatures and heavy load applications.
- **Boot Clamp Gauge:** 0.36mm.
- **OEM Equivalent:** Designed to meet or exceed OEM specifications.

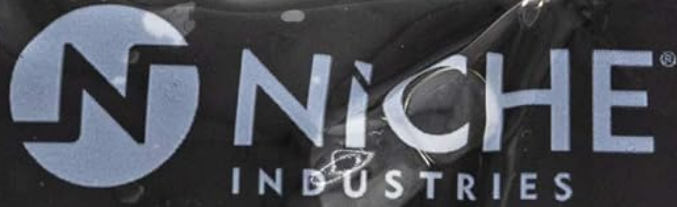
MOLYBDENUM DI-SULFIDE
GREASE

Use for automobile
CV joints, bearings,
rollers, helical gears,
cam chains and guides,
ball cages and more.

Suitable for high
temperatures and heavy
load machines under
extreme pressure.

NLGI GRADE #2

DROPPING POINT 780°F/420°C

WORKING TEMPERATURE RANGE

-13°F/-25°C TO 725°F/400°C

Image 3.2: Packet of Molybdenum Di-Sulfide Grease, included for lubrication during installation.

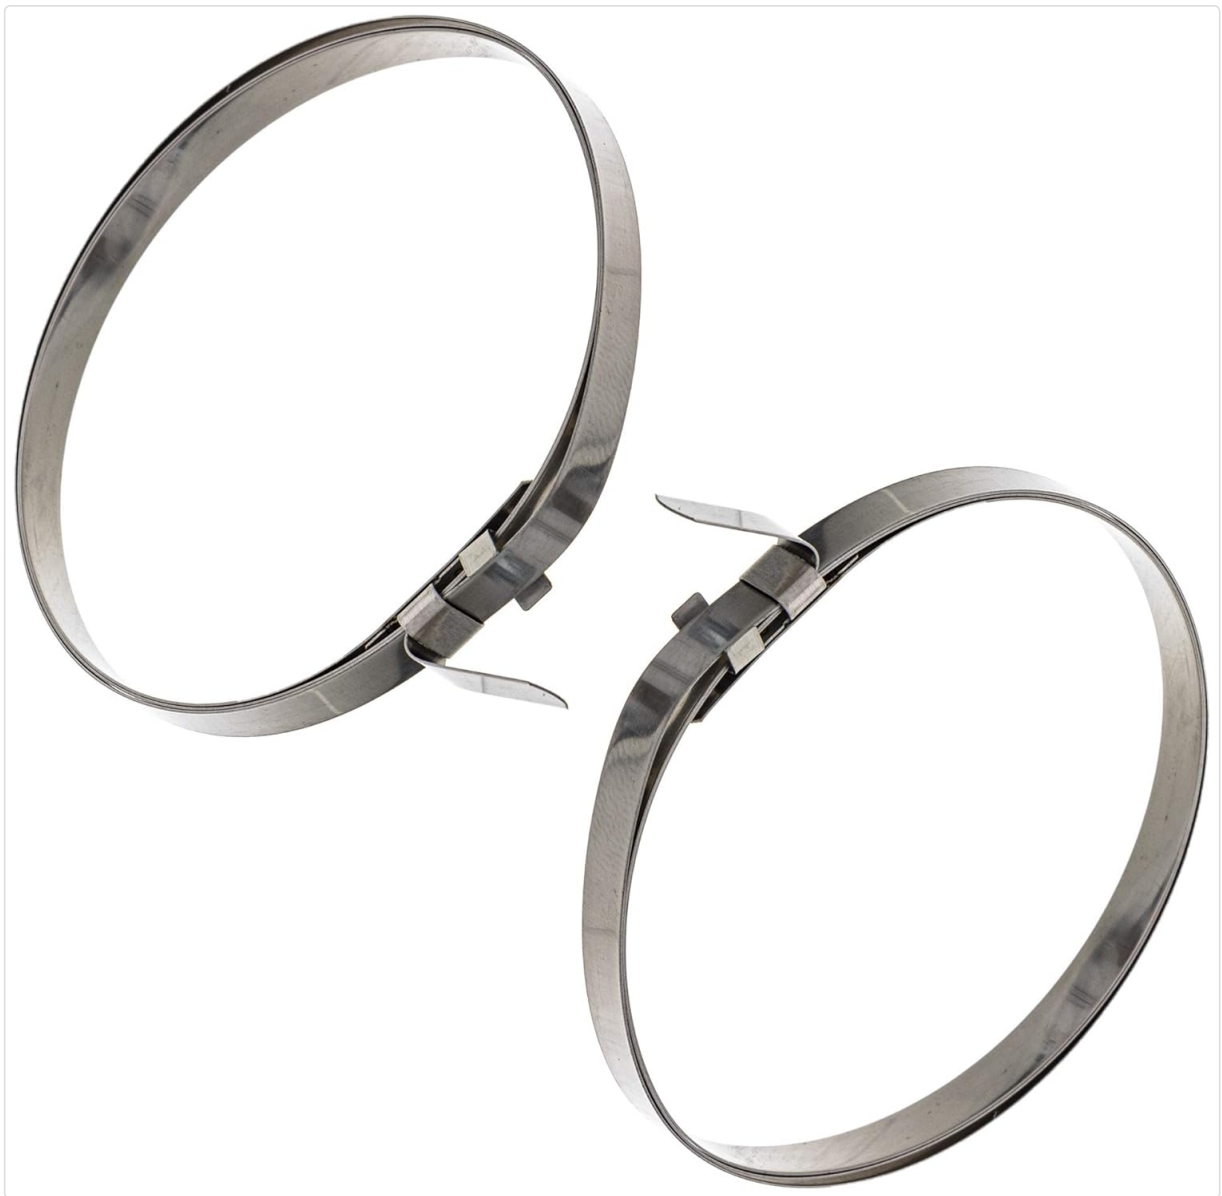
Image 3.3: Two heavy-duty stainless steel boot clamps, designed for secure fastening.

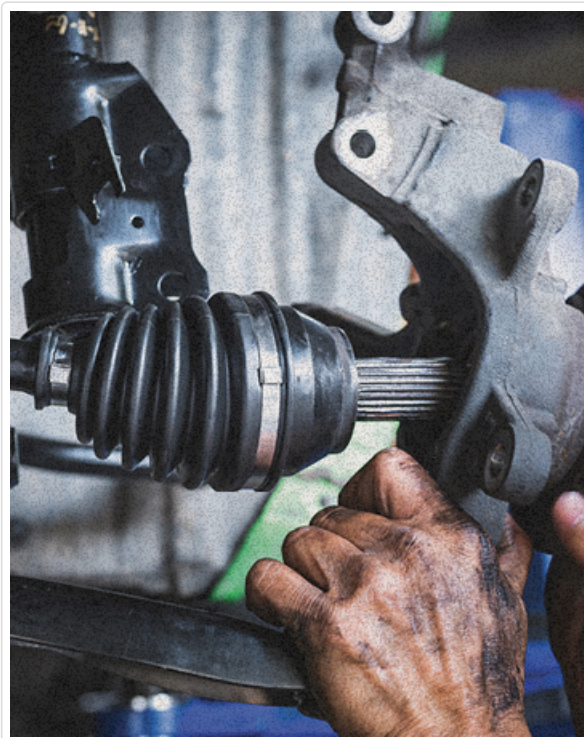
Image 5.2: A close-up view of an ATV axle, highlighting the area where the CV boot is installed.
