Davitu Motherboard PCB Instruction Manual

Model: DVT-91B1C49EB40D5372B697F87C22ABE62E | Brand: DAVITU

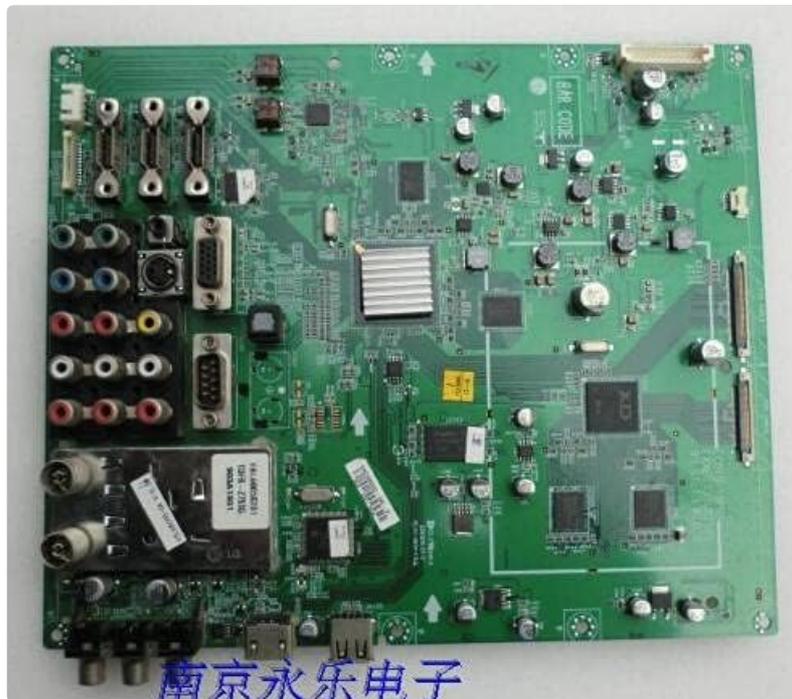
Figure 1: Davitu 42LH50YD-CA Motherboard LC91B EAX60737402(0) PCB. This image displays the Davitu 42LH50YD-CA Motherboard LC91B EAX60737402(0) Printed Circuit Board (PCB). The board is green and features various electronic components, connectors, and integrated circuits. Key features visible include multiple input/output ports (such as RCA, VGA, and USB), a heatsink over a central processing unit, and various capacitors and resistors. The overall layout is typical of a main logic board for electronic devices, designed for specific data processing and connectivity functions.

1. Identify the BIOS (ROM or NVRAM) chip on both the original and the replacement PCBs. This chip is typically an 8-pin SOP (Small Outline Package) IC.
2. Carefully desolder the BIOS chip from the original PCB using appropriate desoldering techniques (e.g., hot air station or fine-tip soldering iron with desoldering braid). Exercise extreme caution to avoid damaging the chip or surrounding components.
3. Clean the pads on the replacement PCB where the BIOS chip will be installed.
4. Carefully solder the original BIOS chip onto the designated pads of the replacement PCB, ensuring correct orientation (pin 1 alignment).
