AUTOSAVER88 92-01 Rear 2.2L

AUTOSAVER88 Rear Complete Quick Struts Instruction Manual

Model: 92-01 Rear 2.2L

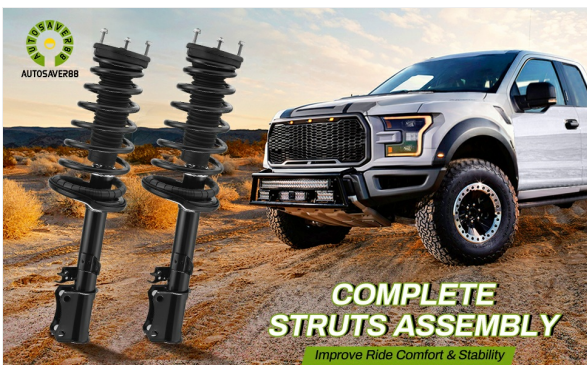
Figure 3.1: Complete Strut Assembly Diagram. This image illustrates the various parts of a complete quick strut, including the upper strut mount, dust boot, coil spring, and the strut itself.

- Struts
- Coil Springs (pre-assembled)
- Upper Mount
- Dust Boot

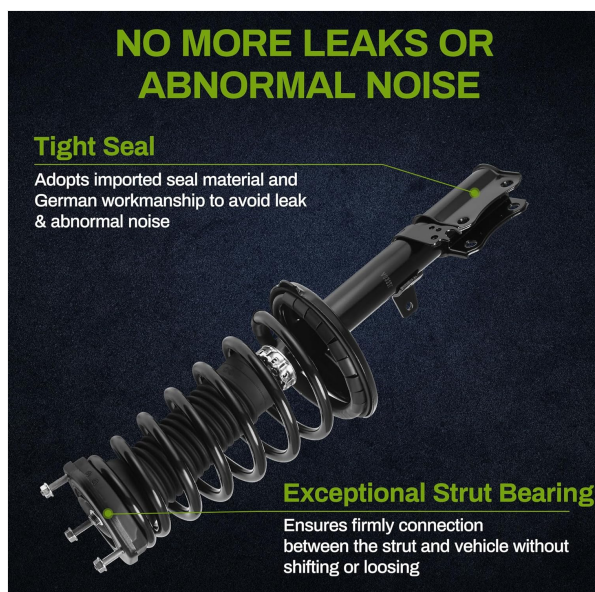
Figure 3.2: Tight Seal and Strut Bearing. This image shows the tight seal, made from imported material and German workmanship, designed to prevent leaks and abnormal noise. It also highlights the exceptional strut bearing for a firm connection.

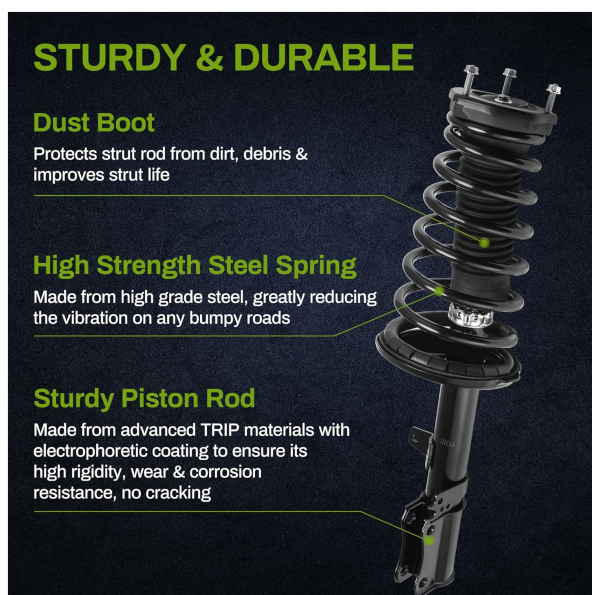
Figure 3.3: Sturdy and Durable Construction. This diagram details the robust features: a dust boot to protect the rod, a high-strength steel spring for reduced vibration, and a sturdy piston rod with electrophoretic coating for durability.
