CTR CB0371 Front Upper Ball Joint Instruction Manual

Brand: CTR | Model: CB0371

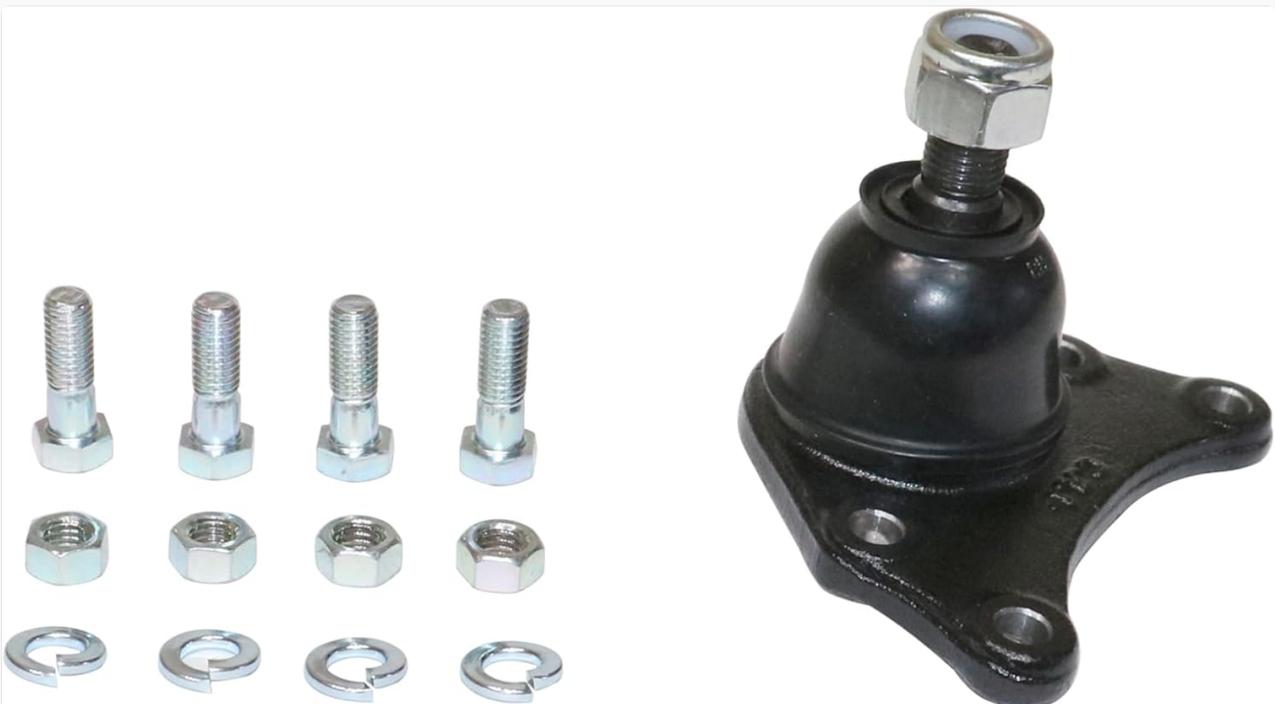
Image 1.1: CTR CB0371 Front Upper Ball Joint and accompanying hardware.

The CTR CB0371 Front Upper Ball Joint is a high-quality, OE supplier replacement part designed for the front upper suspension system of compatible TOYOTA vehicles. It functions as a spherical bearing, connecting the steering knuckle to the control arm, allowing for dynamic and flexible movement of the vehicle's suspension system. This design helps to absorb impacts and ensure a smooth ride.
