Banjo HB150-125 Polypropylene Hose Fitting Instruction Manual

Model: HB150-125

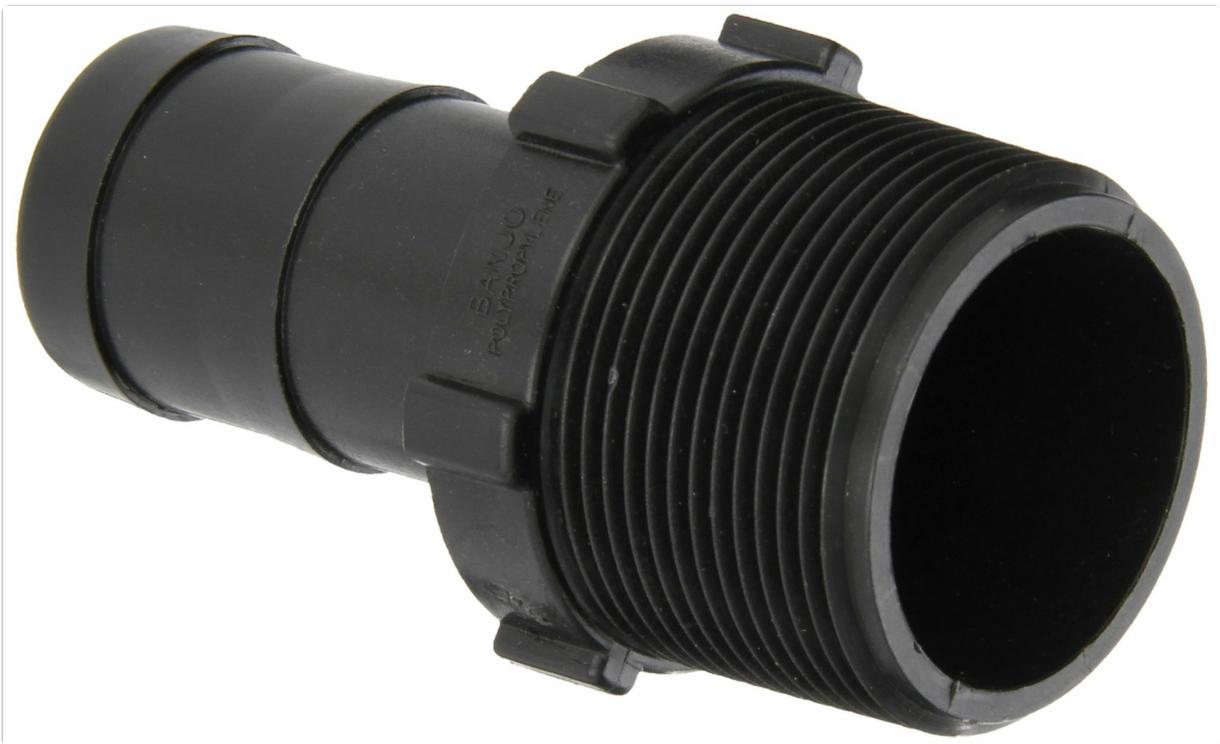
Image of the Banjo HB150-125 hose fitting, a black polypropylene adapter with a threaded male NPT connection on the right and a barbed hose connection on the left. The brand 'BANJO POLYPROPYLENE' is visible on the hexagonal body.

The Banjo HB150-125 is a polypropylene hose fitting designed to adapt a hose or tube to a female NPT threaded connection. This adapter features a 1-1/2 inch Male National Pipe Taper (NPT) threaded connection on one end and a 1-1/4 inch barbed connection on the other.

Constructed from glass-reinforced polypropylene, this fitting offers rigidity, lightweight properties, dimensional stability, and resistance to high impact, heat, corrosion, and most chemicals. An integral hex nut provides a secure gripping surface for tightening during installation.
