# Garrett PowerMax Turbocharger Stage 2 Upgrade

MODEL: GRT-TBO-P32

Manufactured by Sourcefy

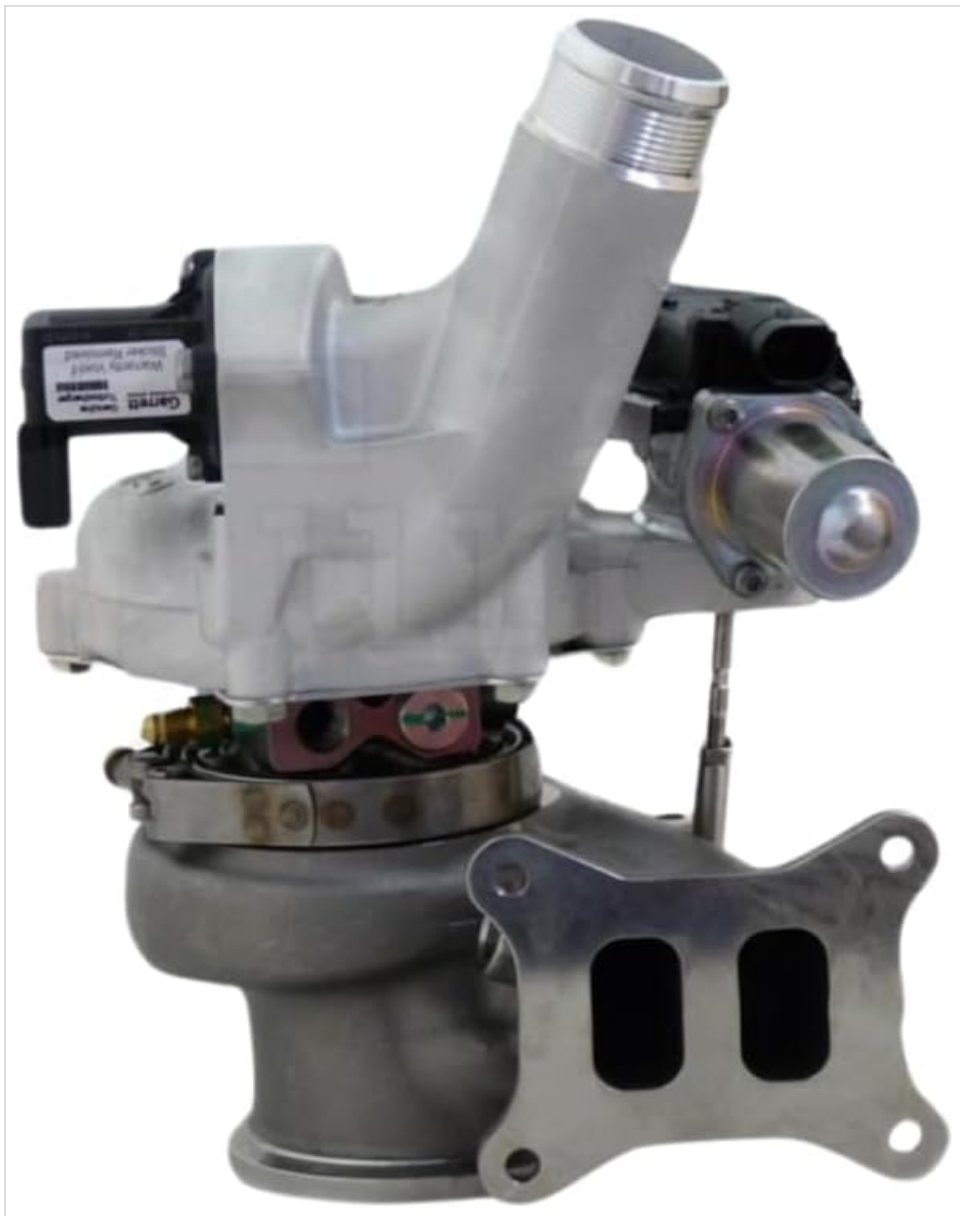
Figure 3.1: Front view of the Garrett PowerMax Turbocharger unit.

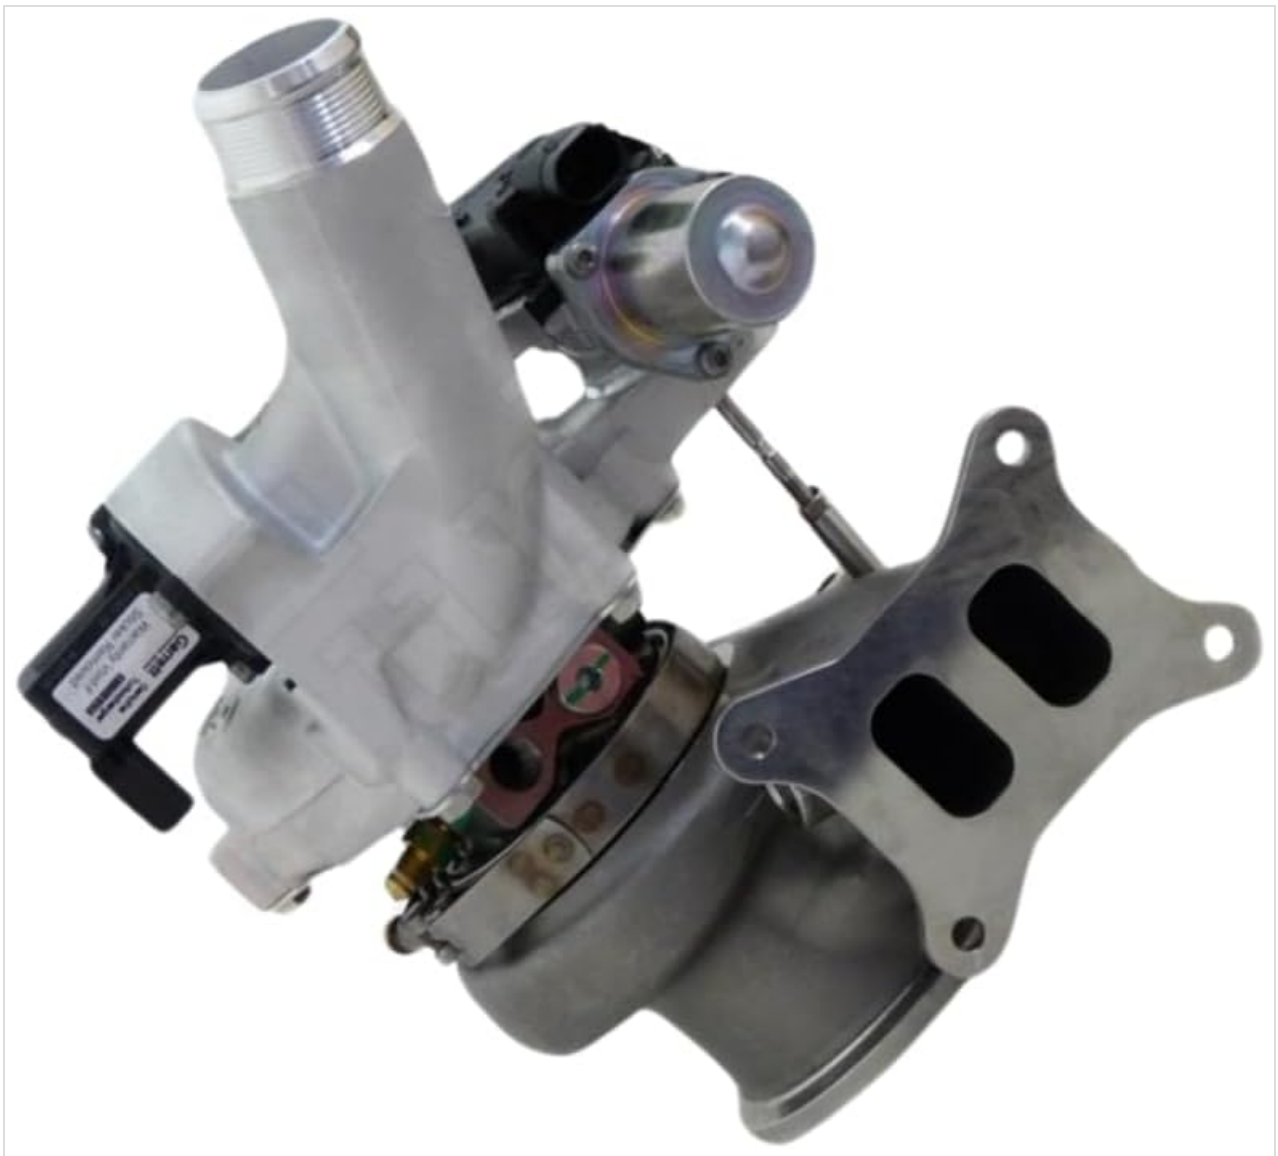
Figure 3.2: Angled view of the Garrett PowerMax Turbocharger, highlighting the exhaust housing and actuator.

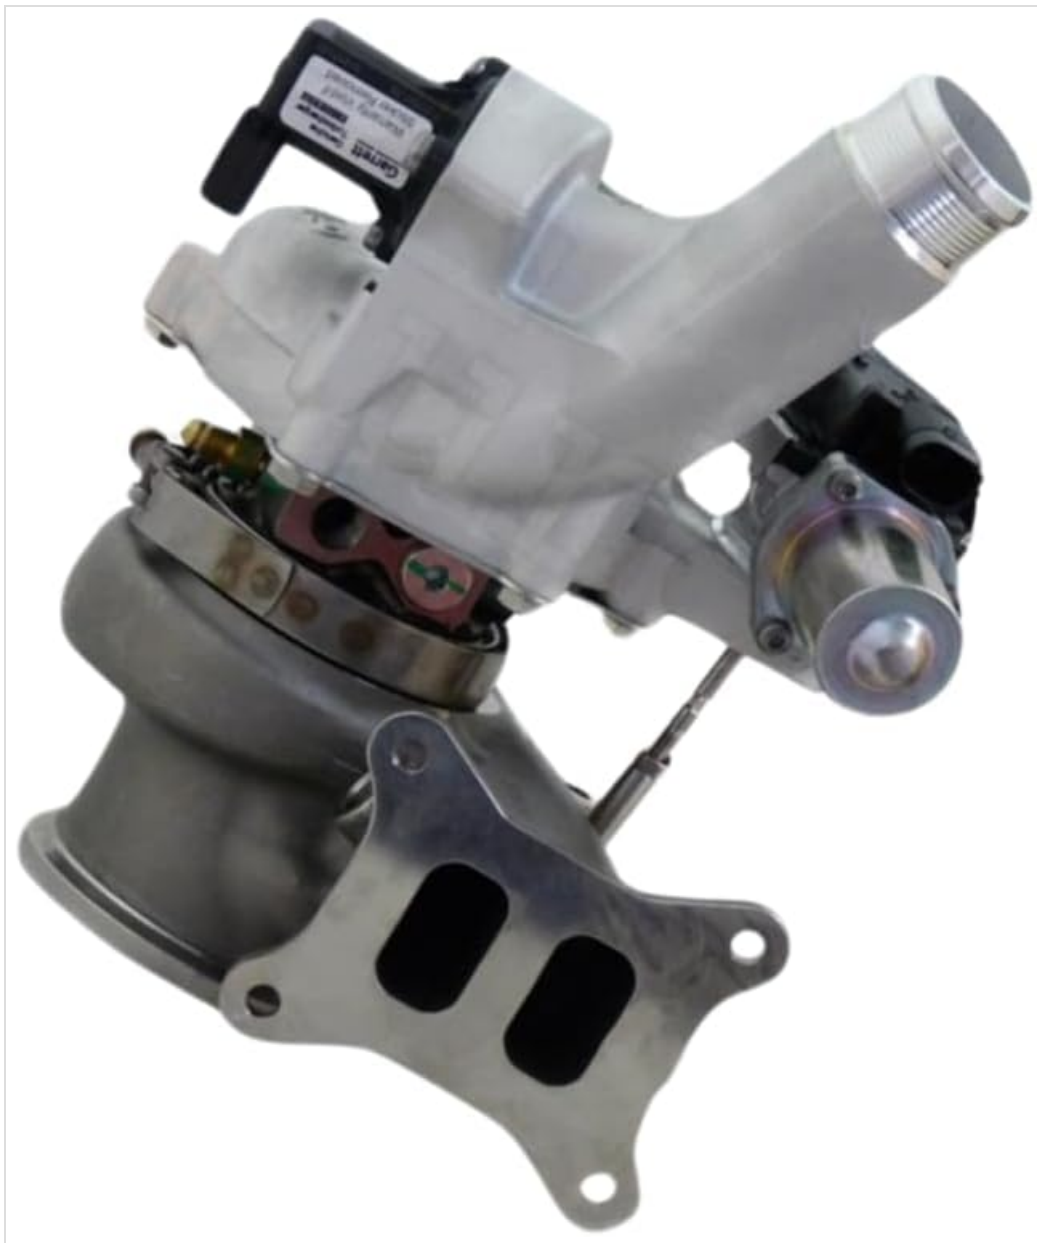
Figure 3.3: Side view of the Garrett PowerMax Turbocharger, showing the compressor housing and electrical connections.
