## Budora WP21366

# Budora WP21366 Spanner Nut for Whirlpool Washing Machines: Installation and Compatibility Guide

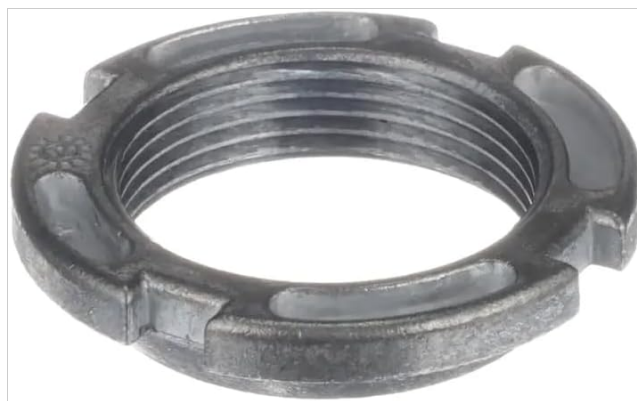
Image 1: The Budora WP21366 Spanner Nut, a critical component for washing machine assembly.

The Budora WP21366 Spanner Nut is a replacement component designed for use in various washing machine models. This nut plays a crucial role in securing the wash basket to the drive shaft, ensuring stable and efficient operation of the appliance. It is manufactured to meet specific compatibility requirements for a range of washing machine brands.

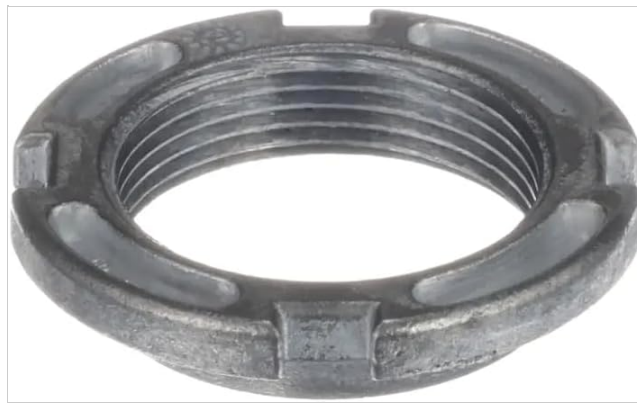
Image 2: A close-up view of the spanner nut, showing the internal threads for securing the wash basket.

The WP21366 Spanner Nut serves as a critical fastener within the washing machine's drive system. Its primary function is to securely hold the wash basket onto the drive shaft. A properly tightened spanner nut prevents the wash basket from wobbling or detaching during the agitation and spin cycles, which are essential for effective laundry cleaning. If this nut becomes loose or damaged, it can lead to excessive noise, vibration, or complete failure of the wash cycle.
