> Giuqa Golf Cart Front End King Pin Rebuild Kit Instruction Manual for Club Car DS Gas & Electric 1993-Up (Models 1016386, 1010150, 1016389)

Giuqa Golf Cart Front End King Pin Rebuild Kit Instruction Manual

Models: 1016386, 1010150, 1016389

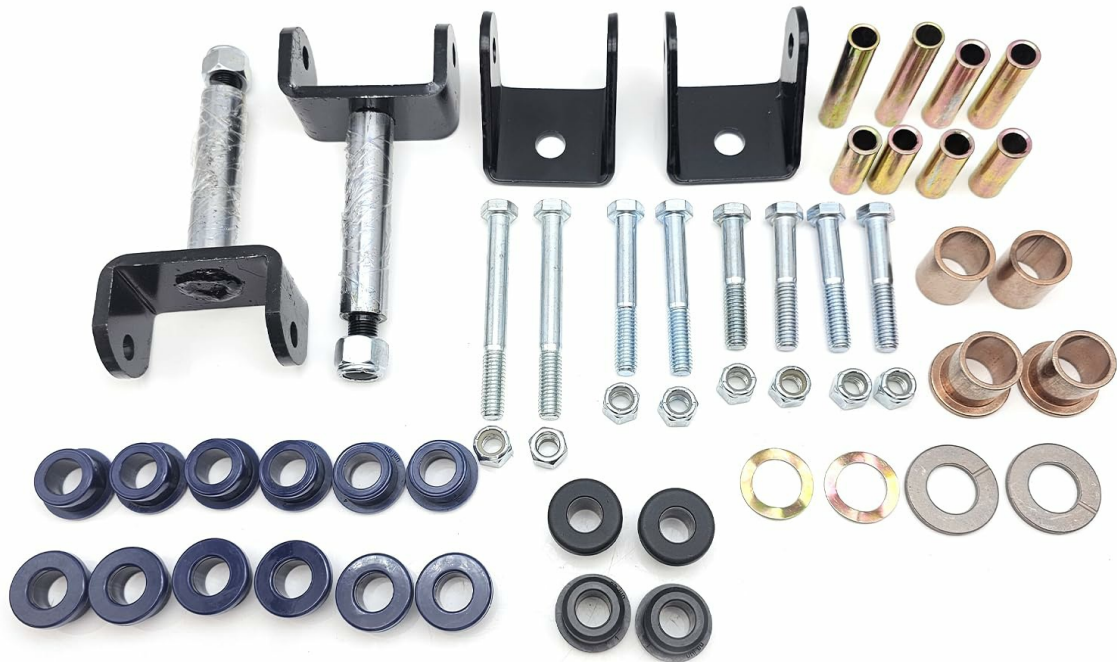
Image: Complete Giuqa Golf Cart Front End King Pin Rebuild Kit components laid out.

- 4 pcs **1015583 Bushing, Urethane** (Steel Plate)
- 2 pcs **1012303 Bushing, Steel** (Steel Plate)
- 12 pcs **1016346 Bushing, Urethane** (Control Arm)
- 4 pcs **1016349 Sleeve, Delta Inner** (Control Arm - Short)
- 2 pcs **1016350 Sleeve, Delta Outer** (Control Arm - Long)
- 2 pcs **1016389 King Pin Wave Washer**
- 2 pcs **1010150 Thrust Bearing**
- 2 pcs **1016384 Delta Upper Clevis**
- 2 pcs **1016386 King Pin for Delta A Plate**
- 8 pcs **8754 Screw Nut**
- 4 pcs **2402 Screw** (DS Control Arm - Short)
- 2 pcs **1016387 Screw** (DS Control Arm - Long)
- 8 pcs **8755 Screw** (DS Steel Plate)
- 2 pcs **8067 Bronze Spindle Bushing**
- 2 pcs **Flanged Bronze Bushing**

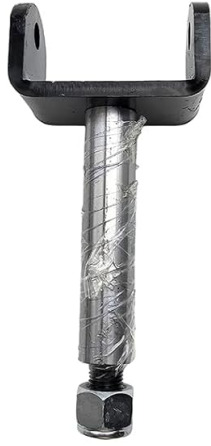
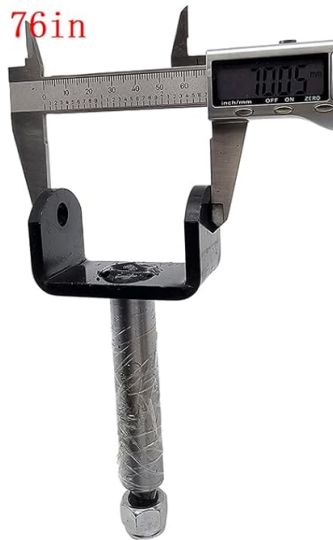
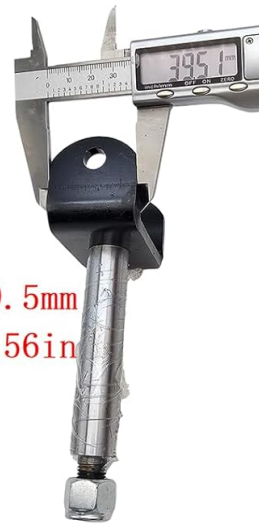
lengths $\approx 152.3\text{mm}$
lengths $\approx 6\text{in}$

height $\approx 70\text{mm}$
height $\approx 2.76\text{in}$

height $\approx 39.5\text{mm}$
height $\approx 1.56\text{in}$

Image: Detailed dimensions of the King Pin (Part 1016386).

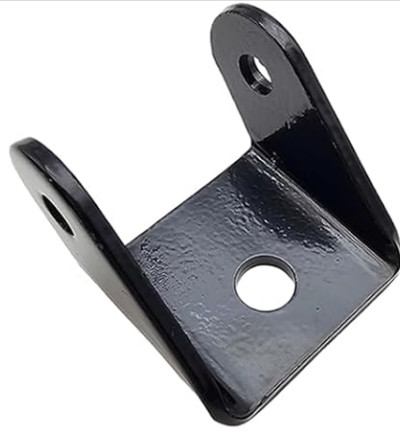
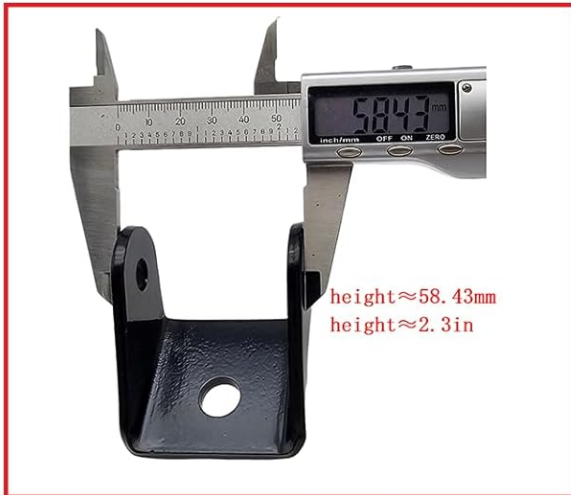
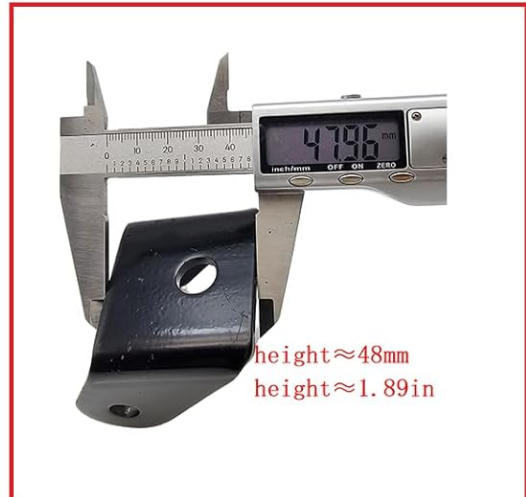
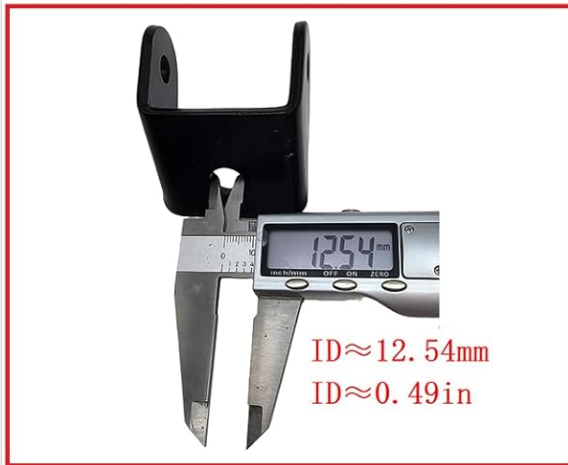
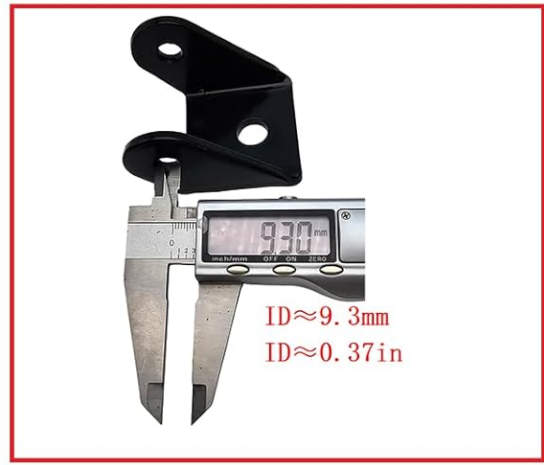
Image: Detailed dimensions of the Delta Upper Clevis (Part 1016384).

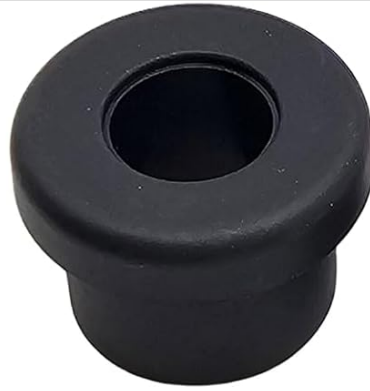
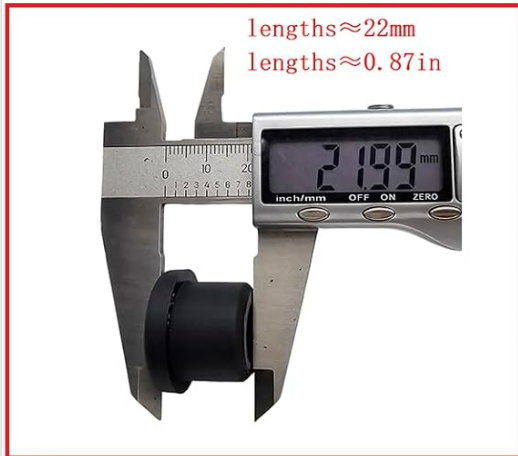
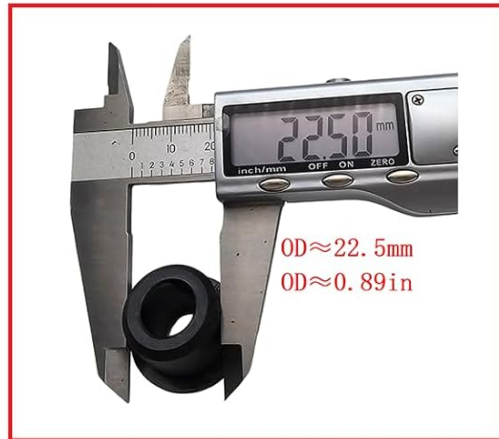
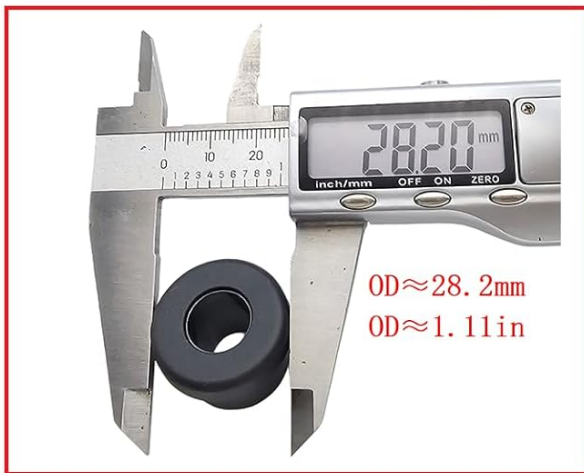
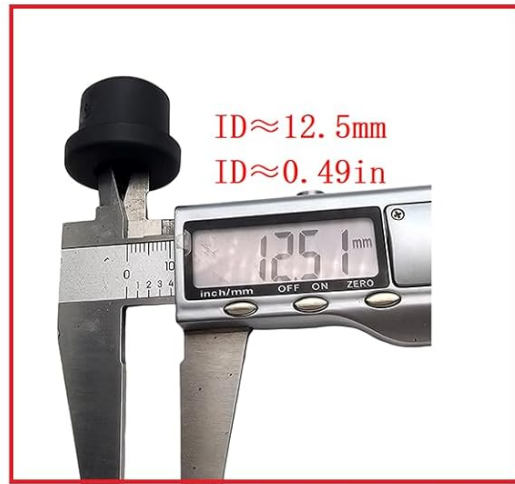
Image: Detailed dimensions of the Urethane Bushings (Part 1015583).

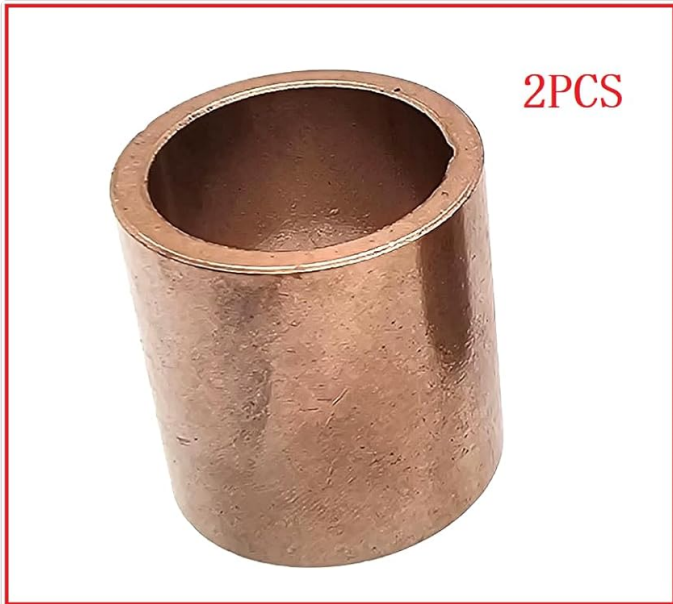
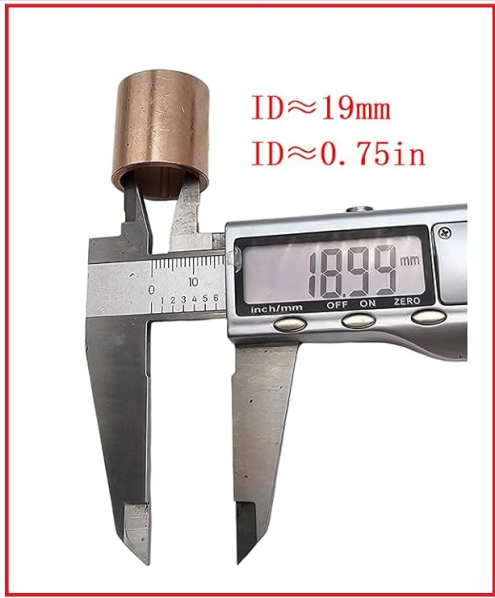
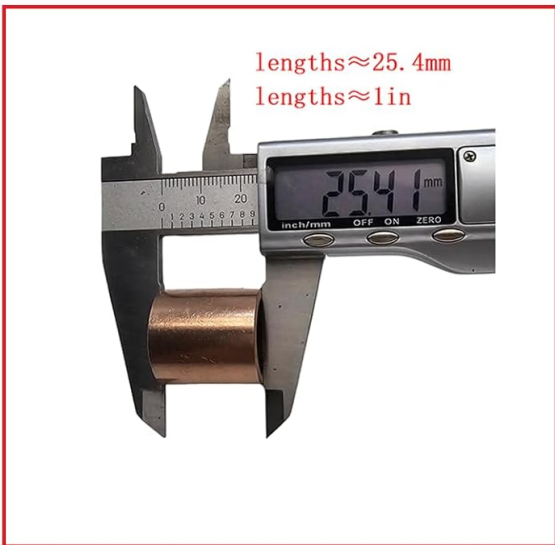
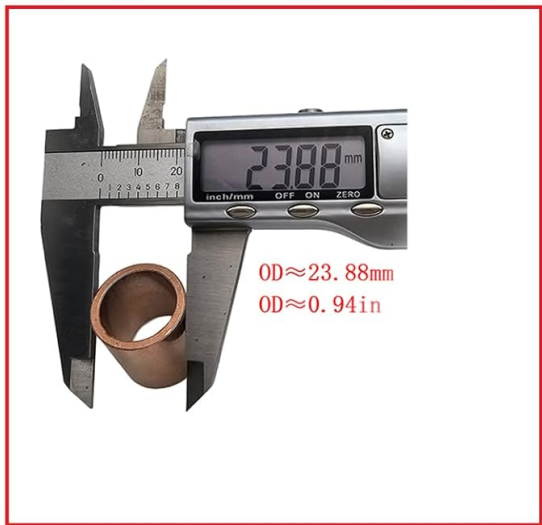
Image: Detailed dimensions of the Steel Bushings (Part 1012303).

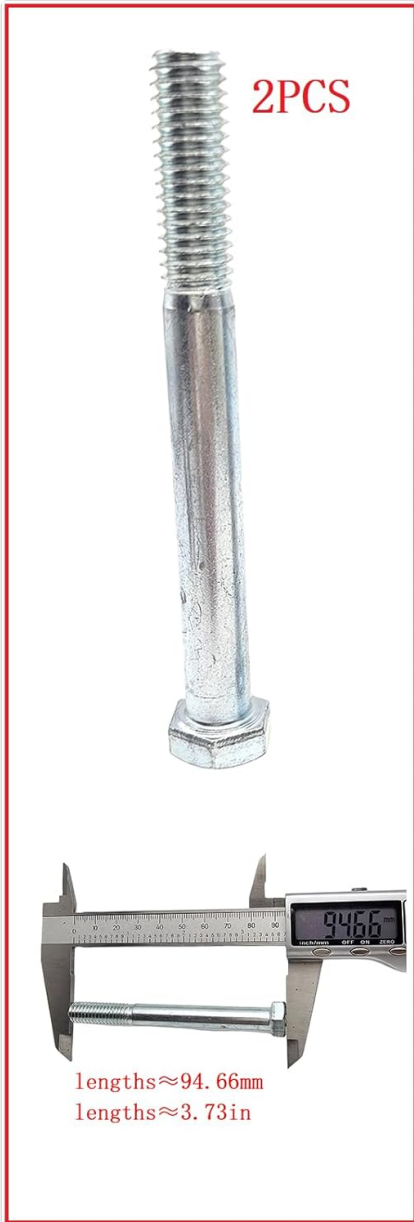
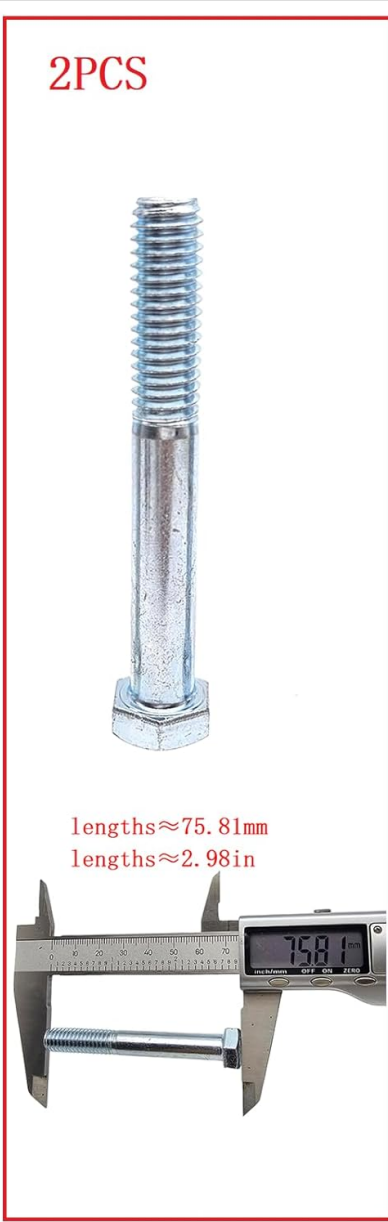
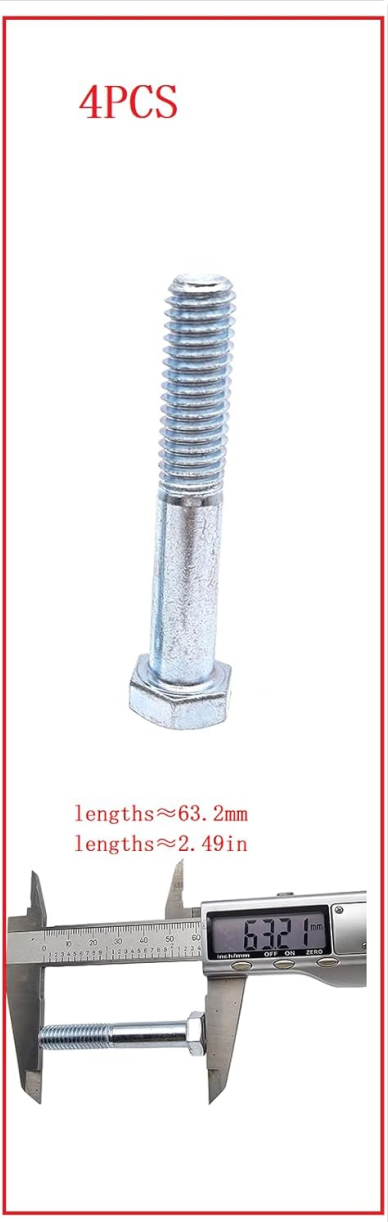
Image: Detailed dimensions of various screws and bolts included in the kit.

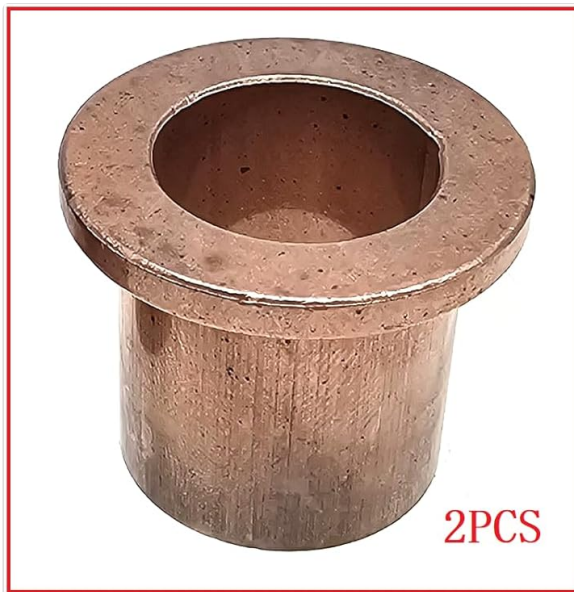
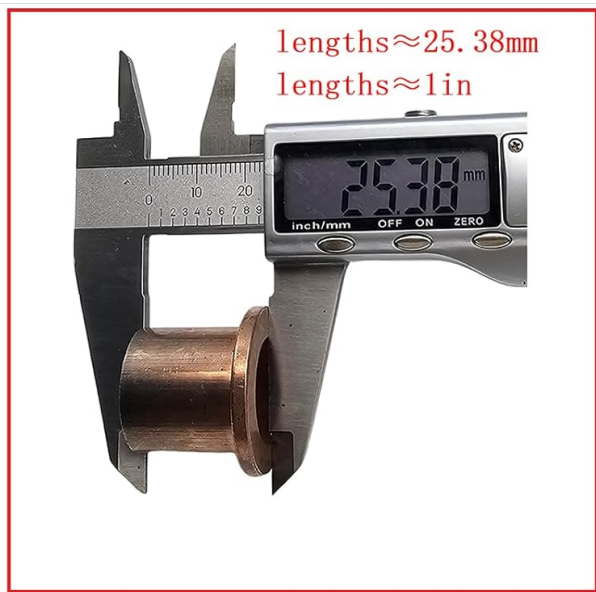
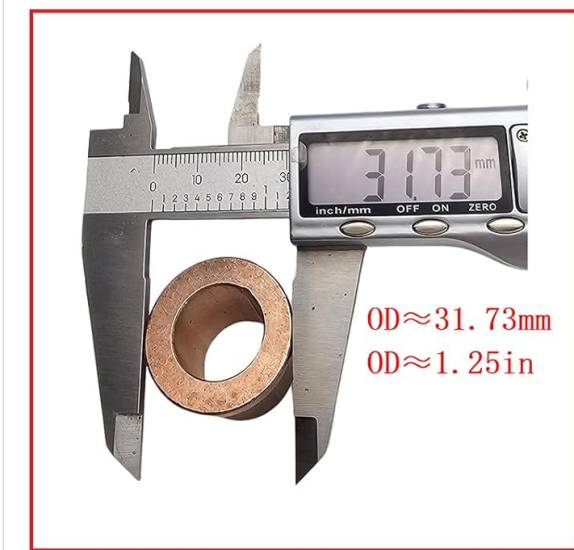
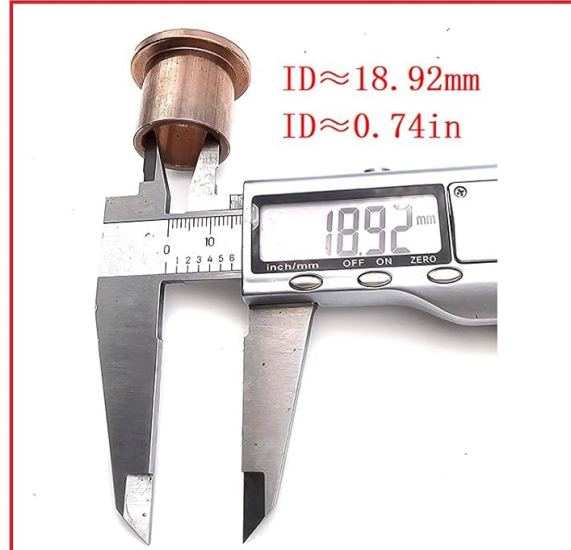
Image: Detailed dimensions of the Flanged Bronze Bushings.
