[Q & A](#) | [Deep Search](#) | [Upload](#)

manuals.plus /

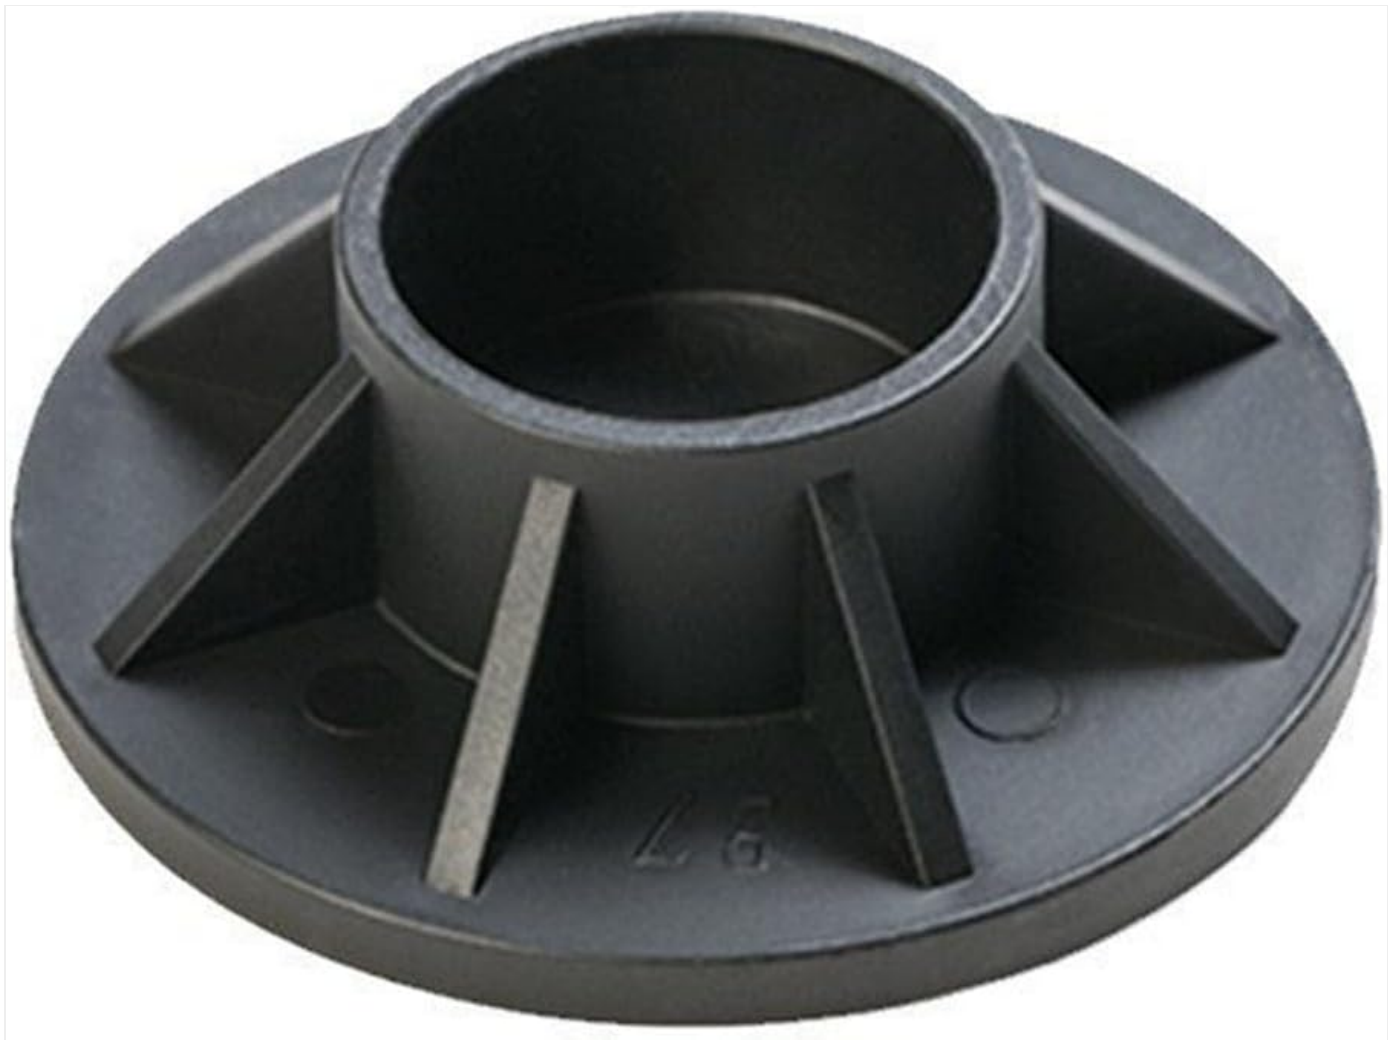
Figure 1: A single XHSESA Pool Accessories Bottom Seat Cap. This image shows the top view of the cap, highlighting its circular base and central cylindrical opening designed to receive the pool's vertical leg.

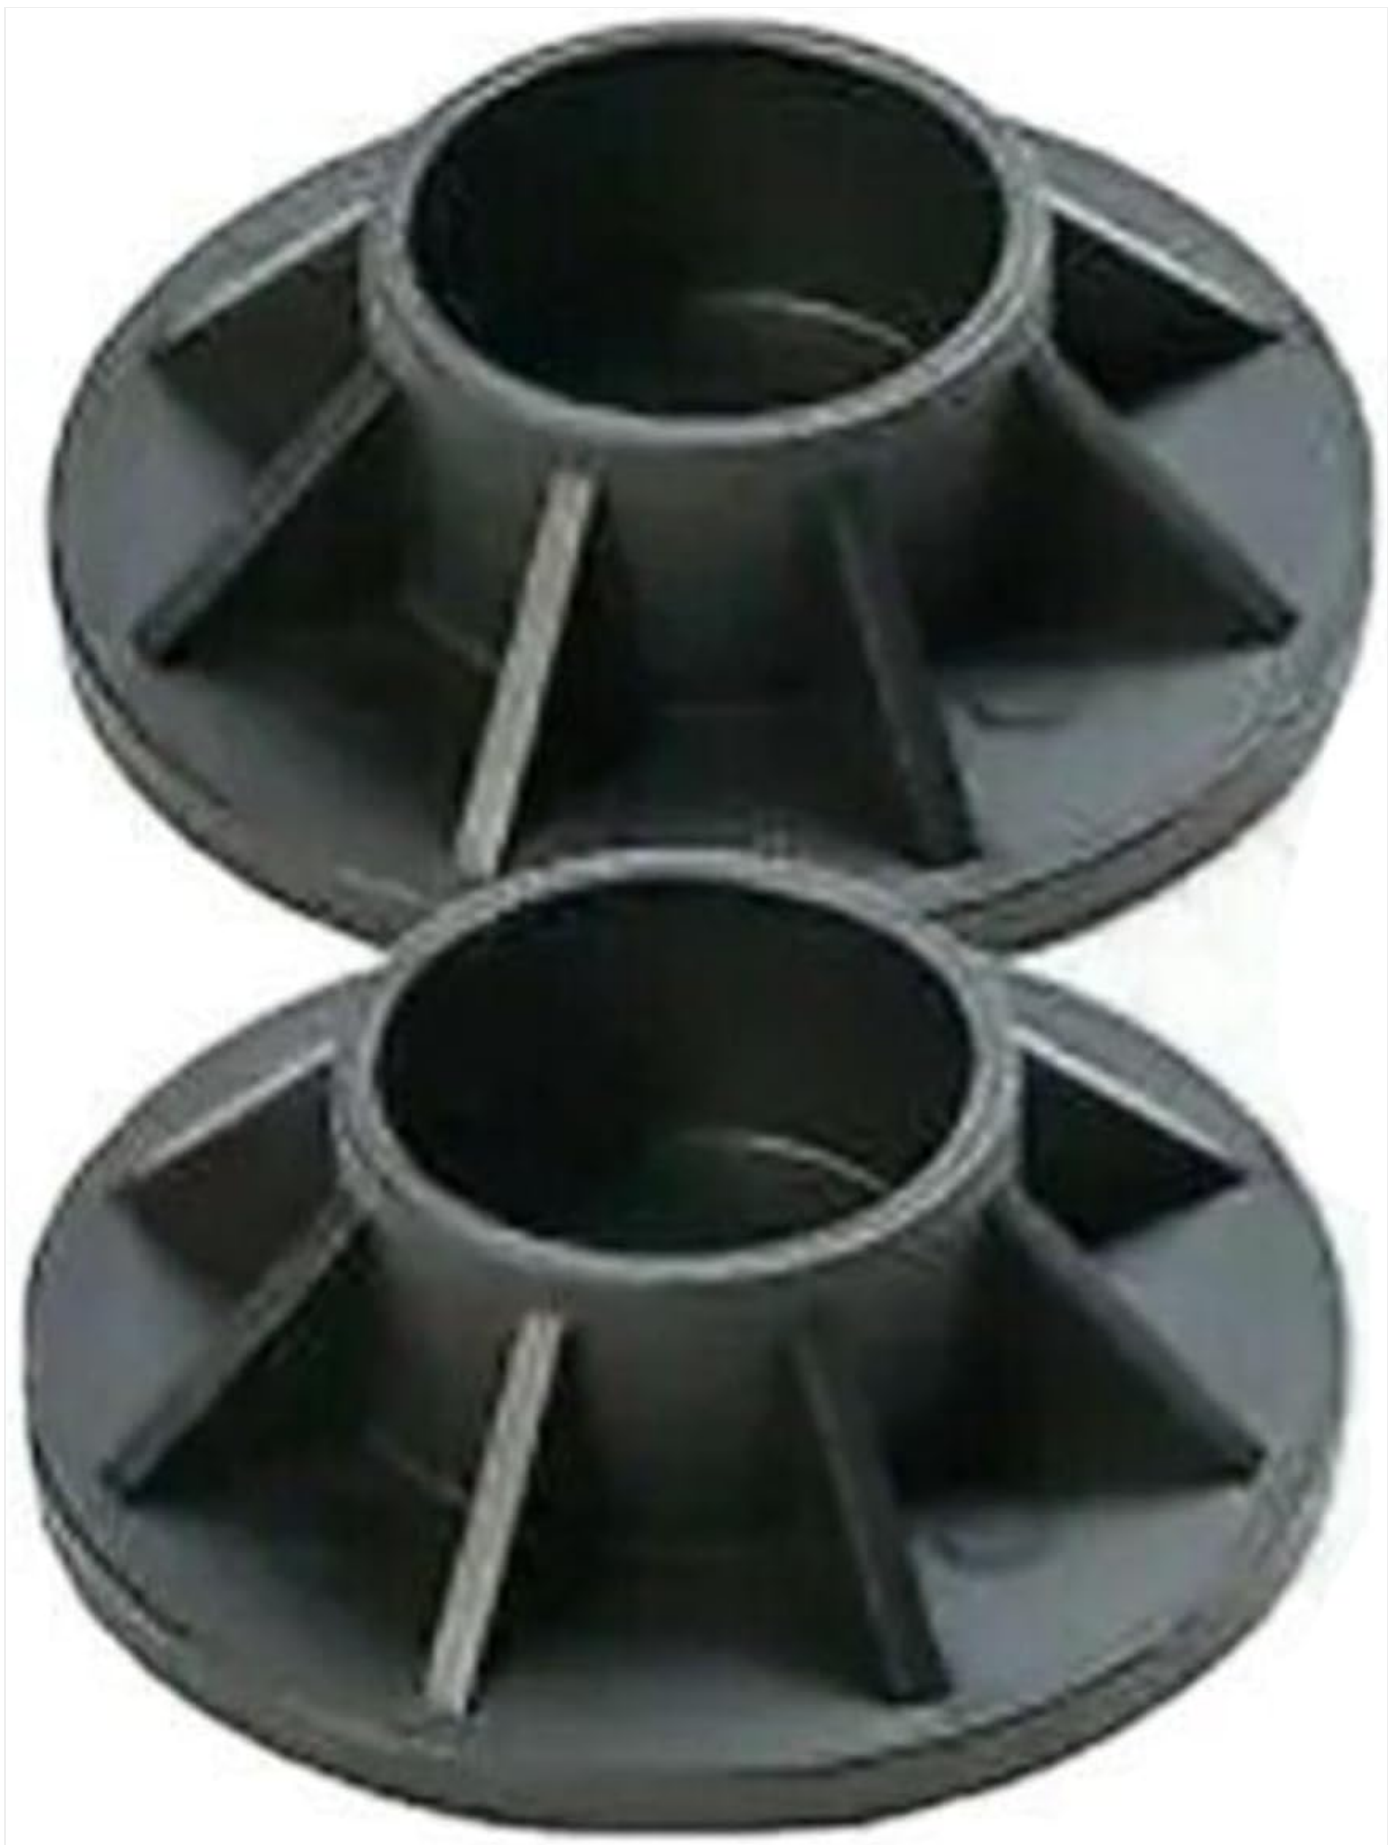
Figure 3: Two XHSESA Pool Accessories Bottom Seat Caps. This image displays a pair of the caps, illustrating the typical quantity provided for replacement or initial setup, emphasizing their identical design and robust construction.

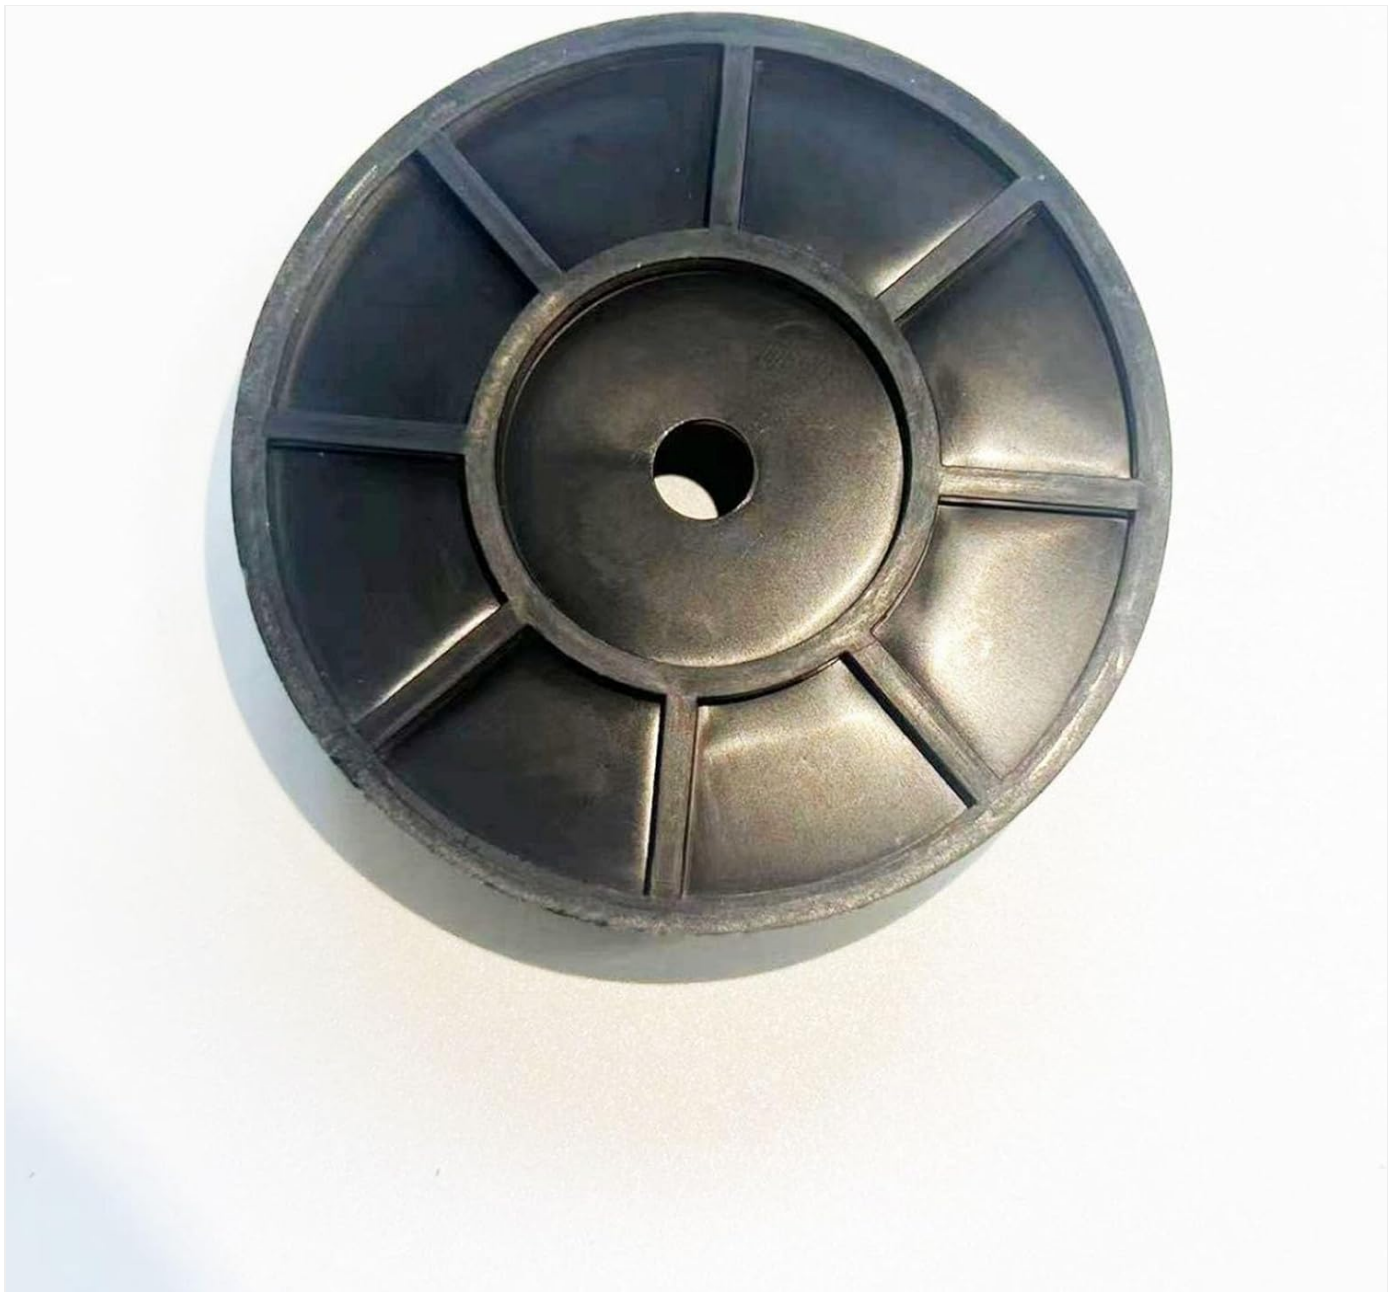
Figure 4: Top view of a single XHSESA Pool Accessories Bottom Seat Cap, showing the central hole. This hole is designed for drainage or to accommodate specific pool leg designs, ensuring proper fit and function.
