# cciyu 66-4155 CV Axle Shaft Assembly User Manual

Model: 66-4155 | Brand: cciyu

- **1998-2002 Honda Accord 2.3L** (Front Left Drive Side, FWD)

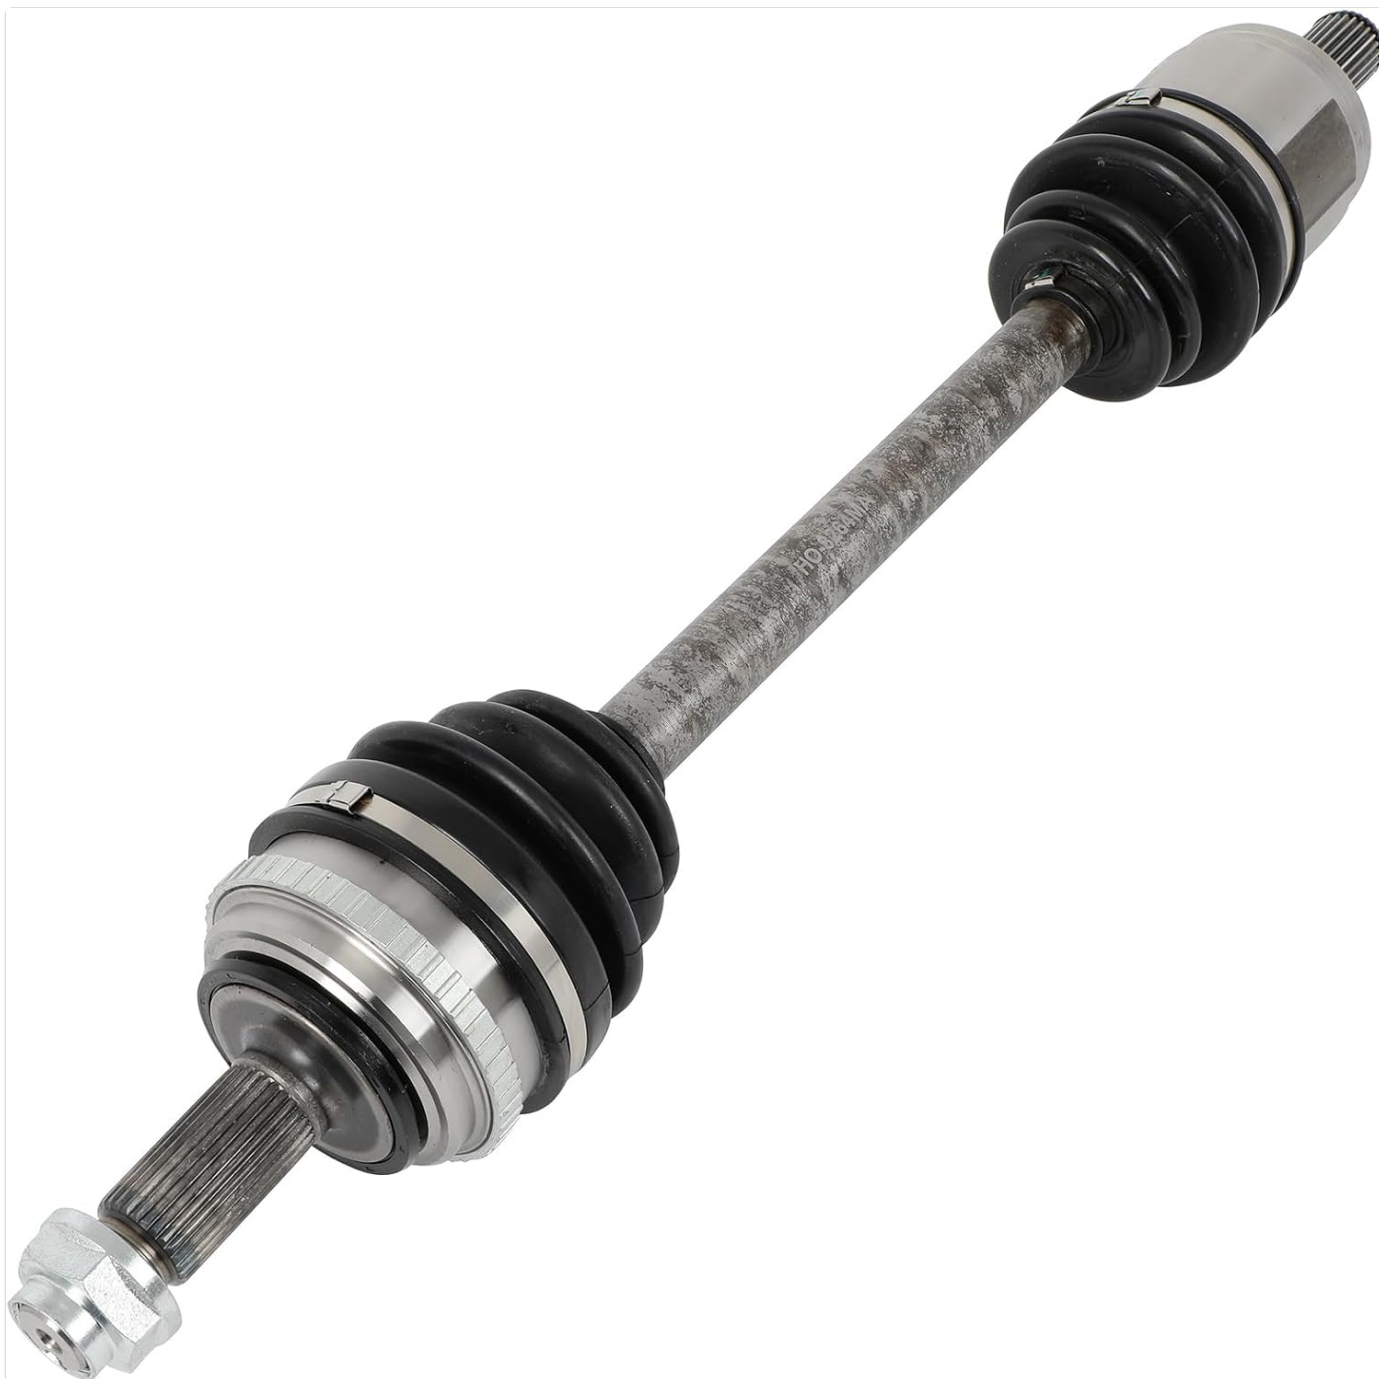
Figure 1: The cciyu 66-4155 CV Axle Shaft Assembly, a complete unit ready for installation.

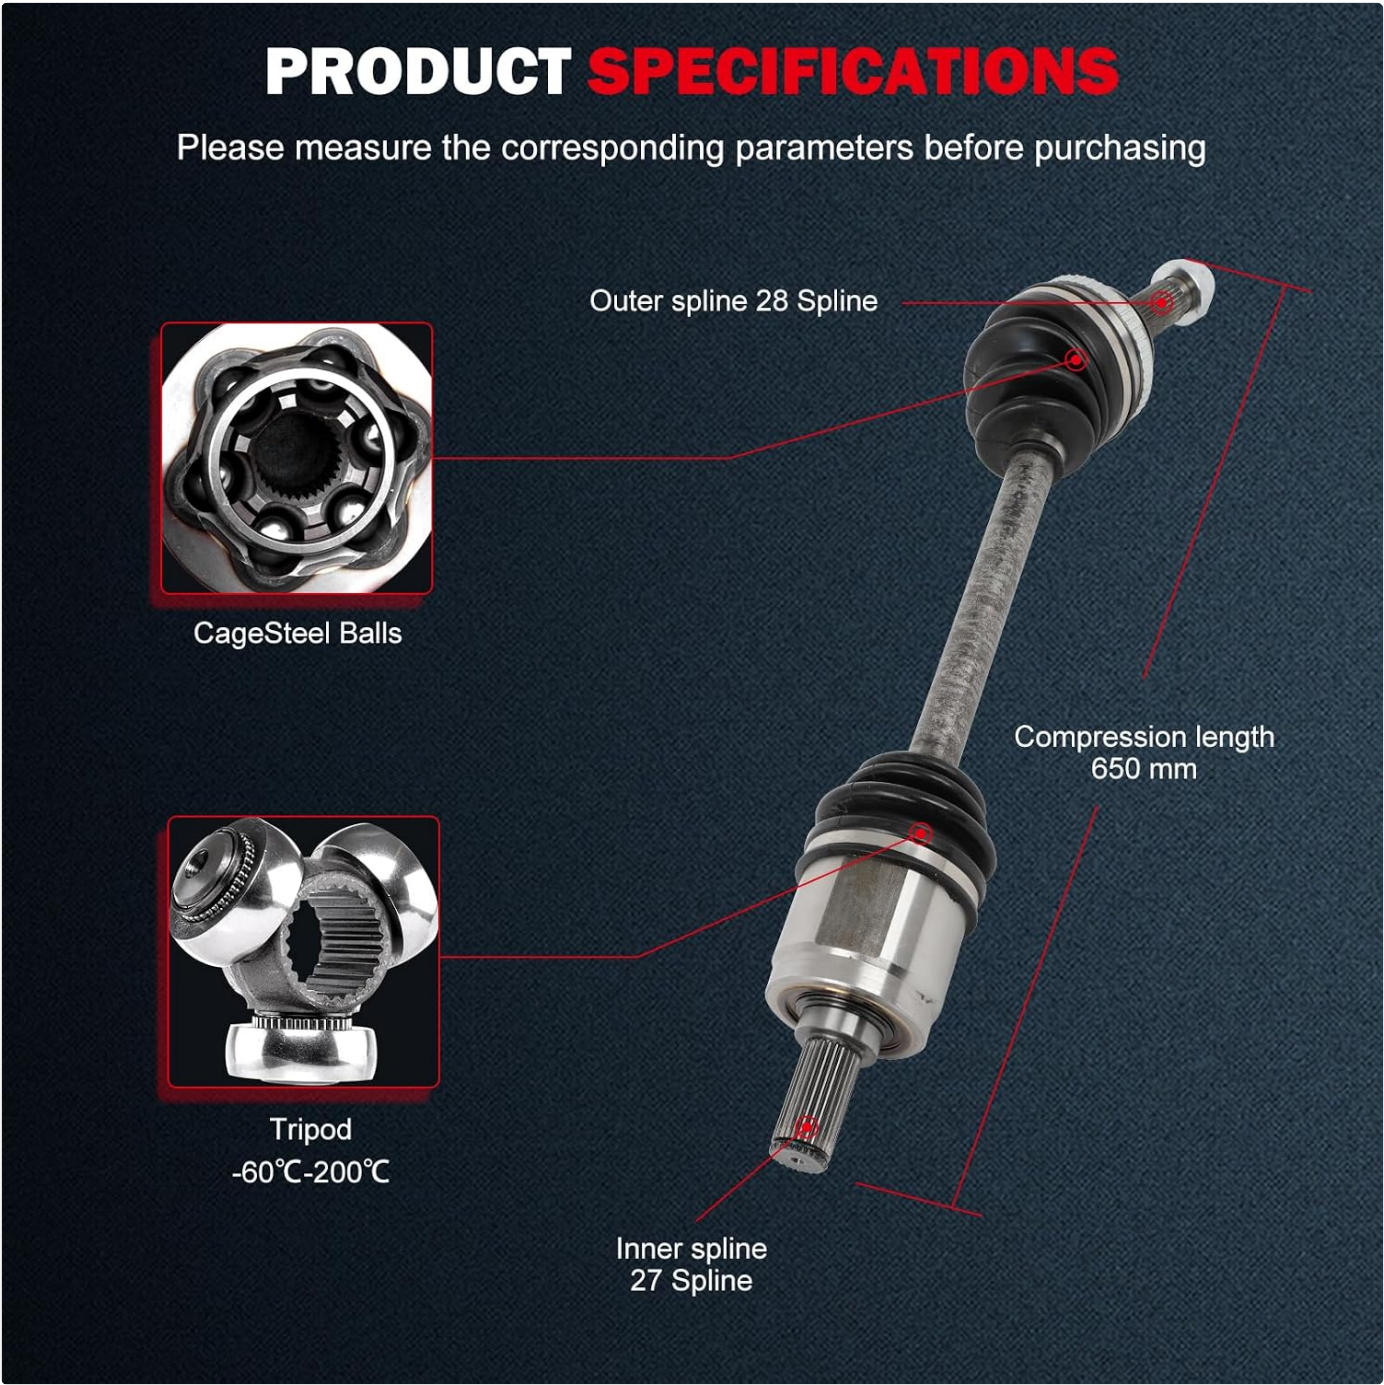
Figure 3: Diagram illustrating key dimensions and components of the CV axle, including spline counts and compressed length.

| Feature | Specification |
| Position | Front Left Drive Side |
| Inner Spline Count | 27 Spline |
| Outer Spline Count | 28 Spline |
| Compressed Length | 650 mm |
| ABS Ring Included | Yes |

| Feature | Specification |
|---|---|
| ABS Ring Tooth Count | 50T |

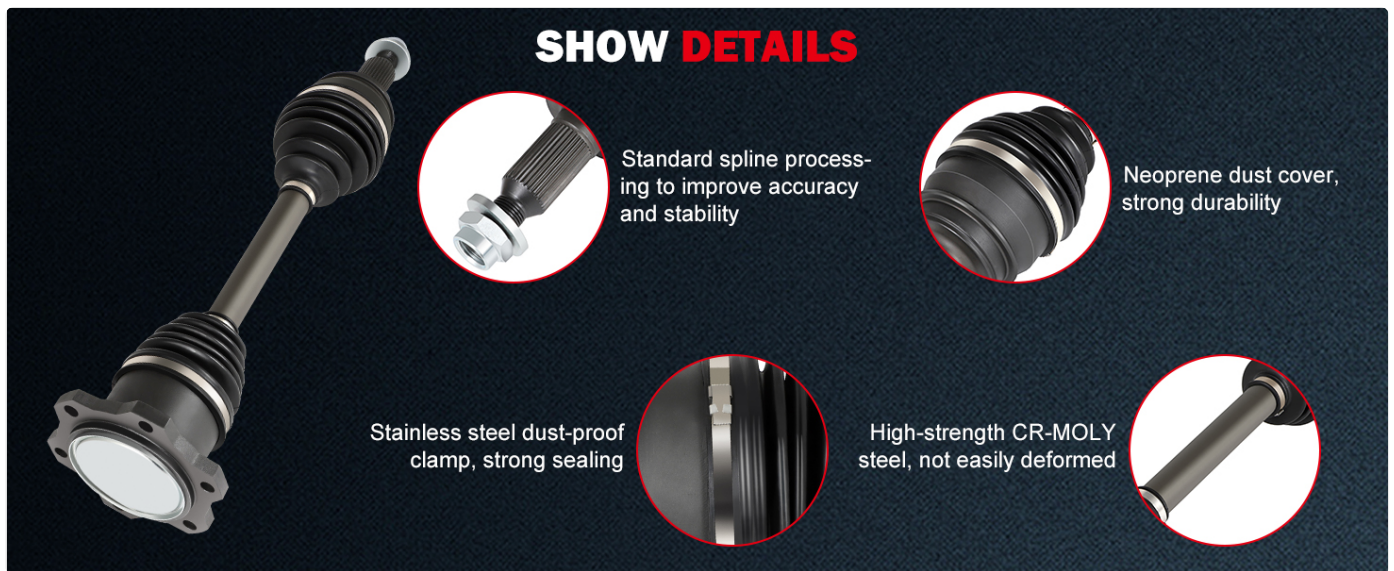
Figure 4: Detailed view of CV axle components, highlighting standard spline processing, neoprene dust cover, stainless steel dust-proof clamp, and high-strength CR-MOLY steel construction.

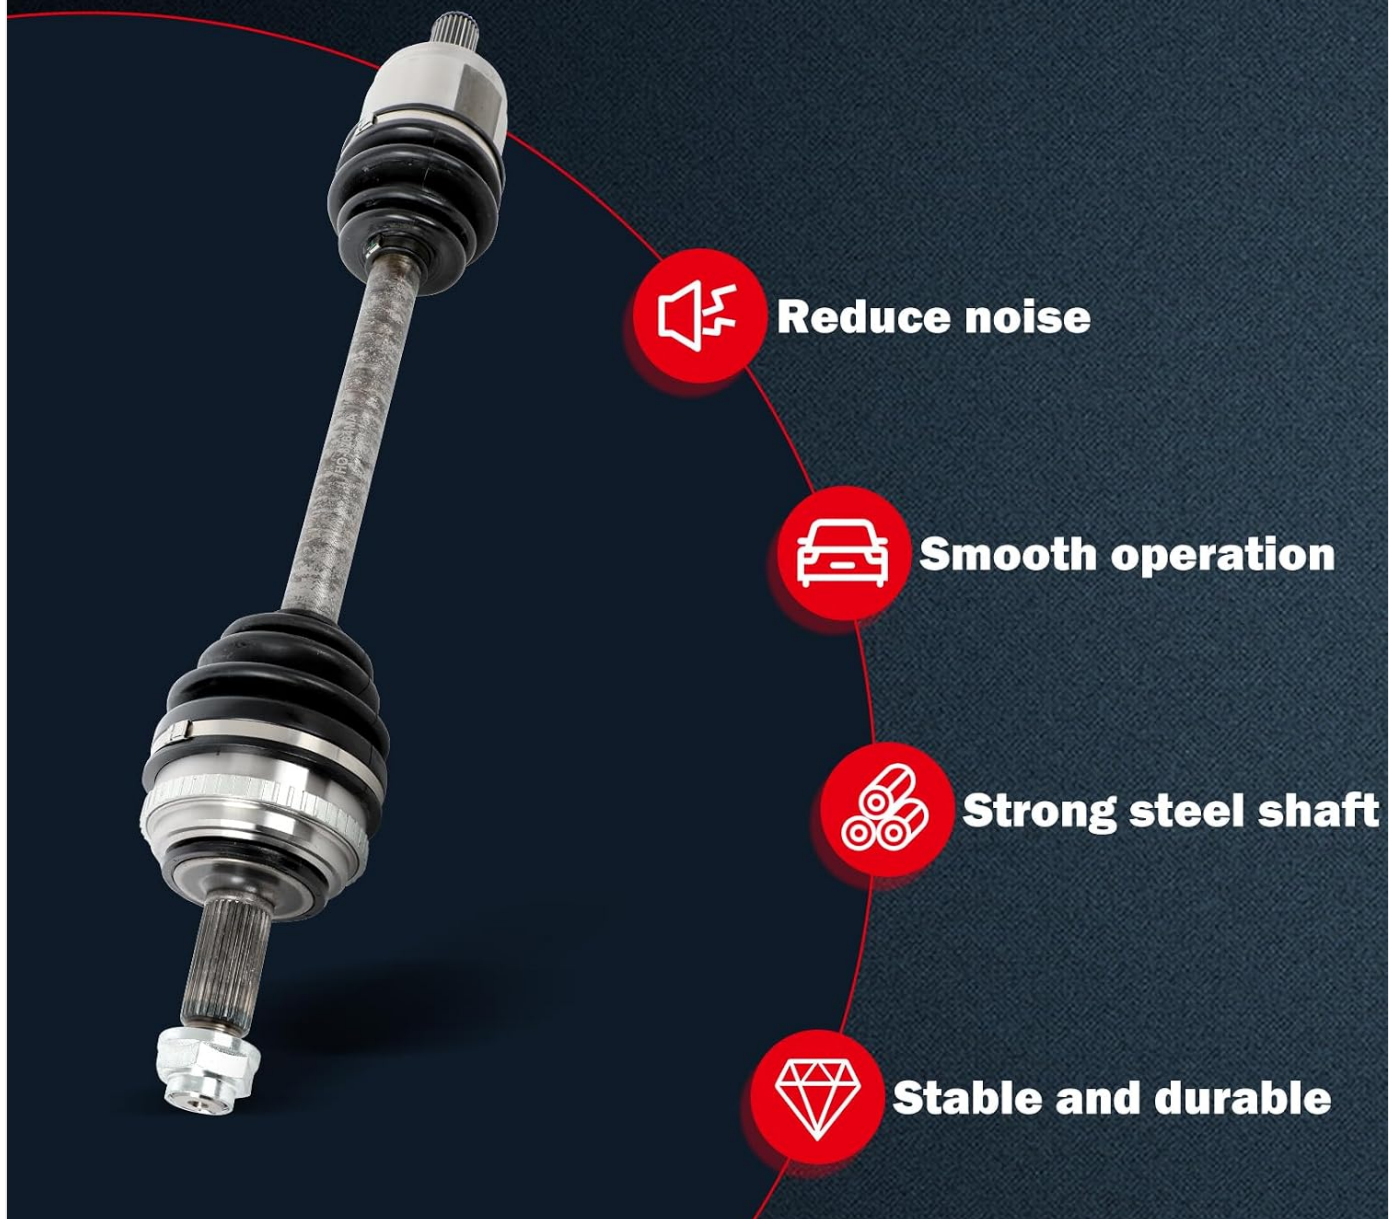
Figure 6: Visual representation of the performance benefits of the cciyu CV axle, including noise reduction, smooth operation, strong shaft, and durability.

- **Reduced Noise:** Designed for quiet operation.
- **Smooth Operation:** Ensures consistent power transfer without vibrations.
- **Strong Steel Shaft:** Constructed from durable materials for reliability.
- **Stable and Durable:** Built to withstand various driving conditions and provide long-lasting performance.

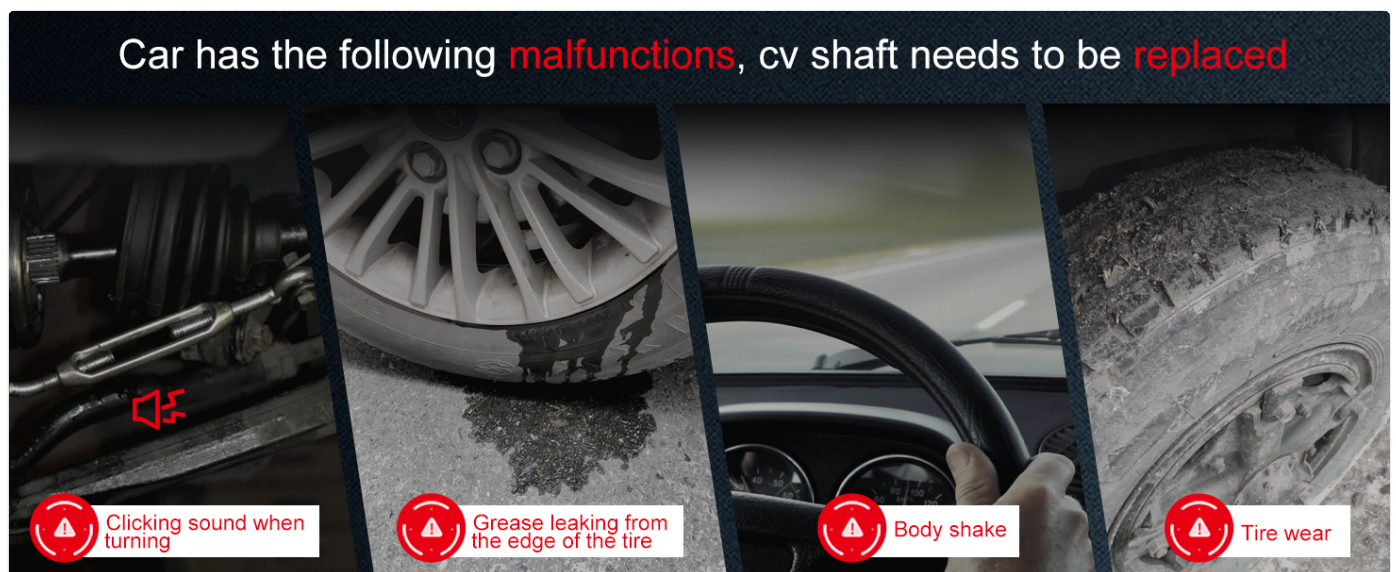
Figure 7: Visual guide to common signs of a failing CV axle, including clicking sounds, grease leaks, body shake, and tire wear.

- **Clicking Sound When Turning:** A common symptom of a worn outer CV joint. The clicking noise typically becomes more pronounced when turning, especially at low speeds.
- **Grease Leaking from the Edge of the Tire:** Indicates a torn or damaged CV boot, allowing the lubricating grease to escape. This can lead to joint failure if not addressed.
- **Body Shake/Vibration:** Vibrations that increase with acceleration or at highway speeds can be caused by a worn or unbalanced inner CV joint.
- **Tire Wear:** While not a direct symptom, severe CV axle issues can sometimes contribute to uneven tire wear due to improper wheel alignment or suspension geometry changes.
