A-Premium CV Axle Shaft Assembly User Manual (Model APCVA3530)

Comprehensive guide for installation, maintenance, and troubleshooting.

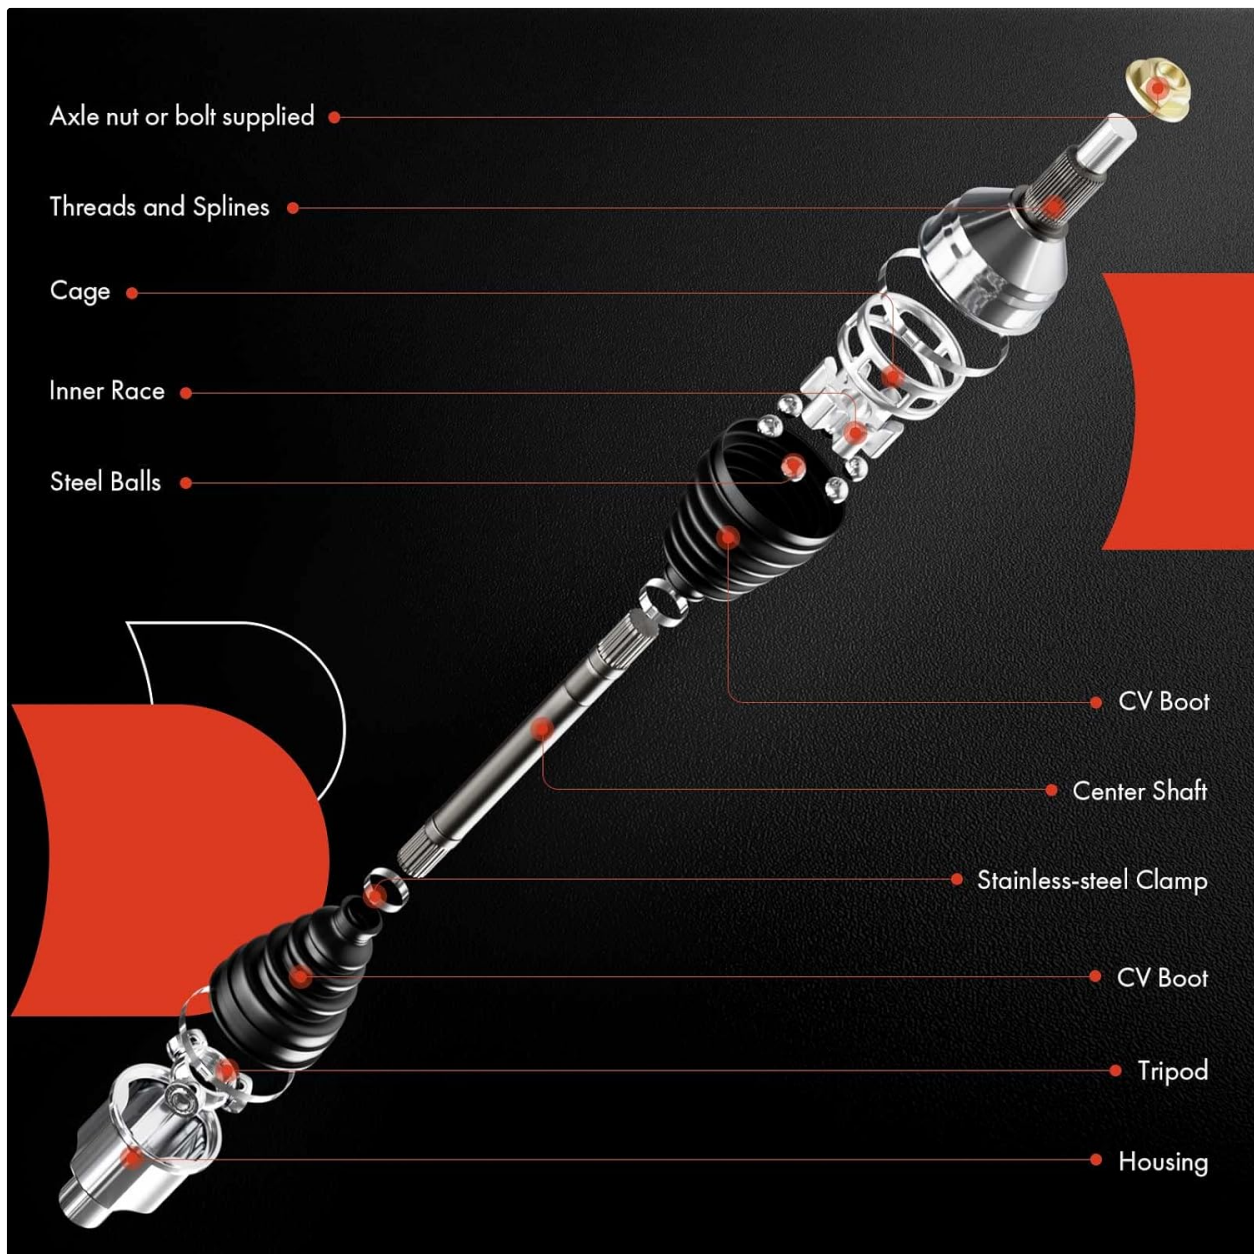
Figure 3: Exploded view illustrating the internal components of the CV Axle Shaft.

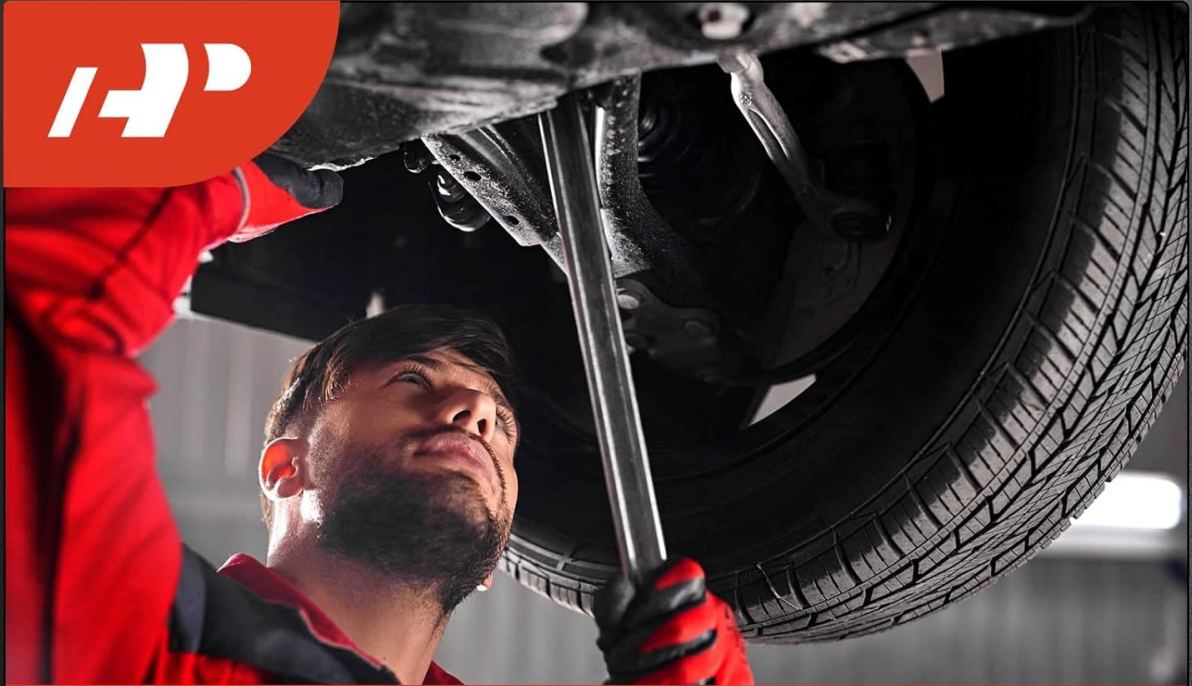
WHEN TO REPLACE YOUR CV AXLE SHAFT

- 1 Grease on edge of the tire
- 2 Excessive vibration while driving
- 3 Deformation of CV Axle Shaft
- 4 Loud clicking noise when turning or accelerating

Figure 4: Visual guide to common symptoms indicating a need for CV Axle Shaft replacement.

- **Grease on the edge of the tire:** This often indicates a torn CV boot, allowing grease to escape.
- **Excessive vibration while driving:** A damaged or unbalanced CV axle can cause noticeable vibrations, especially at higher speeds.
- **Deformation of the CV Axle Shaft:** Visible bending or damage to the shaft itself.
- **Loud clicking noise when turning or accelerating:** This is a common symptom of a worn or damaged outer CV joint.
