# 1409KMT Active Radiator Grille Shutter User Manual

Model: KMT-OT002450 for Chevrolet Silverado 1500 (2019-2023)

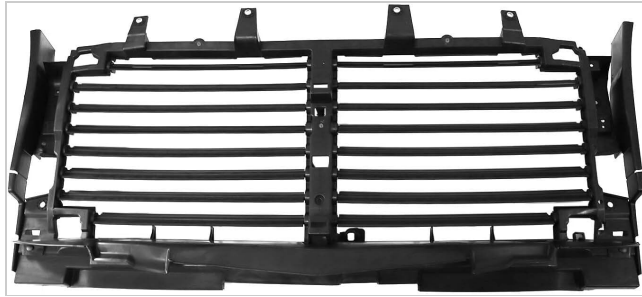
Figure 1: Front view of the active grille shutter, showing the blades in an open configuration.

- **Aerodynamic Efficiency:** At higher speeds, the shutters may close to reduce aerodynamic drag, improving fuel efficiency.
- **Engine Temperature Management:** The shutters open to allow airflow to the radiator when the engine requires cooling (e.g., during heavy loads, high ambient temperatures, or low speeds). They may close to help the engine warm up faster or maintain optimal operating temperature in colder conditions.
- **Automatic Operation:** No manual intervention is required for the operation of the active grille shutter. The system is fully automated based on various sensor inputs.

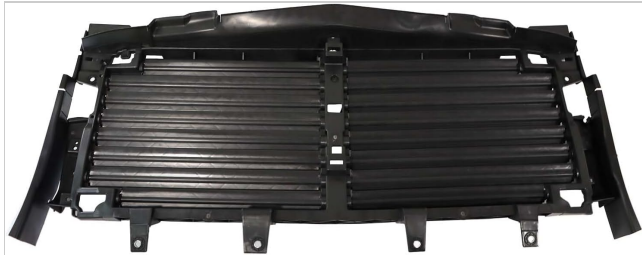
Figure 2: Front view of the active grille shutter, showing the blades in a closed configuration.

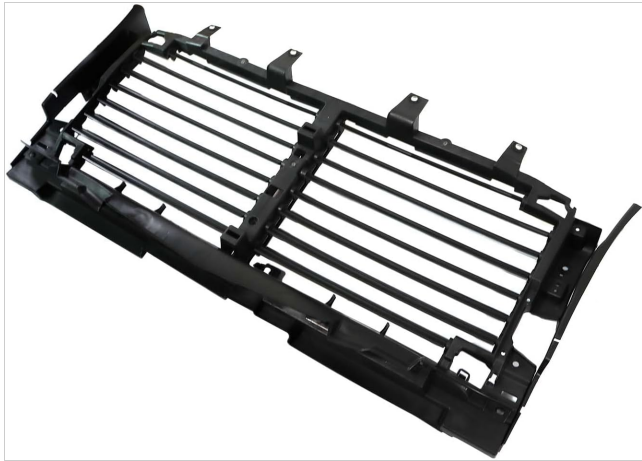
Figure 3: Angled perspective of the active grille shutter with blades open.

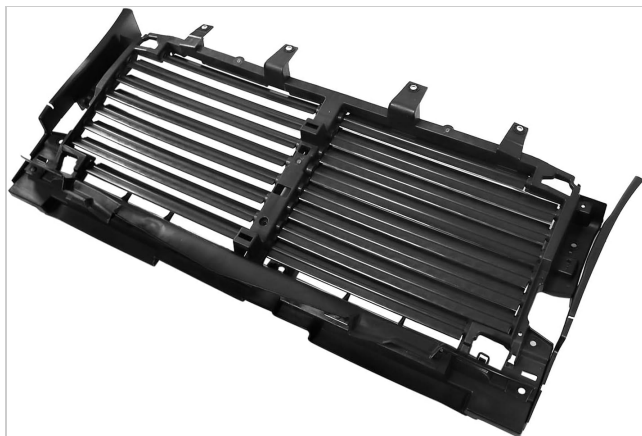
Figure 4: Angled perspective of the active grille shutter with blades closed.

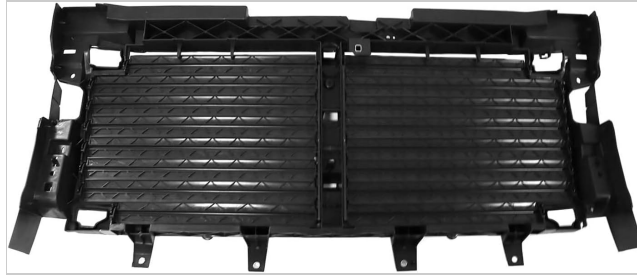
Figure 5: Rear view of the active grille shutter, showing the reverse side of the closed blades.

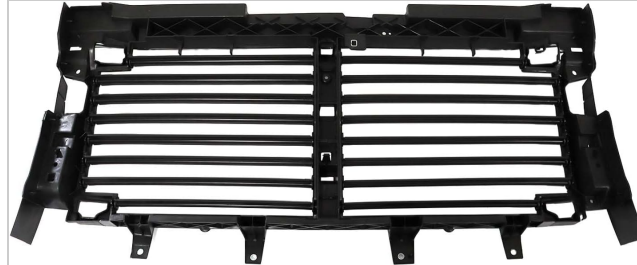
Figure 6: Rear view of the active grille shutter, showing the reverse side of the open blades.

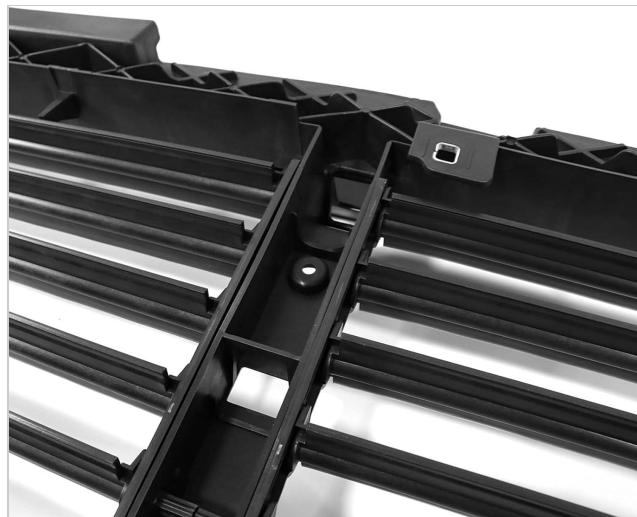
Figure 7: Detailed view of the internal mechanism of the active grille shutter.

Unusual noises from the grille area	<ul style="list-style-type: none"> <li>• <b>Loose Components:</b> Ensure all mounting hardware is secure.</li> <li>• <b>Debris:</b> Check for foreign objects lodged within the shutter mechanism.</li> <li>• <b>Damaged Blades/Mechanism:</b> Inspect for physical damage to the shutter blades or the internal mechanism.</li> </ul>
