Kenmore 110.20022014 HD Washer Main Drive Belt Replacement Manual

Model: 110.20022014 | Part Number: FRIC-PL-APP-TP-22052025-022460

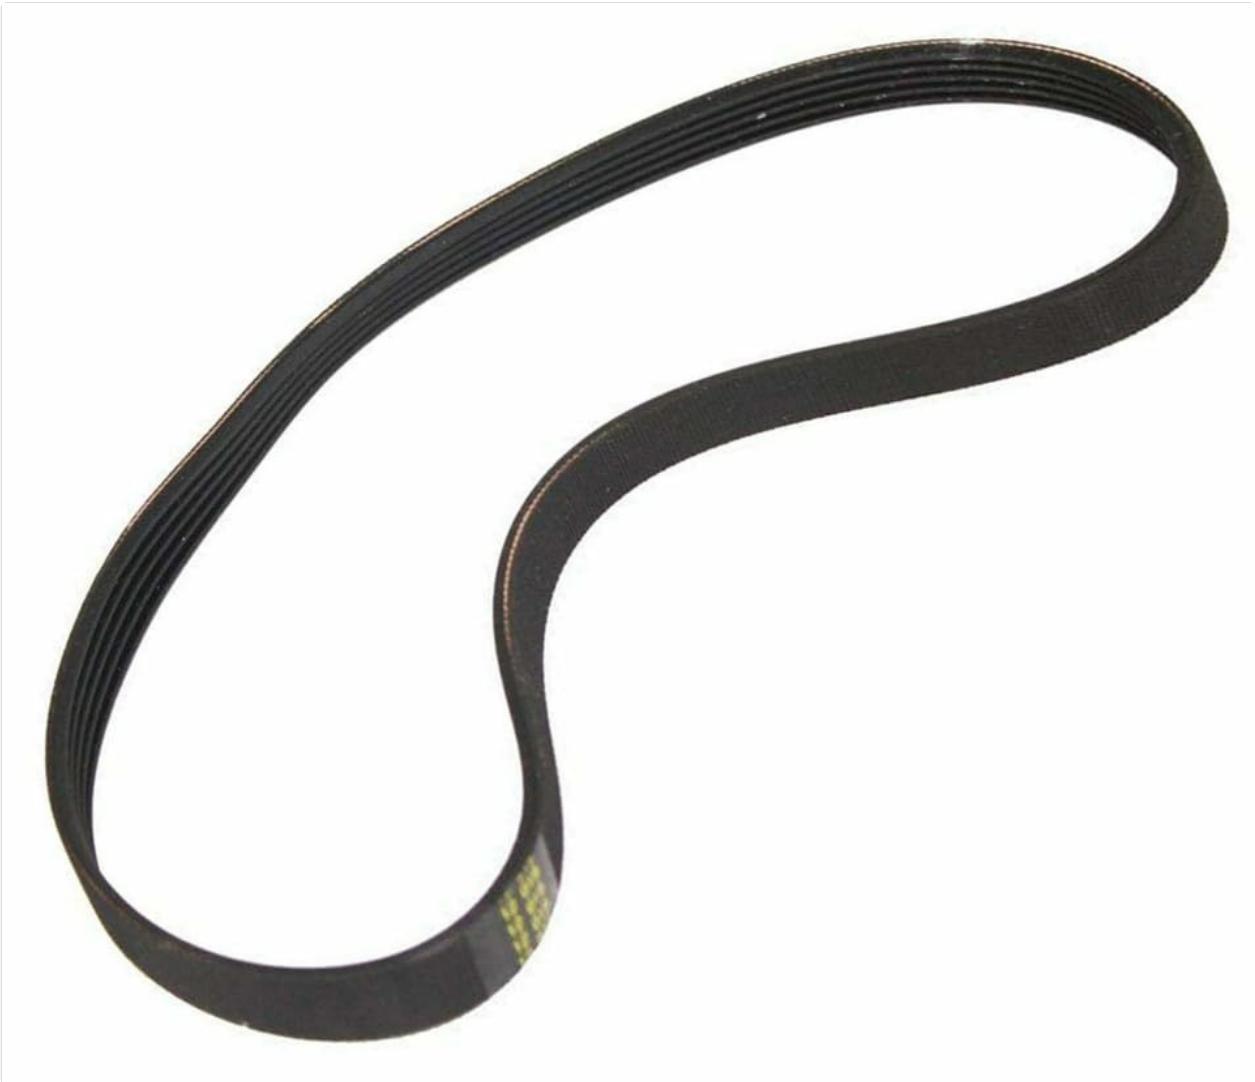
This image shows the replacement main drive belt, designed for Kenmore 110.20022014 HD washing machines. The belt is typically black and has a ribbed surface for grip, ensuring efficient power transfer.

- Install the New Drive Belt:** Begin by placing the new belt around the larger transmission pulley. Then, partially place the belt onto the motor pulley. While holding the belt firmly on the transmission pulley, slowly rotate the motor pulley by hand, guiding the belt onto it until it is fully seated. Ensure the belt is properly aligned in the grooves of both pulleys.

- Verify Belt Tension:** The new belt should be snug but not overly tight. It should have a small amount of play when pressed, but not be loose enough to slip off easily.
