Instruction Manual: Generic Replacement Door Boot Seal Bellow

For Maytag MFW9800TQ0 Washer (Model: Fricpart-123426)

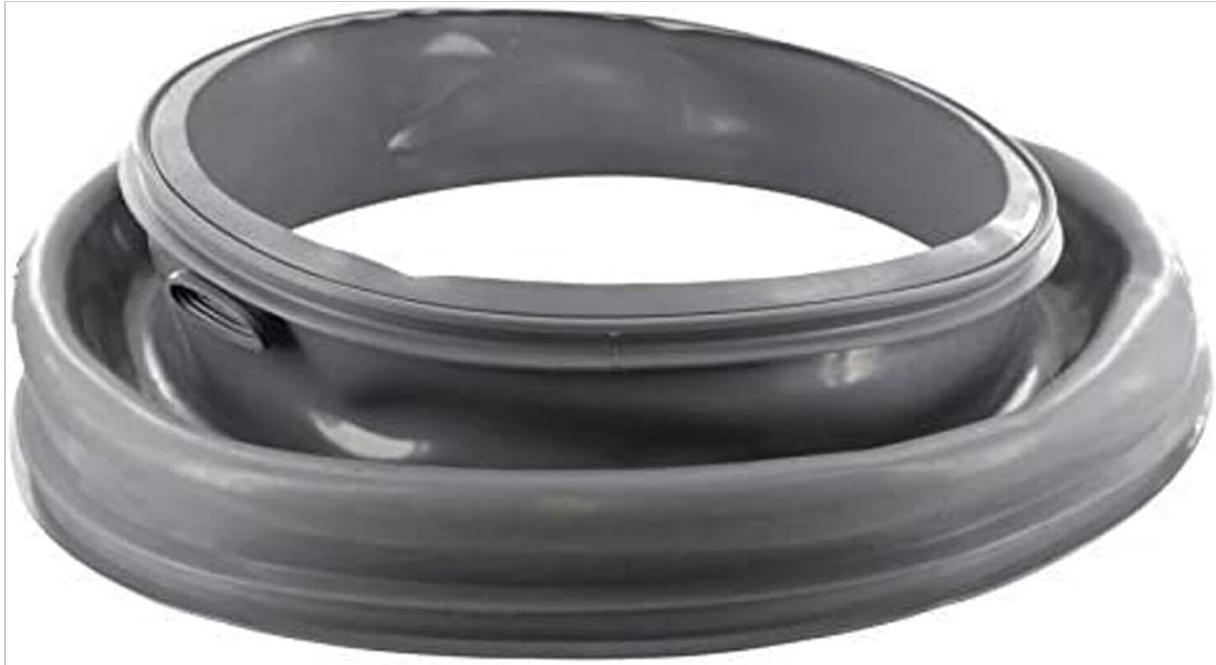
This image displays the Generic Replacement Door Boot Seal Bellow, a circular rubber component designed to create a watertight seal between the washer tub and the door opening. It features a ribbed exterior and a smooth interior rim, indicating its flexible and sealing properties.

The door boot seal, also known as a bellow, is a critical component in front-load washing machines. It forms a watertight seal between the outer tub and the door opening, preventing water leaks during wash cycles. It also helps to cushion the door and tub, reducing vibration and noise. This replacement part is designed to meet the specifications required for compatible Maytag washer models.
