T-SB-0069-12

# SRS Airbag Light "ON" - B0111/B0116 Open Side Squib Circuit

| YEAR(S) | MODEL(S) | ADDITIONAL INFORMATION |
|---|---|---|
| 2005 – 2009 | Sienna | |

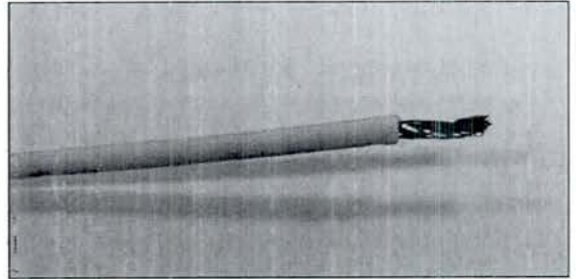
Figure 9.

- B. Remove 8 mm (0.32 in.) of insulation from the end of the 2 female terminal pigtails.

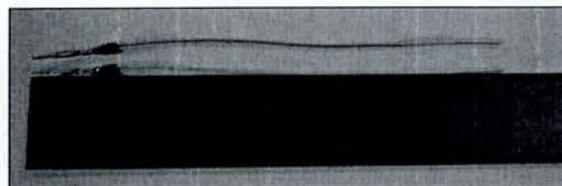
Figure 38.

- A. Measure from the ends of the male terminals and cut the new wires.

**Manual Seat, Left: 165 mm (6.5 in.)**

**Manual Seat, Right: 70 mm (2.76 in.)**
