# THETA GDI ENGINE DTC P1326 - ENGINE INSPECTION/REPLACEMENT (SERVICE CAMPAIGN T3G)

### SERVICE CAMPAIGN BULLETIN

Reference Number(s): 20-01-004H-3, Date of Issue: December 22, 2020

Applicable vehicles with 2.0L Turbo and 2.4L GDI engines may experience the Check Engine warning lamp illuminated with DTC P1326. Follow the procedure to inspect the vehicle and replace the engine or update the engine ECU software based on the inspection results.

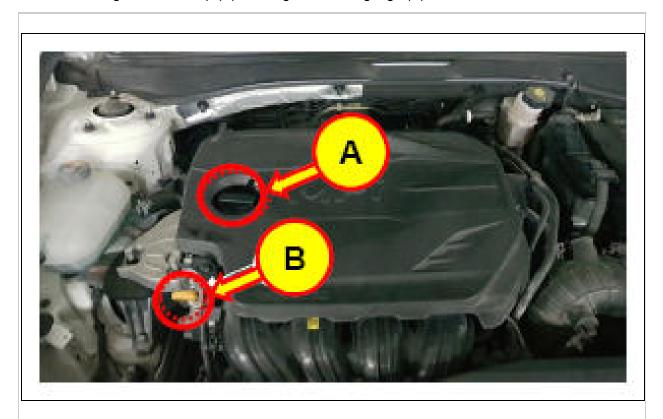
1. Remove the engine oil filler cap (A) and engine oil level gauge (B).

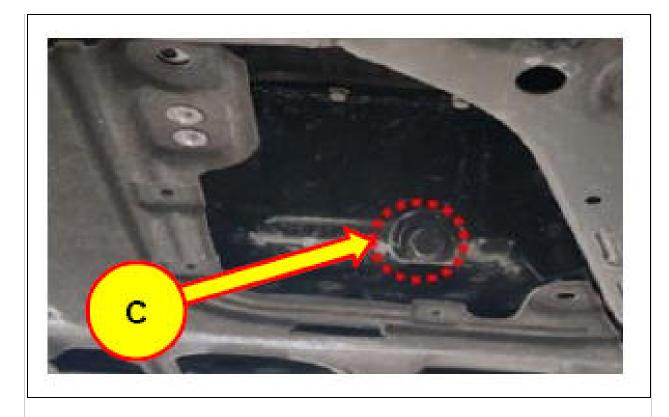
2. Lift up the vehicle and remove the oil drain plug (C).

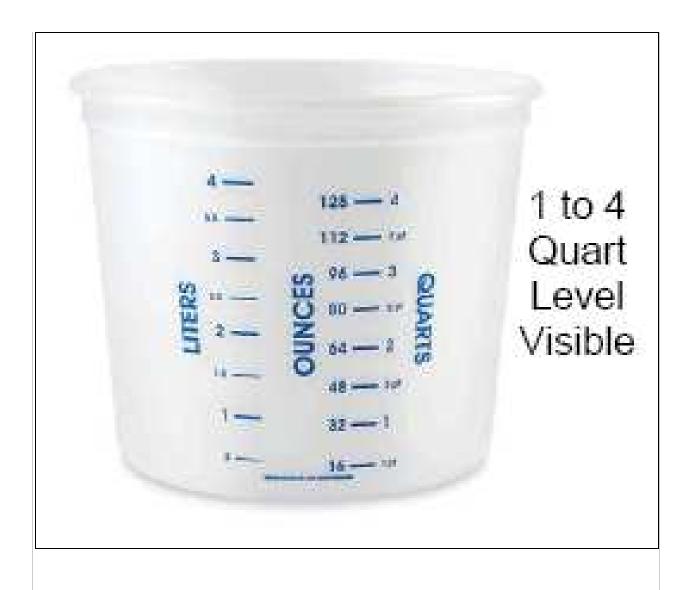
- 3. Drain the engine oil into a container. The 1-4 quart level should be clearly marked and visible on the container. Using STUI in the GDS, take and submit a picture of the oil container with the drained oil level clearly visible and the VIN in the background of the photo (RO or last 6 digits written on paper) for records, if needed. **VIN must be legible.**
- 4. Submit PA for engine replacement approval.

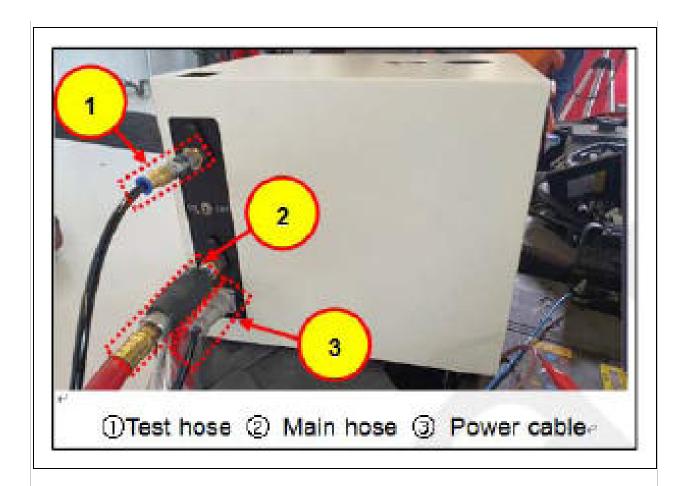
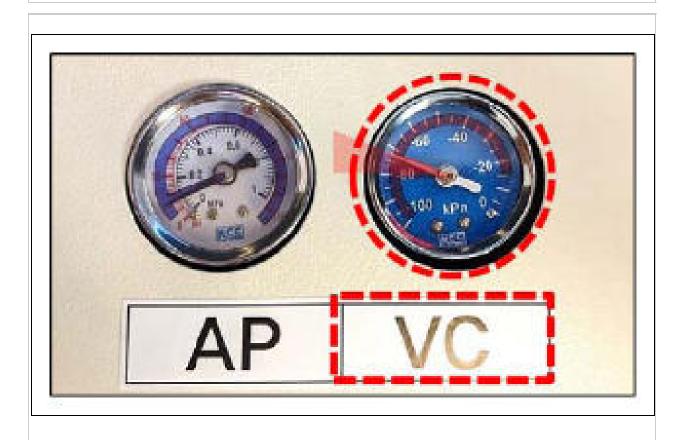
# AP/VC air pressure calibration check:

- a. Connect the main air compressor hose.
- b. Connect the test hose. (The other end of the test hose should be left disconnected from the spark plug rod.)
- c. Confirm that the AP/VC toggle switch at top is in the middle position.
- d. Inspect the AP/C gauge indicators and compare to the specification range:

a. **AP:** 0.1 ~ 0.11MPa b. **VC:** -73 ~ -83Kpa

**NOTE:** Do not continue if any of the above readings are out of specification range.

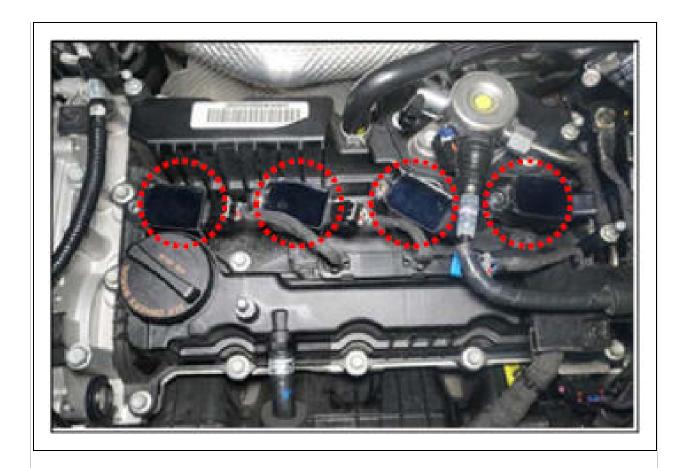
2. Remove the engine cover and the 4 ignition coils.

Tightening Torque (ignition coils): 9.8 - 11.8 N.m (1.0 - 1.2 kgf.m, 7.2 - 8.7 lb ft)

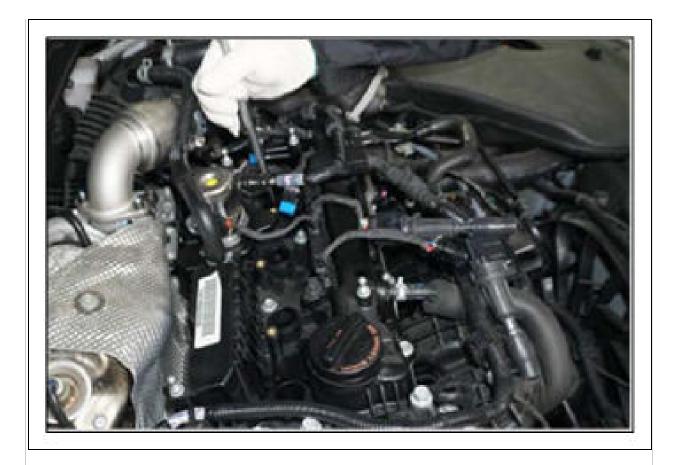
3. Remove the 4 spark plugs. **Tightening Torque:**

14.7 - 24.5 N.m (1.5 - 2.5 kgf.m, 10.9 - 18.0 lb.ft)

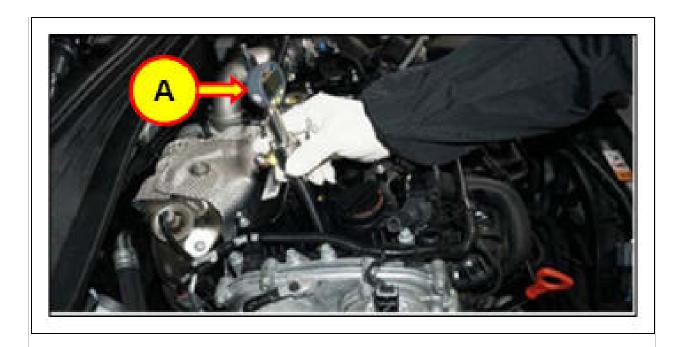
4. Insert the spark plug rod SST (A) into Cylinder #1 spark plug hole and turn until hand tight. Insert the clearance gauge SST into the spark plug rod and tighten using the thumb screw.

**NOTE:** DO NOT connect the test air hose to the clearance gauge at this time.

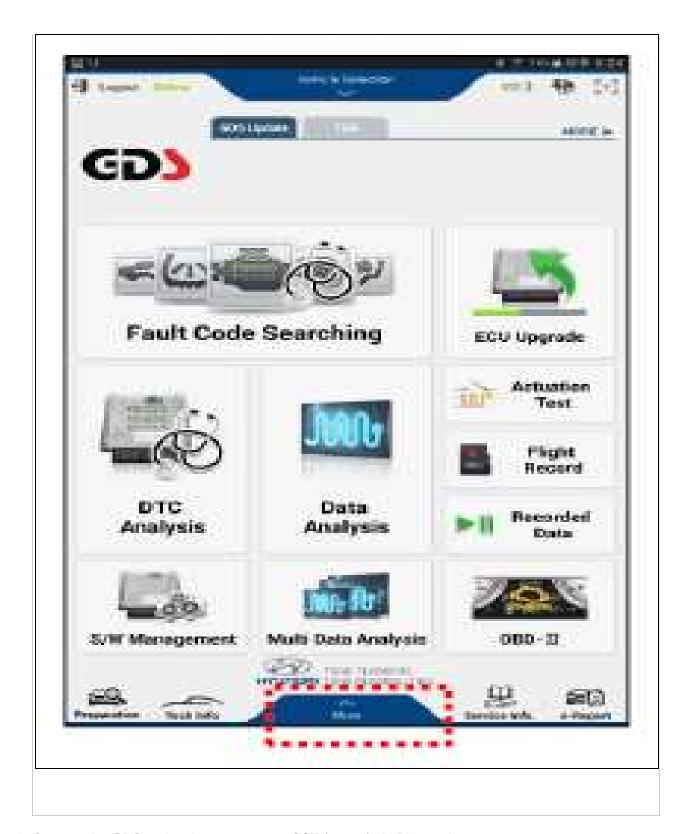
- 5. Connect the GDS to the vehicle and turn the ignition 'ON'.
- 6. Swipe up on the 'More' tab at the bottom of the GDS home screen. Select the 'Special Inspection' function.
- 7. Enter the vehicle info into the GDS as prompted then select 'Next'.

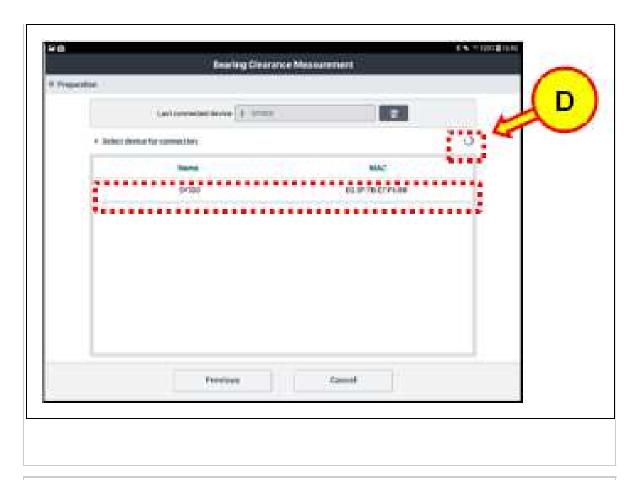
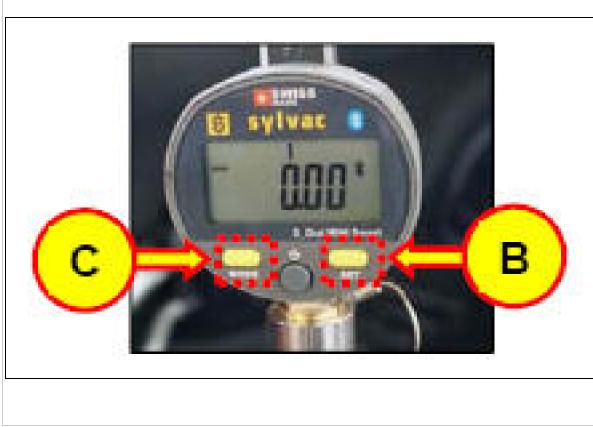
- 8. Connect the GDS to the clearance gauge SST (gauge) via Bluetooth:
  - 1. Press the "Set" button (B) on the gauge to turn it on.
  - 2. Press the "Set" (B) and "Mode" (C) buttons at the same time for about 4 sec until the "reset" message is displayed.
  - 3. Select the gauge in the list of devices on the GDS. Select the 'Refresh' icon (D) if the gauge doesn't appear automatically.

- 4. Check that the ball point tip (E) of the clearance gauge SST is securely installed to the tool as shown. **Do not continue if ball point tip (E) is loose or missing.**
- 9. Turn the ignition 'OFF' and remove the VCI.

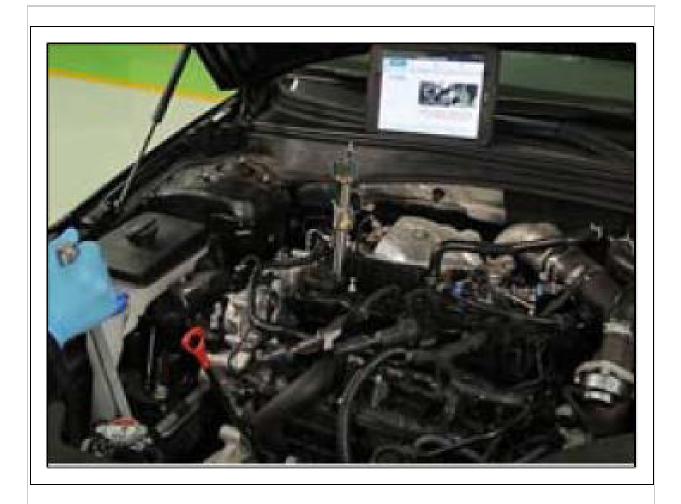
- 11. To find TDC compression (TDC), rotate the crankshaft with the crank rotator SST at least one cycle (1/2 turn). (If the SST does not fit the specific vehicle type, remove the front passenger wheel and wheel liner or underbody tray as needed to rotate the crankshaft using standard shop tools.)
  - 1. Monitor the piston height value on GDS screen or the clearance gauge SST while rotating the engine clockwise using the Crank Rotator Tool.
    - 1. Rotate the engine SLOWLY as the value increases towards a MAX value. (BTDC → TDC)
    - 2. When the value changes direction (increasing/BTDC  $\rightarrow$  TDC  $\rightarrow$  decreasing/ATDC), stop rotating the crank when the piston height is at MAX value minus 0.03mm.

**NOTE:** The testing point is slightly towards ATDC from TDC when the piston has moved down 0.03mm from its highest position.

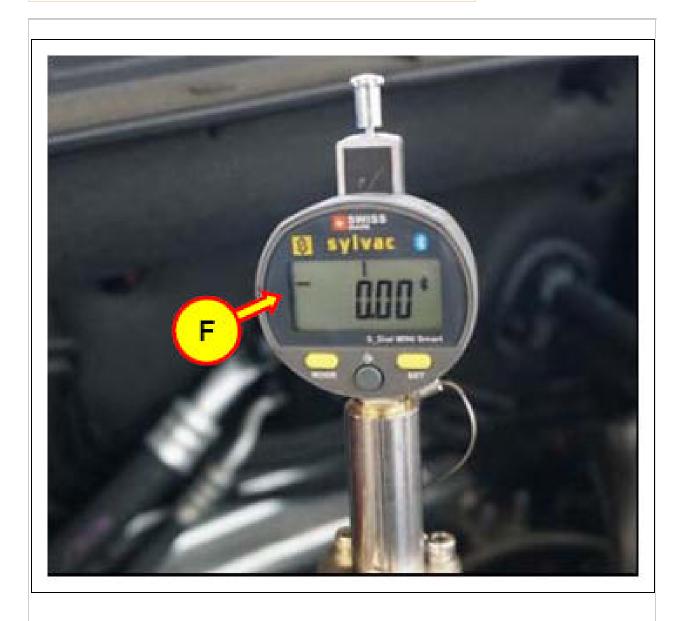
- 1. Ideal set point for testing from TDC is found when the maximum value minus 0.03mm is reached on the clearance gauge SST (F).
- 2. The value is also displayed on the GDS.
- 13. Once the set point for bearing testing is found, select 'Start' in the GDS screen and proceed directly to the next step below.
  - 1. Do not turn the crank rotator SST until instructed to do so.

**NOTE:** The value at TDC varies depending on the specific vehicle and engine type.

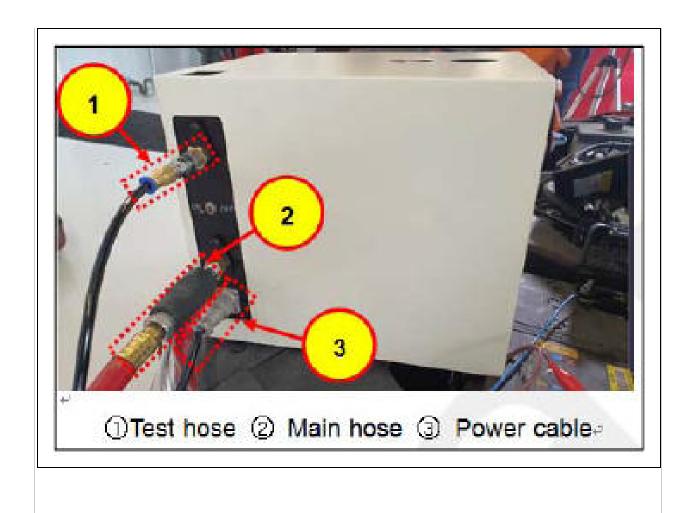
14. Connect the test hose (1) to the spark plug rod SST and to the bearing tool SST.

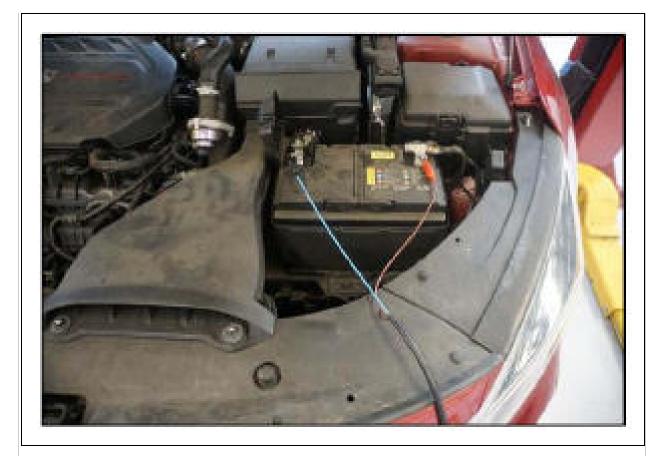
15. Connect the SST power cables to a fully charged 12V battery or to an external AC/DC power supply.

1. Turn the bearing tool SST power switch 'ON'.

- a. Supply 12 volts (or an alternate external AC/DC 13.8 volt power supply with at least ~2 amp output) to the power cable (3) connected to the bearing tool SST.
- b. Turn power switch to ON.
- c. Toggle AP/VC transfer switch between AP <> VC.
  - a. The solenoids should "click" while switching between AP/VC when the unit is ON.
  - b. If the solenoids are not switching, then check the power cable or the power supply.
- 16. Locate the AP/VC switch on the bearing tool SST and switch it to the AP Position.
- 17. Follow the instructions on the GDS to test each cylinder. Cylinder #1 is checked first.
  - 1. The cylinders will be checked per the engine firing order:  $\#1 \rightarrow \#3 \rightarrow \#4 \rightarrow \#2$ .
- 18. On the bearing tool SST, change the AP/VC switch to the VC position when instructed by the GDS.

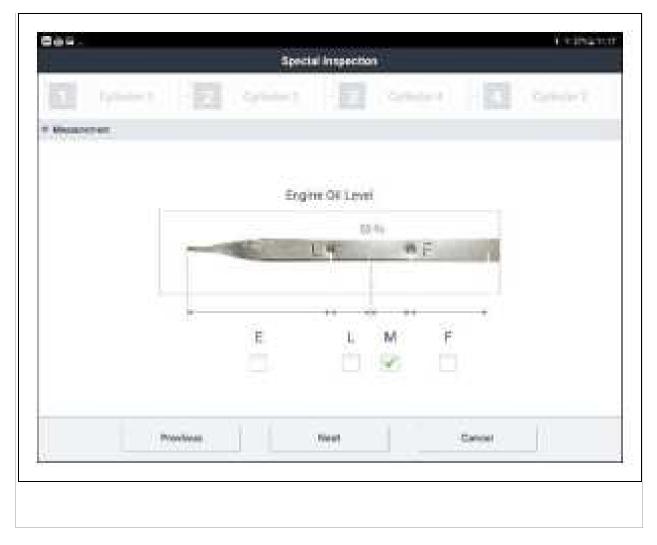
19. Continue following the instructions on the GDS to complete the bearing inspection. Check the engine oil level and select the level in the GDS.

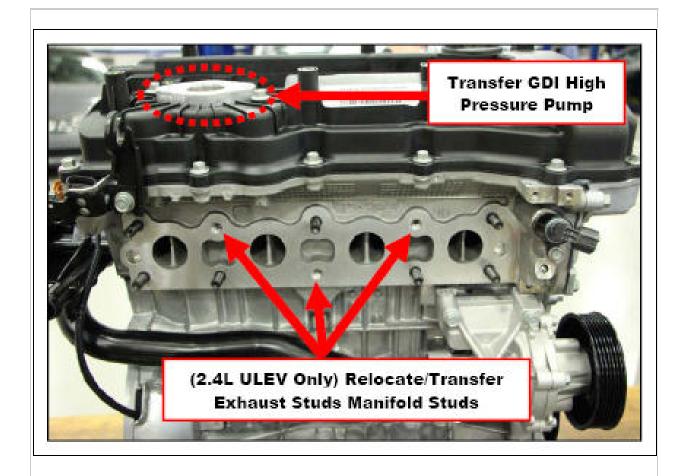
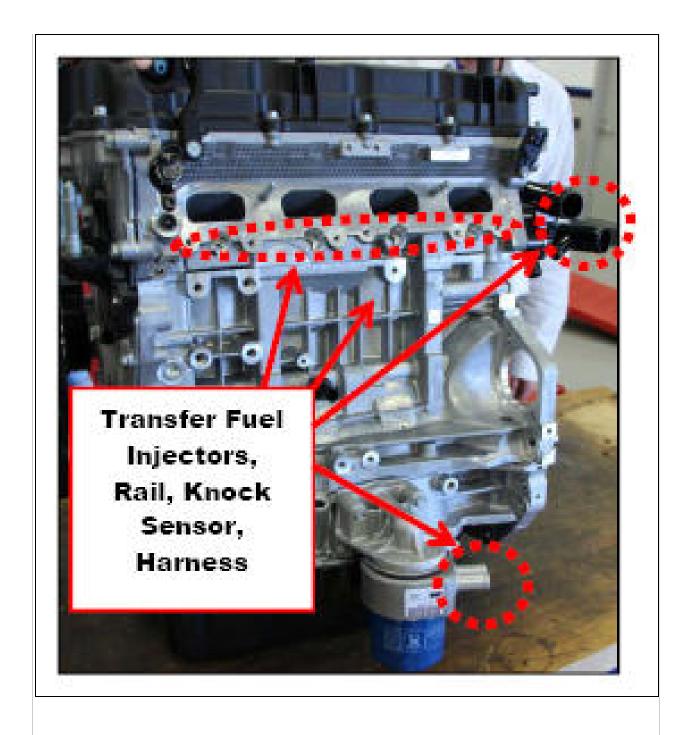
3. Certain replacement engines must be prepared prior to installation. Some components from the existing engine must be transferred to the new engine.

**NOTE:** Take special care of the original engine parts that will be required for reinstallation on to the replacement engine.

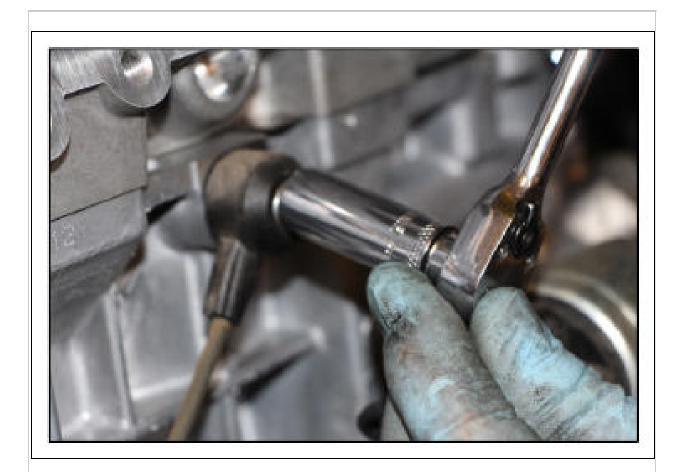
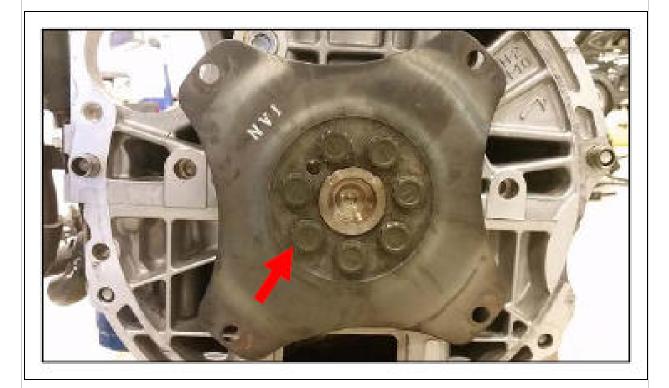
- 1. Install the oil filler cap from the old engine to the new one.
- 2. Install the drive plate/flywheel on the new engine using new bolts (QTY 7).
  - 1. **Drive Plate Tightening torque:** 111.7 ~ 127.5 Nm (86.8 ~ 94.1 lb-ft)

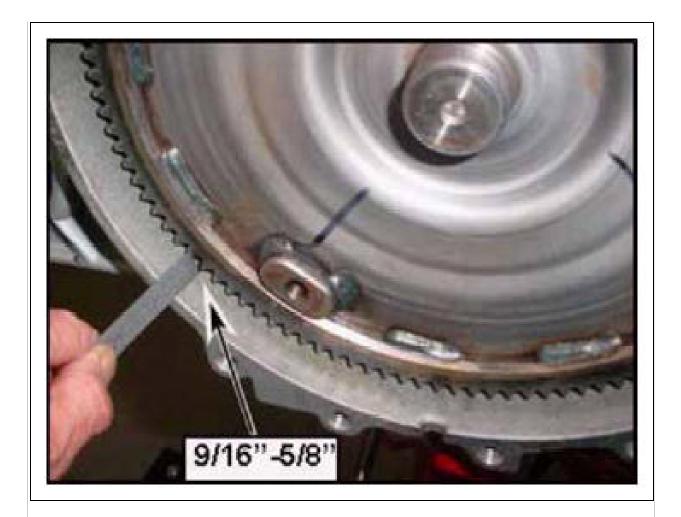
**NOTE:** If the torque converter has moved from the fully inserted position, carefully push inward and rotate the torque converter until the converter is recessed approximately 5/16 –9/16 (8-14 mm) into the transaxle case when reinstalling the automatic transaxle.

Check the depth of the torque converter to confirm it's fully installed in the transmission otherwise the oil pump may be damaged resulting in transmission failure.

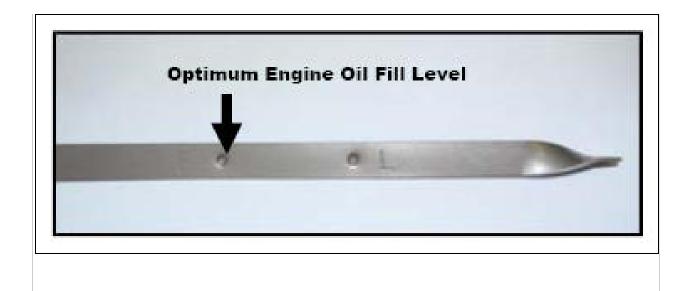
- 1. Check for any leaks during this time.
  - 2. After the engine has warmed up to normal operating temperature, turn the engine off, wait a few minutes, and then adjust the engine oil level to near the "F" mark as shown.
