Tesla, Inc. Service Bulletin		<i>Install Ferrite Cores onto Ancillary Bay Harness</i>	
SB-23-16-008 February 29, 2024		R2			
Classification		Section/Group		Mobile Service	Configuration
Repair Bulletin		16 - HV Battery System		Cannot Perform	LHD Structural Pack
Model Year	Model	Country/Region		Build Location	
2023	Model Y	Europe		Giga Berlin	
The model(s) and model year(s) listed are a general approximation of the affected VIN list. Refer to the VIN/Bulletin Tracker or Customer/Vehicle profile to determine applicability of this bulletin for a particular vehicle.

Some Model Y vehicles built at Giga Berlin are equipped with a low voltage (LV) harness in the ancillary bay with suboptimal placement of ferrite cores, which may cause electromagnetic interference that triggers a recoverable graceful-power-off event.

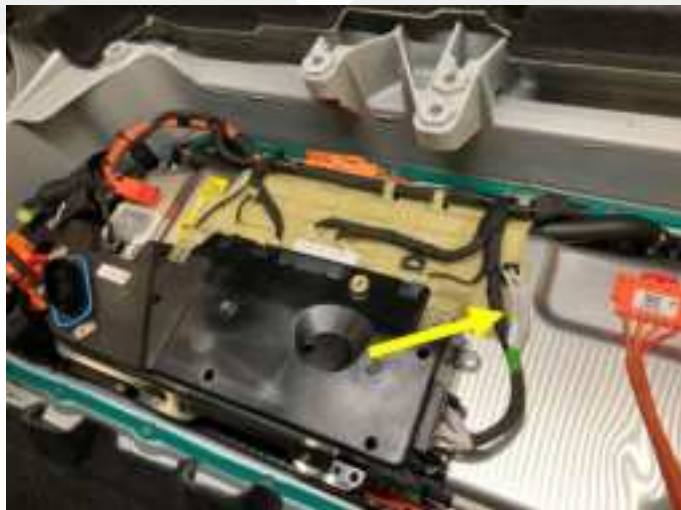
Figure 1

**NOTE:** The part number label is located on top of the PCS, next to HVC connector (Figure 1).

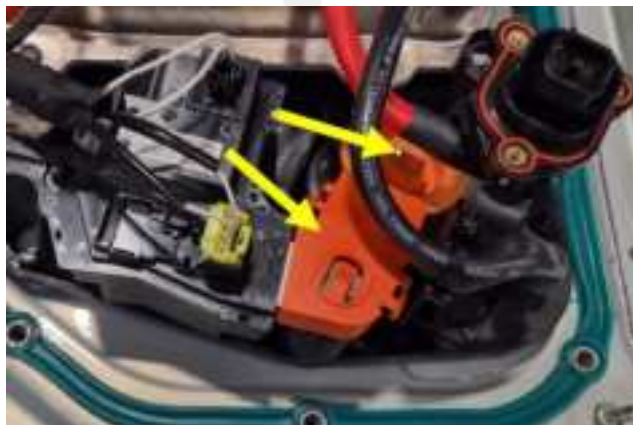
Figure 2

- If the part number is 1616706-00-F or later, go to step 23.
 - If the part number is 1616706-00-E or earlier, go to the next step.
5. Verify that the HV insulator covers are present (Figure 2).

**NOTE:** If necessary, install insulator covers before continuing this procedure.

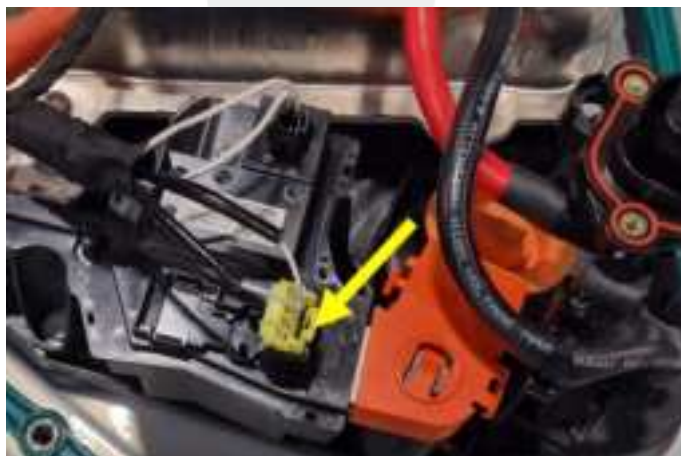
Figure 4

8. Disconnect the HV+ sense connector (Figure 4).

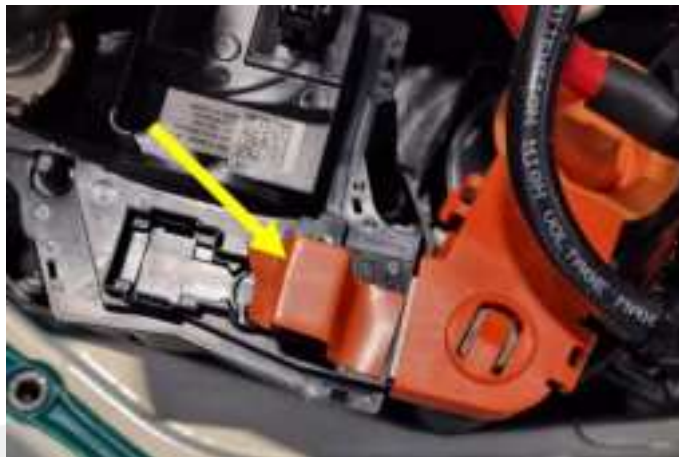
Figure 5

9. Apply electrical tape to the positive pack contactor (Figure 5).

21. Remove the tape from the positive pack contactor (Figure 5).

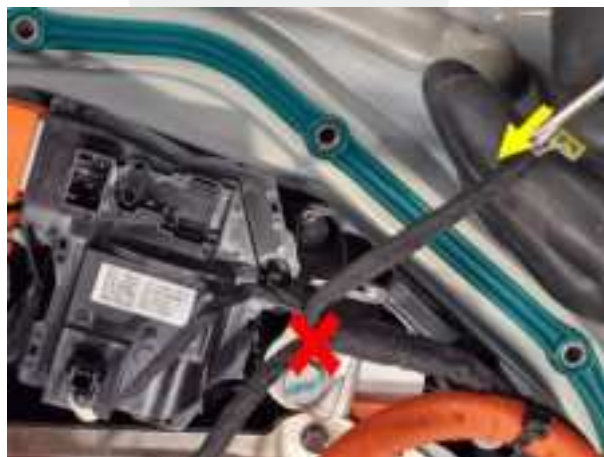
Figure 6

10. Remove the tape from the HV+ sense harness branch. (Figure 6).

**CAUTION:** Do not cut past the splice and do not remove the cable sleeves.

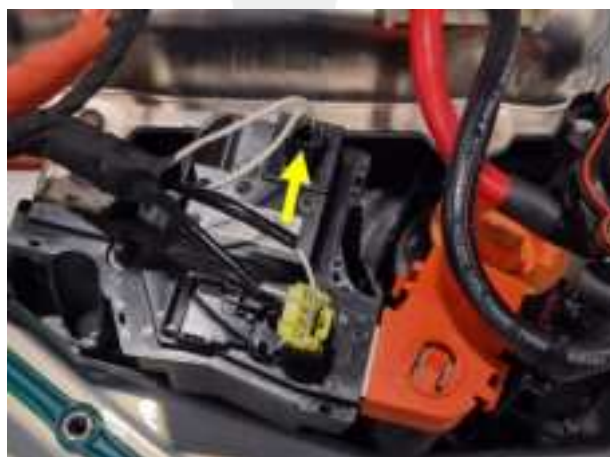
Figure 7

11. Disconnect the positive pack contactor switch connector (Figure 7).

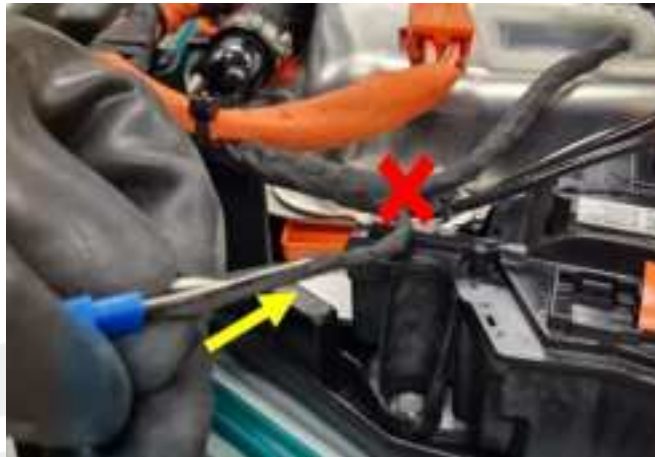
Figure 8

12. Remove the tape from the positive pack contactor switch harness branch. (Figure 8).

**CAUTION:** Do not cut past the splice.

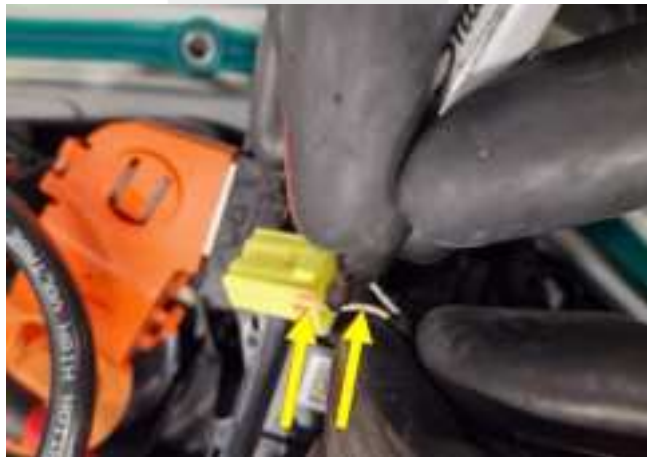
Figure 9

13. Mark the connector housing and the wires of the HV+ sense connector to help identify the wires later in this procedure (Figure 9).

**NOTE:** Use two different colors of paint pen to differentiate the terminals.

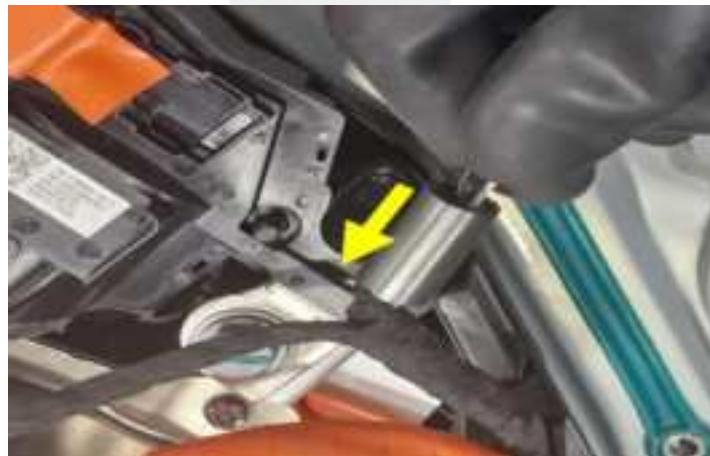
Figure 13

17. Route the wires (x4) through the solid core ferrite, and then position the ferrite as close to the harness splice as possible. (Figure 13).

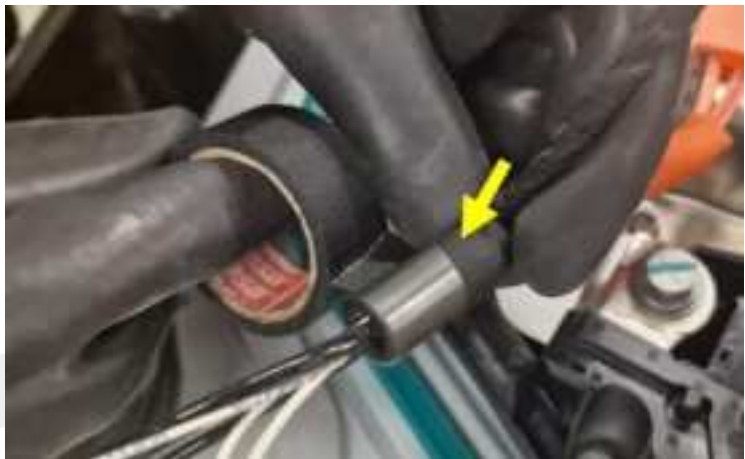
Figure 14

18. Secure the solid core ferrite to the harness using tape (Figure 14).

NOTE: Make sure the tape is wrapped around the harness on both sides of the ferrite core.

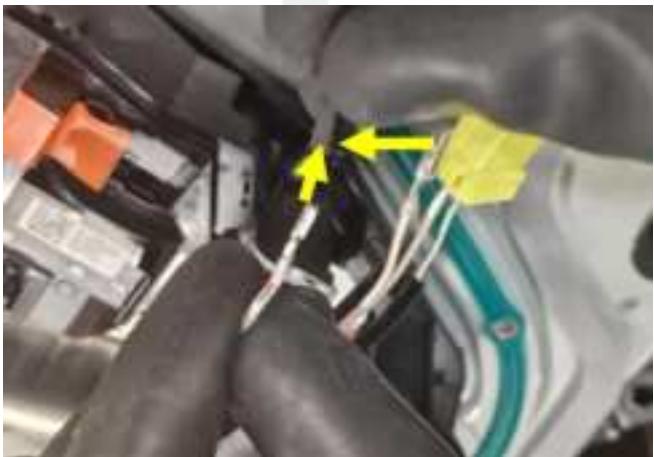
Figure 17

20. Insert the terminals (x2) to the positive pack contactor switch connector (Figure 17).

NOTE: Use the markings from step 13 for positioning. If necessary, use the wiring diagram (Figure 16).

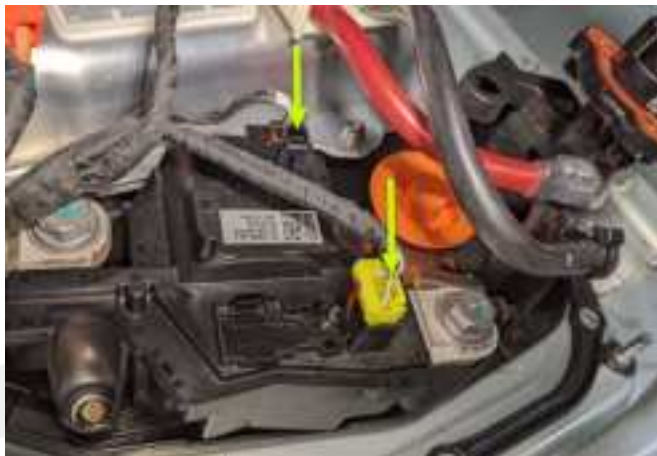
Figure 18

22. Reconnect the HV+ sense connector and the positive pack contactor switch connector (Figure 18).
