Title	French Door Direct Cool Ice Maker Frozen		
Create Date	2017.05.24	Service Bulletin Number	ASC20170602002
Revision Date	2019.04.16	Model: Listed Below	2014 - 2018 Production Units
Symptom	No ice	Frozen Ice Room	Ice Bucket Stuck with Frost

The purpose of this bulletin is to provide servicers with instruction on how to resolve the direct cool ice maker frozen symptom with the Ice Maker Service Kit (IM SVC Kit). The IM SVC Kit comes with an Ice Maker, Y Clip Kit, Auger Drain, Zip Tie, and Main PCB. The IM SVC Kit for the particular model being serviced needs to be ordered.

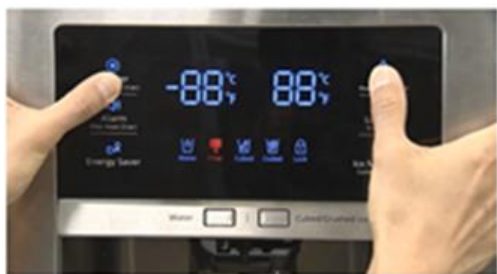
1. Place the unit into Self Diagnostic mode to identify known fault codes.

Code	Item
14 C	Ice Maker(FF) Sensor Error
15 C	Ice Room Sensor Error
39 C	Ice Maker(FF) Function Error
40 C	Ice Room - FAN Error
61 C	Ice dDuct heater Error

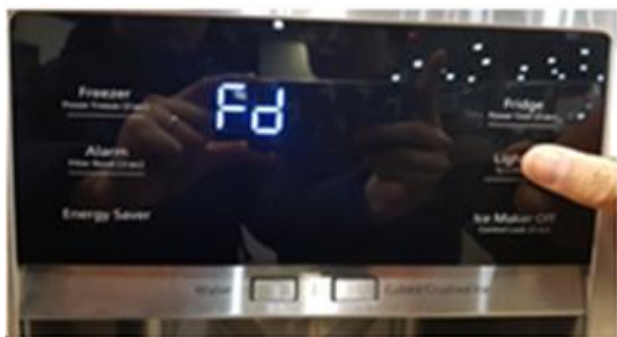
2. Place the unit into forced defrost mode. This will loosen the ice and warm up the cooling loop in preparation for removal of the ice maker. While the unit is in forced defrost mode, move on to the next steps.

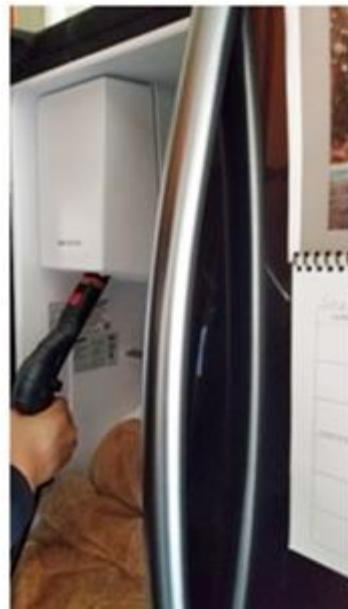
3. Remove the ice bucket. If the ice bucket cannot be removed, use your steamer to loosen the ice bucket.

NOTE: If the ice bucket is stuck, use a steamer to melt the ice until you can remove the bucket. Be sure to place a towel under the ice bucket to catch water as it drips down as shown.

Do not use a heat gun or hair dryer to defrost the ice room. This may cause the plastic liner to melt creating permanent damage.

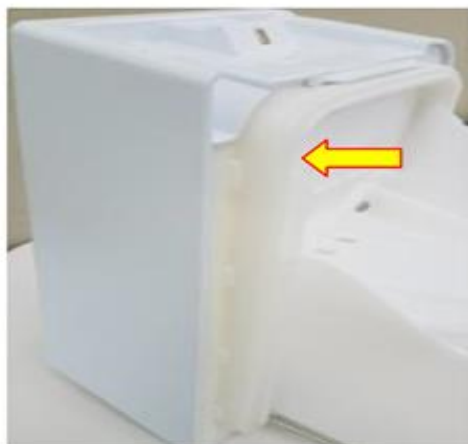
- Remove the ice bucket from the Ice Room.
- Check for cracks or fractures in the ice bucket.
- Check the gasket around the edge of the bucket making sure it is not ripped, cracked, rolled, or has become too rigid, preventing a proper seal.

**If damage is noted,
replace the ice bucket**

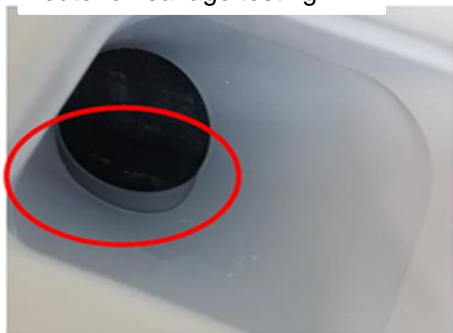
② Inspect the Ice Route Flapper and Assembly for a proper seal

Add some water to the ice route for leakage testing.

Inspect the ice route flapper. Ensure the rubber is still soft and pliable, has no tears or rips, and that the flapper is in the fully closed position when out. Also inspect the ice dispensing opening for cleanliness. If build up has occurred, wipe clean before reinstalling the ice route assembly.

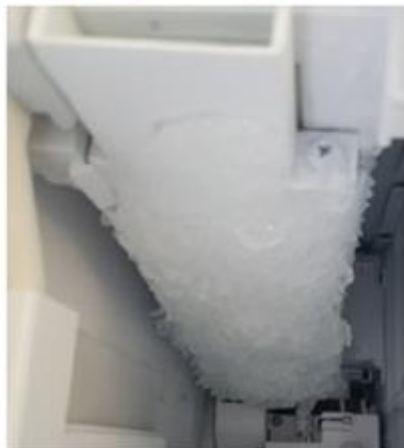
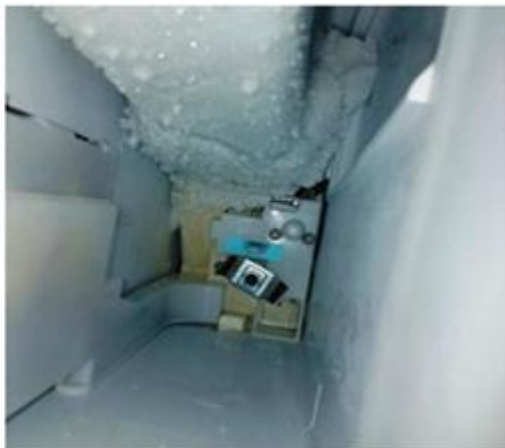
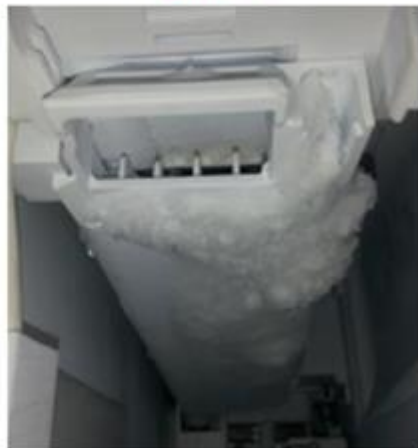
- 3 Remove the unit from force defrost mode and then **unplug the unit**. This will prevent the cooling loop from frosting up during service and prepare the unit for additional service steps.

You **MUST** remove **ALL** ice from the ice room and auger area using a **STEAMER**.

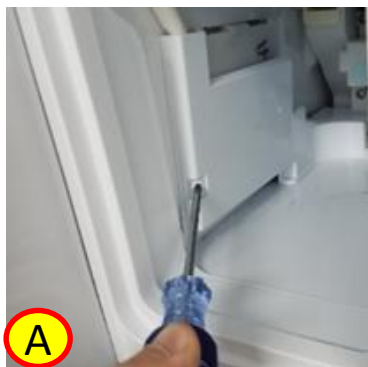
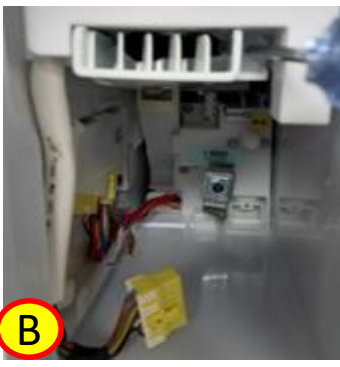
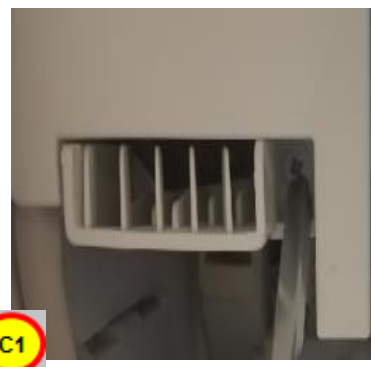
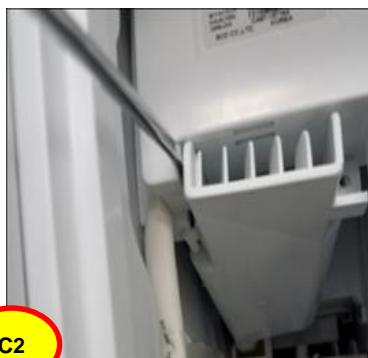
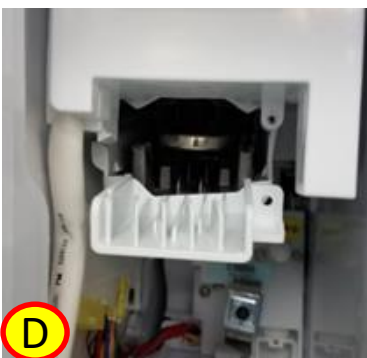
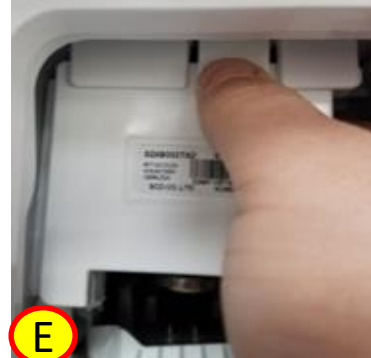
- 4 Disassemble the ice maker (See pictures below)

- Remove the left screw, and then open the harness cover.
- Disconnect the ice maker cable.
- Locate the Duct left hook (C1). Unlock the drain duct by removing the upper right screw (C2).
- Unlock the left hook, and then open the drain duct.
- Unlock the upper hook, and then pull out the ice maker from the opening of the drain duct.

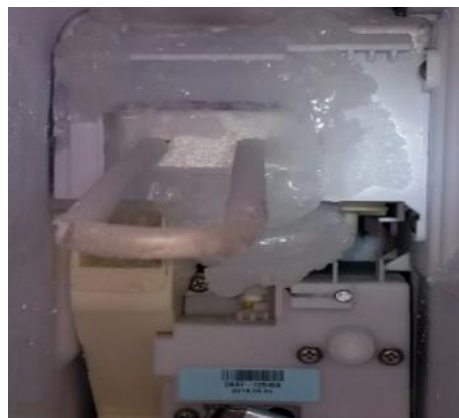
5 Check for Icing Symptoms in the Ice Room

- Check for traces of water spray in the upper ice room area.
- Check for ice in the air flow path (L-Duct).
- Check for ice in the drain pipe of the auger motor.
- Check for ice on the ice room bottom.

Continue steaming the unit to remove all traces of ice and frost to allow for the safe removal of the auger motor assembly. Failure to remove all ice traces will result in a possible repeat visit to the customer.

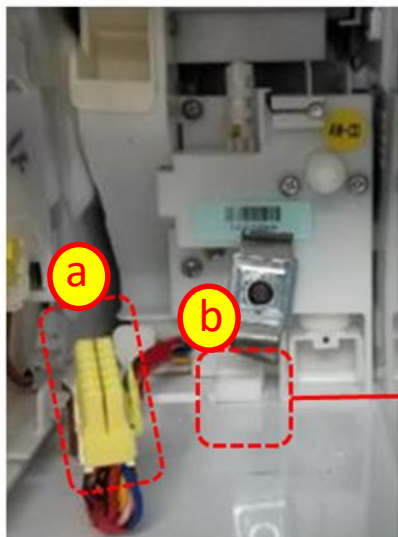
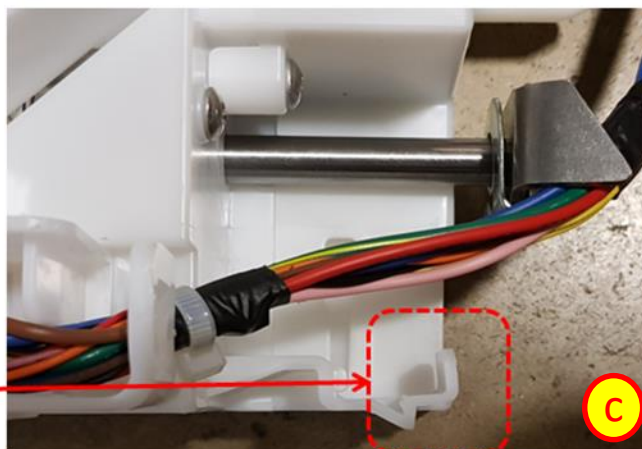
Illustration above: Auger motor removed. Bottom Hook highlighted.

- Disconnect the cable of the auger motor.
- Push the bottom hook.
- Remove the auger motor.

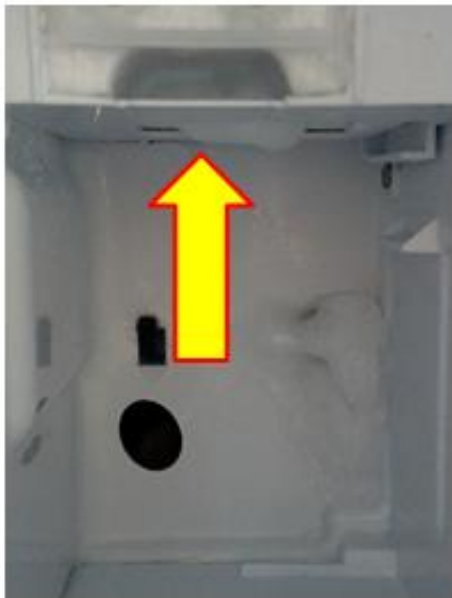
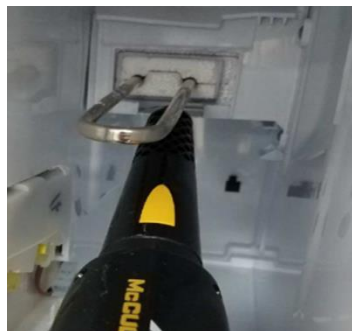
- 7 Inspect the air channel above the auger assembly and remove all traces of ice from this area. Failure to do so will create new ice build up there and on the floor, side walls, and rear.

NOTE: It is very important to remove all accumulated ice anywhere in the ice room and auger. Don't miss any. Failure to remove all ice can result in a return visit.

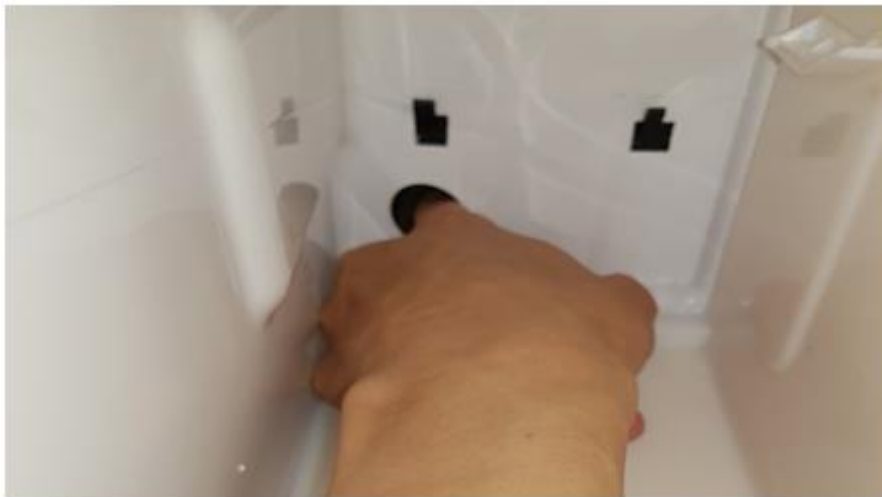
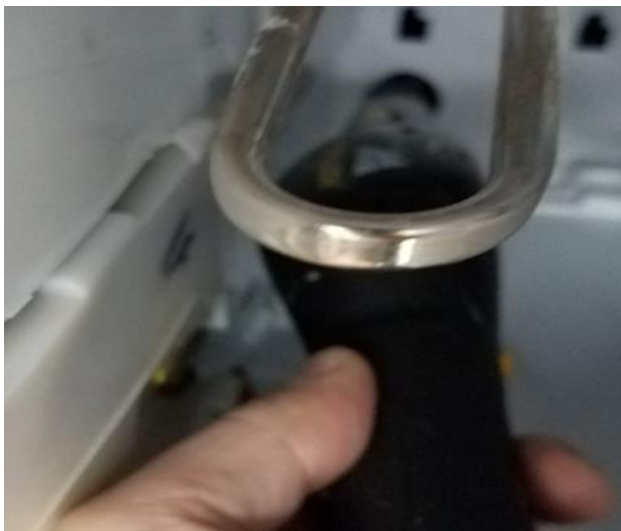
- ⑧ With the auger motor assembly removed, inspect the drain of the ice room. Place your finger into the drain area to feel for any foam remnants or ice blockage, etc. Remove any and all found materials.

If ice is found, use a steamer to remove and ensure you have flow from the ice room to the drip pan in the rear. Drains must always remain open.

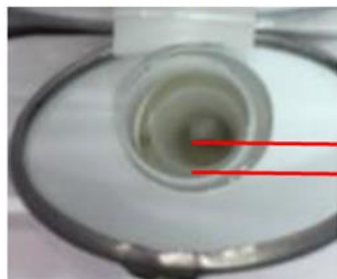
< Correct >

- ⑩ Check for any particles in the fill tube using a mirror. Remove all particles.
Check the gap between the water line outlet and the fill tube to prevent water spray.
If the gap between the water line outlet and the fill tube is less than 10mm, adjust the insertion length of the water line in the cabinet rear.

enough gap : 10mm↑

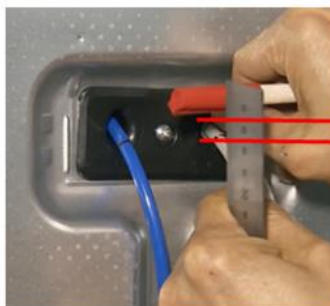
If the gap between water line limit marking and cabinet rear wall is below 15mm (ex. within 10mm), Adjust it to be about 15mm~20mm

enough gap : 15mm~20mm

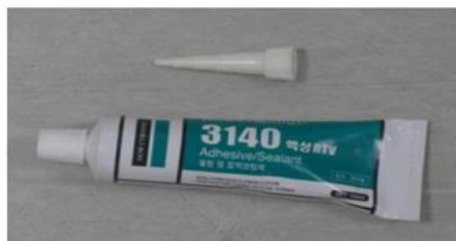
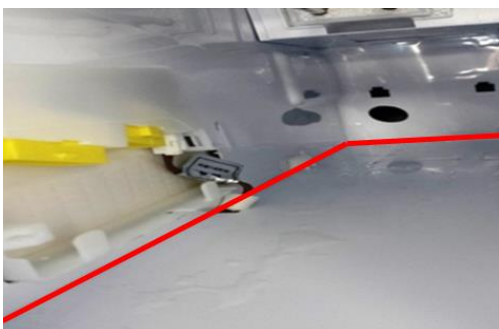
- ⑪ Sealing the ice room with RTV sealant. Seal any gaps that you find in the ice room sides and floor. If no gaps exist, omit this step.
NOTE: Only use Samsung provided RTV sealant. No substitutions or other products are authorized for use in this repair step.

Part number required:
DA81-05595A

Cut the applicator tip at a 45 degree angle, and then apply the sealant along the joints identified by the red line. This will help to provide a sealed ice room environment.

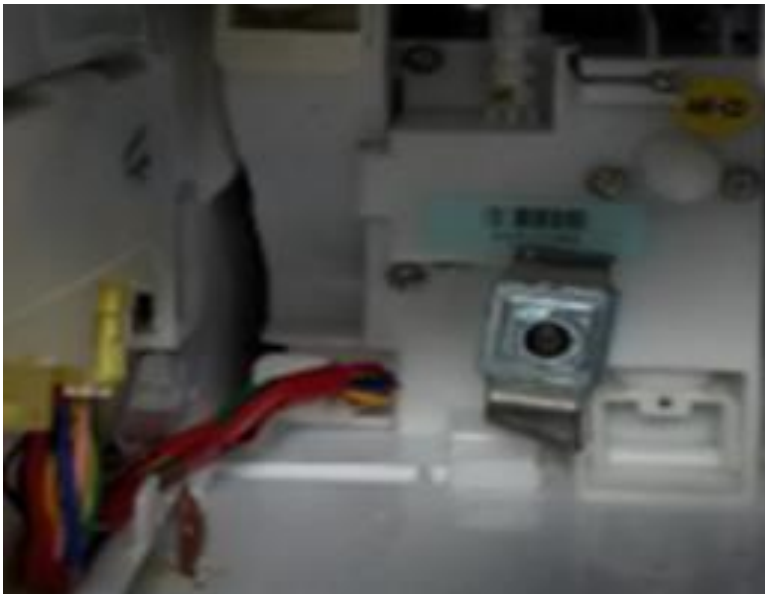
- 12 Re-install the auger motor assembly ensuring it is installed fully to the rear and locked into place with the lock tab. Reconnect the auger motor wire harness to the connection point on the left wall making sure to route the wiring properly.

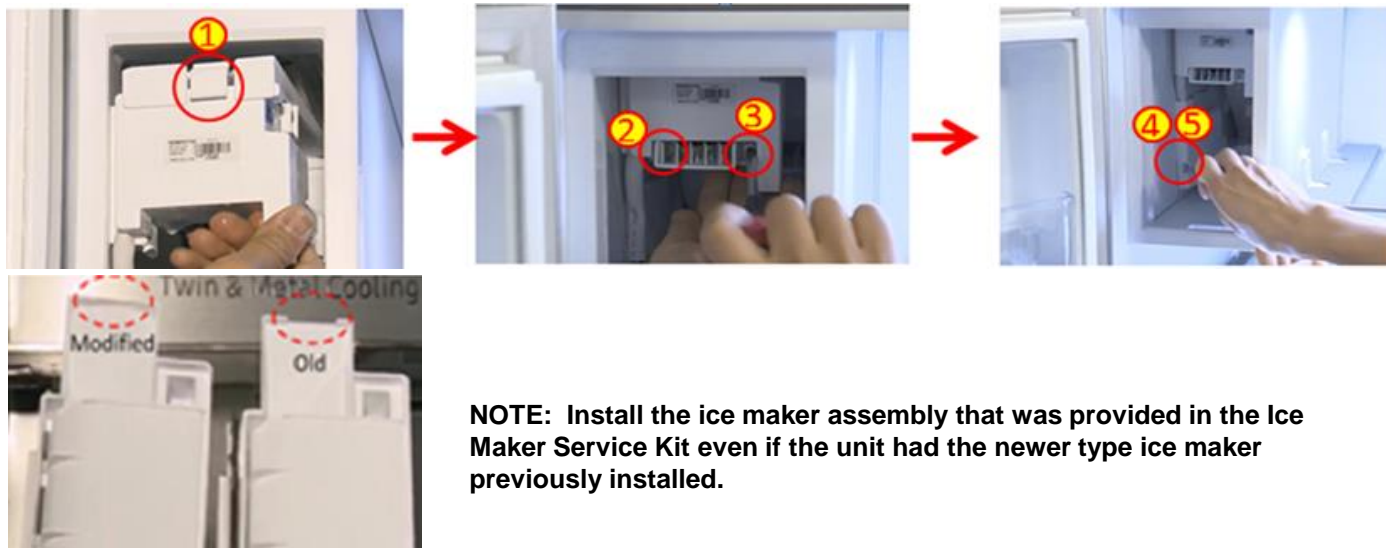
- Insert the ice maker into the opening of the drain duct. Lock the upper hook with 'click' sound.
- Lock the left hook with 'click' sound to close the drain duct.
- Insert and tighten the upper right screw to lock the drain duct.
- Connect the ice maker cable.
- Close the harness cover, and then screw in and tighten the left screw.

NOTE: Install the ice maker assembly that was provided in the Ice Maker Service Kit even if the unit had the newer type ice maker previously installed.

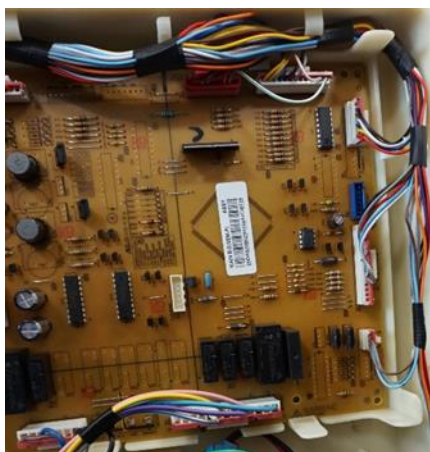
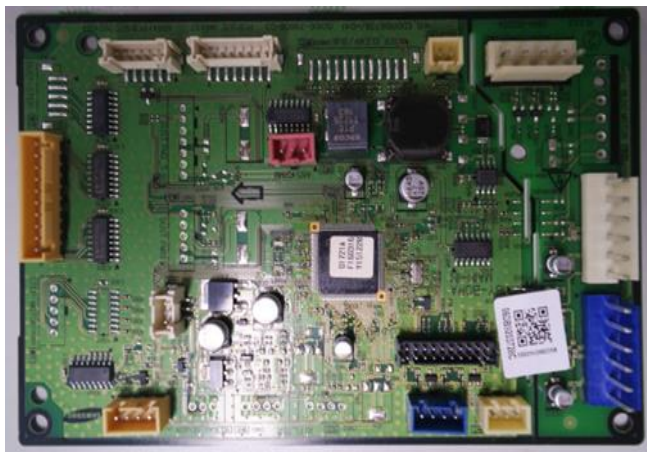
- 15 Install the new MAIN PCB included in your IM SVC Kit.

While the unit is still unplugged, remove all wire connections from the Main PCB.

Once all wire connections are removed, remove and replace the Main PCB, and then re-install all connectors securely.

WARNING: To prevent damage to the Main PCB, you must turn the power off before you connect or disconnect wires going to or coming from the it.

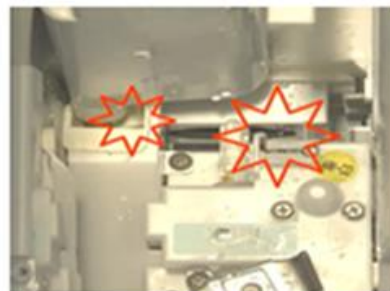
Press "Test Mode" button and check for leaking water or functional failure

When pressing test, listen for the chime. This indicates the test function has begun. This process takes 6 minutes to complete and will produce a shortened fill at the very end of the process. Check for any leaking, spraying, or drips after the 6 minute test is completed.

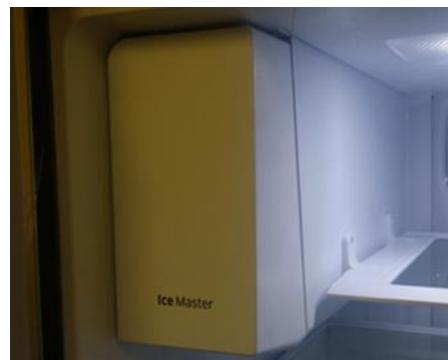
Re-install the Ice Bucket.

To complete the repair, place the unit into Self Diagnosis mode to ensure the unit has no other error codes and is operating as it should.
