## TESLA 3 Inspect and Replace Front Tires Due to NVH Issue

<b>Tesla, Inc.</b> Service Bulletin		<b><i>Inspect and Replace Front Tires due to NVH Issue</i></b>			
<b>SB-24-34-002</b> August 8, 2025		<b>R1</b>					
<b>Classification</b>		<b>Section/Group</b>		<b>Mobile Service</b>		<b>Configuration</b>	
Campaign Bulletin		34 - Wheels & Tires		Cannot Perform		All	
<b>Model</b>	<b>Model Year</b>	<b>Country/Region</b>		<b>Build Location</b>			
Model 3	All	Europe		All			
Model Y	All						
The model(s) and model year(s) listed are a general approximation of the affected VIN list. Refer to the VIN/Bulletin Tracker or Customer/Vehicle profile to determine applicability of this bulletin for a particular vehicle.

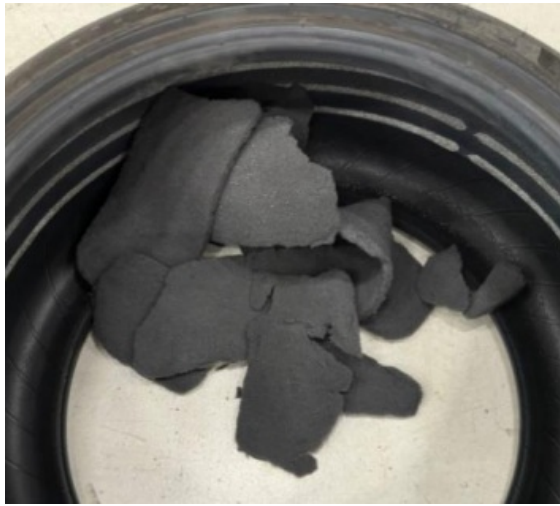
Figure 1 – Loose NVH foam inside tire

On some Model 3 and Model Y vehicles, there may be noise from the factory installed left-hand front and/or right-hand front Michelin tire(s) due to the foam insert detaching from the tire which may cause imbalance and vibration.

1. Dismount the tire from the wheel (refer to Service Manual procedure 34021002).
2. Inspect the inside of the tire to see if the NVH foam is loose (Figure 1).

If the NVH foam is loose, replace both tires on the front axle. Go to section Replace Tires.
