TRANSGO SK6T70-G2 Pressure Regulator and Actuator Feed System Instructions

SK® 6T70-G2 Fits 2013-2017

SK6T70-G2 Pressure Regulator and Actuator Feed System

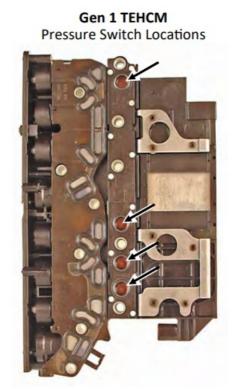
Gen 2 TEHCM
No Pressure switches

Gen 2 Vehicles Only!
Gen 2 TEHCM's Do Not Have Pressure Switches.
This kit does not fit Gen 1 Vehicles Gen 1 TEHCM's have Pressure Switches.
Use Kit # SK®6T70-A 2007-2016

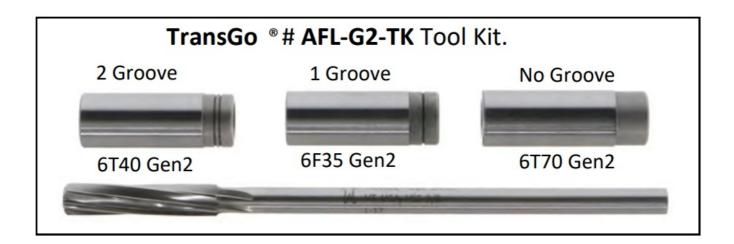
Note: This product requires TransGo ® # AFL-G2-TK Tool kit to repair the Actuator Feed Limit Valve.

AFL-G2-TK Tool kit works on 3 different transmissionsFits All Gen 2 Vb's 6F35's, 6T40s, and 6T70's. The 2013 model year can be a Gen 1 or a Gen 2 Transmission.

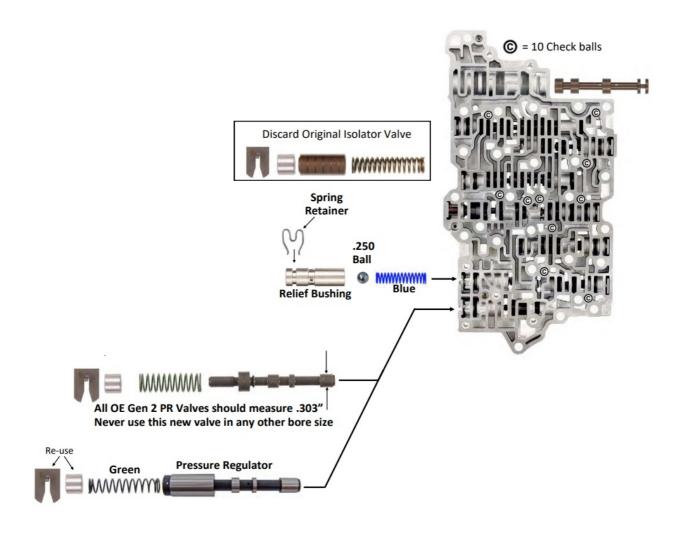
If the original PR measured .303" discard the original Pressure Regulator valve and spring Install New Pressure Regulator Valve, New Green Spring, and original end plug, and retainer.

The new TransGo Gen 2 PR Valve has a positive internal balance circuit drilled thru the valve for faster and smothers regulation, it also has extended lands that seal in unused portions of the bore.

Remove and Measure the original PR Valve's inner land.

If it measures .303" proceed to Step 3.

If it measures .314" Stop! It's a Gen 1 VB and this kit does not fit.

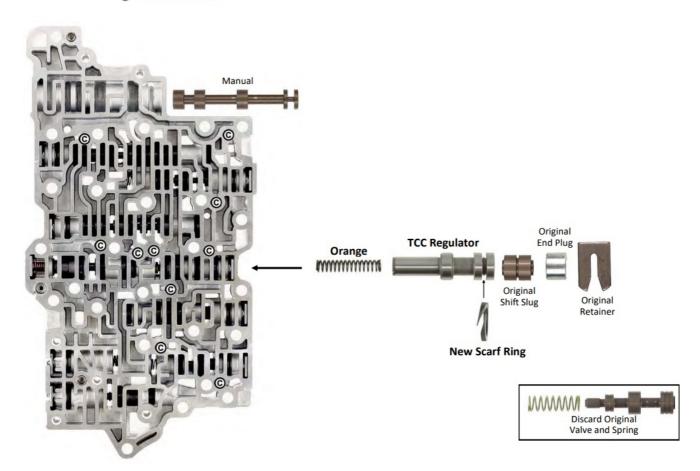
Discard the original TCC Regulator Valve and spring. Clean the New TCC Regulator Valve provided and test fit it into the clean VB bore. If it moves freely, remove it and put a

small dab of assembly gel into the groove of the new valve followed by the NEW Scarf Cut Ring. Now roll the small O-ring provided on top of the scarf cut ring and place it in the freezer for 15 minutes. This will "size" the ring into the groove.

To install, roll the O-ring off the valve and set it aside. Insert the NEW Orange Spring into the hollow end of the new valve and insert the new valve and spring into the bore while it's still cold, followed by the original Shift Slug, End Plug, and Retainer. It will go right in if the outer diameter of the ring is flush with the new valve.

Note: The O-ring is only used as a sizing tool.

Never force the valve in. Once you install the valve and ring-DO NOT REMOVE IT!

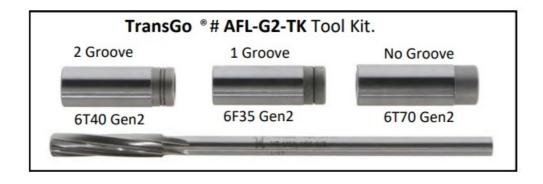
Due to the new vent location in a Gen 2 Rear body and the amount of bore wear seen, the AFL leak can not be fixed with a "drop-in" solution for the Gen 2 Actuator Feed Limit Valve. To repair the AFL Valve bore a tool kit is also required: TransGo # AFL-G2-TK Tool kit

Tool Kit fits 3 different transmissions, just use the correct reamer guide. Fits All Gen 2 Vb's 6F35's, 6T40's and 6T70's.

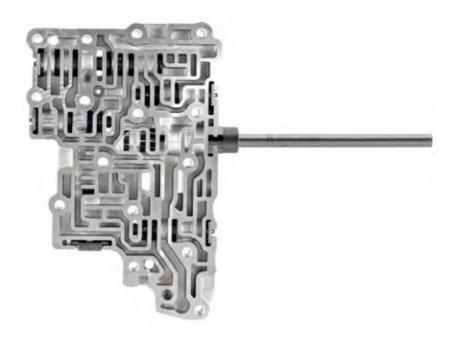
Step 1. The 6T70 Gen 2 uses the "No Groove" reamer guide. Place the no groove guide into the bore till it stops, with the stepped end out as shown. Use lots of WD-40 and low speed on your favorite portable drill, let the reamer do the cutting until it bottoms in the bore. Don't force the reamer, the bore finish and Reamer life require a slow inward movement and lots of WD 40.

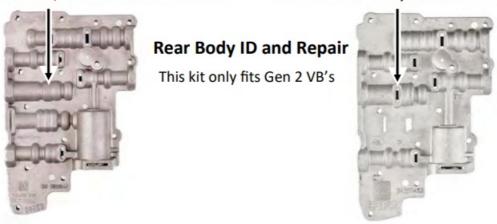
Gen 1 Rear body has No Exhaust here

Gen 2 Rear body has Exhaust here

Drop-in sleeves work great on Gen 1 casting. Drop-in sleeves won't fix a worn Gen 2 casting. Step 2. After reaming, clean the bore and the new AFL Valve furnished in this kit. Make sure the valve is free in the bore. Install the New AFL Valve and reuse the original spring and retainer.

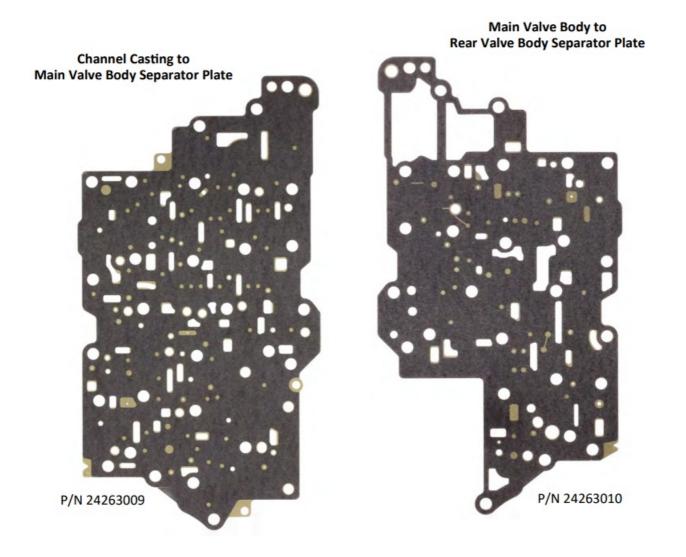
Replacement is recommended to prevent cross-leaks. No changes to stock plates.

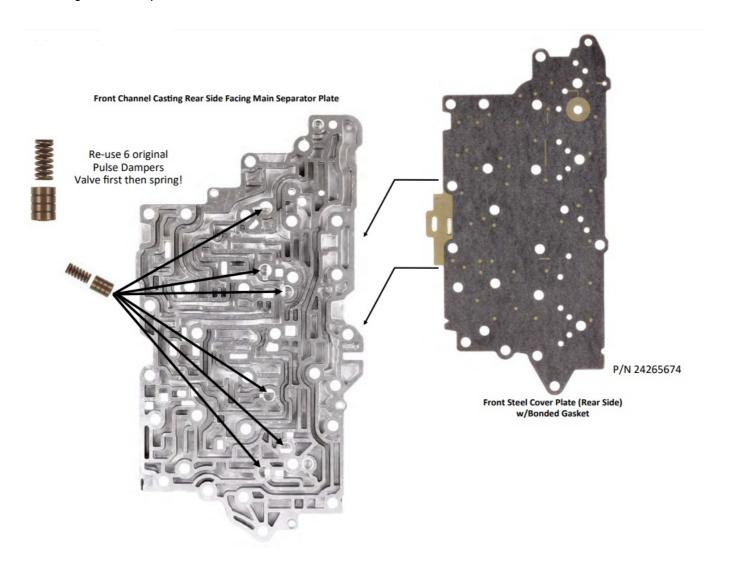
We have seen a couple of these castings worn in the damper holes. Always look carefully. **6T-PDP-TK**

Repairs Worn Dampener bores on 6T70 Gen 1and2 and also 6T40 Gen 2and3.
