Title	LIFEPAK 35 Technical Bulletin				Page	Page 1 of 30
QS Process	Field Service, Depot, Aftermarket	Owner	DAVID.HUBER		Doc #	M0000021809
Doc State	Release	Effective Date	07 Jul 2025		Doc Rev	AD
QS Parent	7000180, Servicing Process Work Instruction					
Confidential – Stryker Proprietary Information – Do Not Duplicate

Technical Bulletin

Bulletin Name: TB_LP35_Tech Bulletin

Product Family: LIFEPAK 35

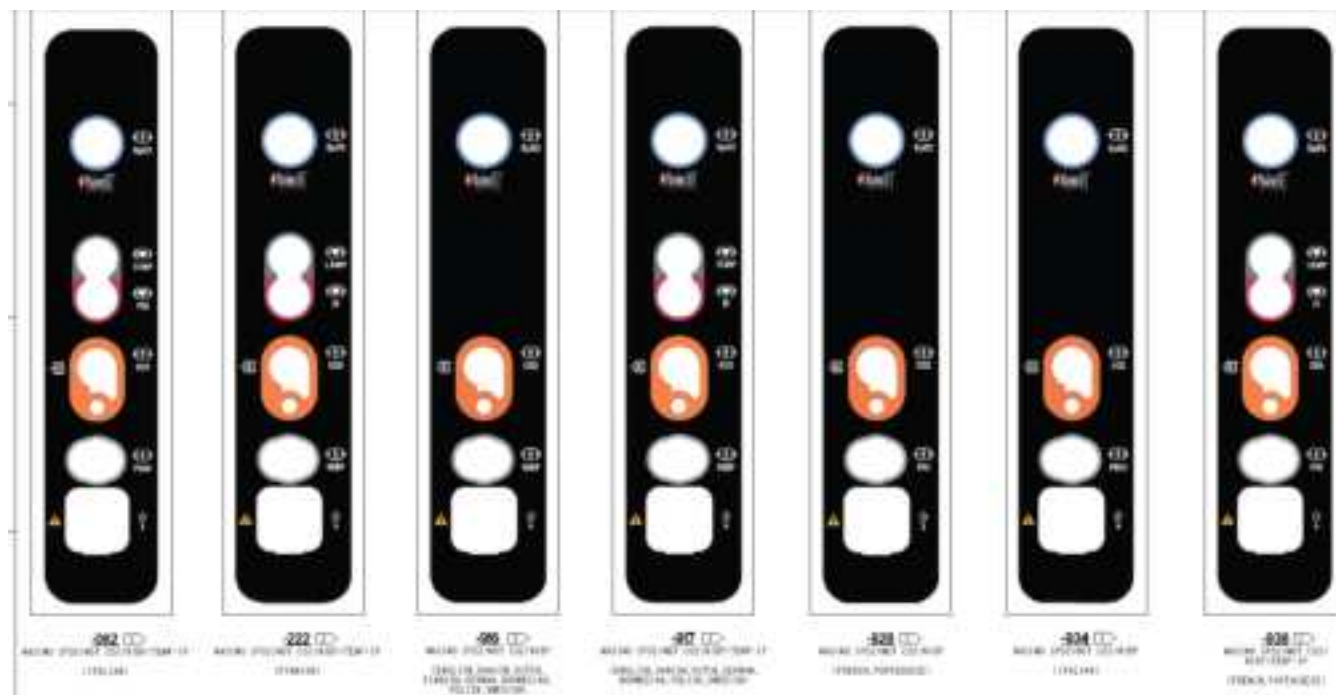
5.1. PMOD Labels

Use the drawing below to help determine the correct PMOD label to order based on the device configuration and language.

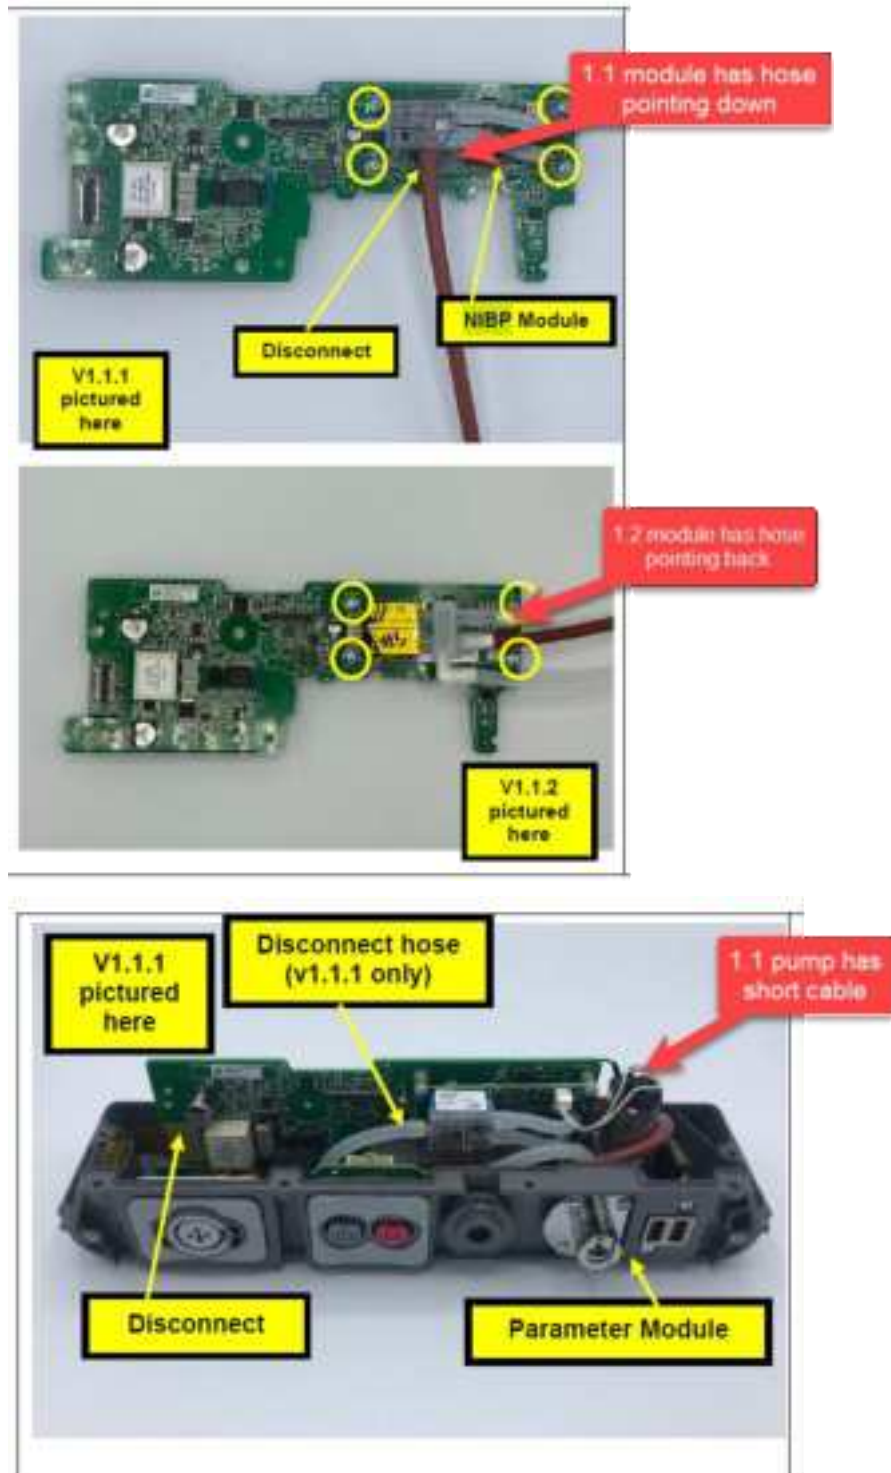
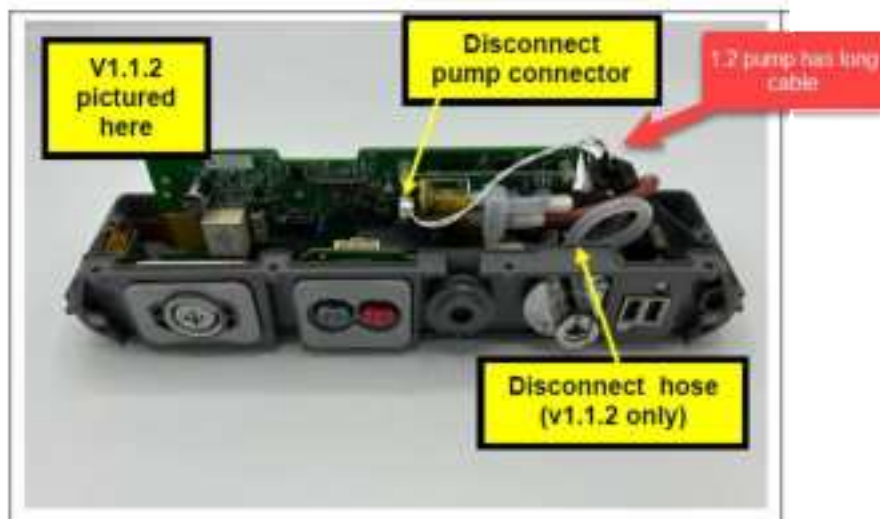
5.2. NIBP Module

In October 2024 LP35 devices started shipping with version 1.2 of the NIBP Module. The pump in the 1.1 version of the NIBP module is not compatible with the 1.2 version and vice versa. When repairing the NIBP module in a LP35 device make sure that both the pump and module are the same version (1.1 or 1.2).

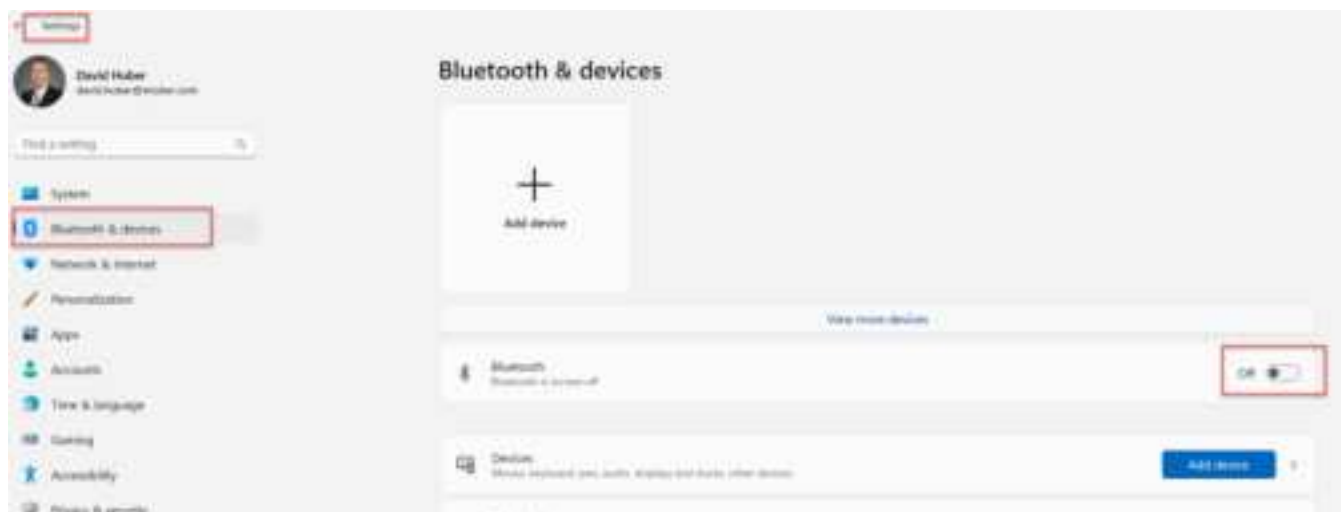
6.1. Bluetooth

Bluetooth must be turned off on the laptop when using the DCT and CAPIP application.

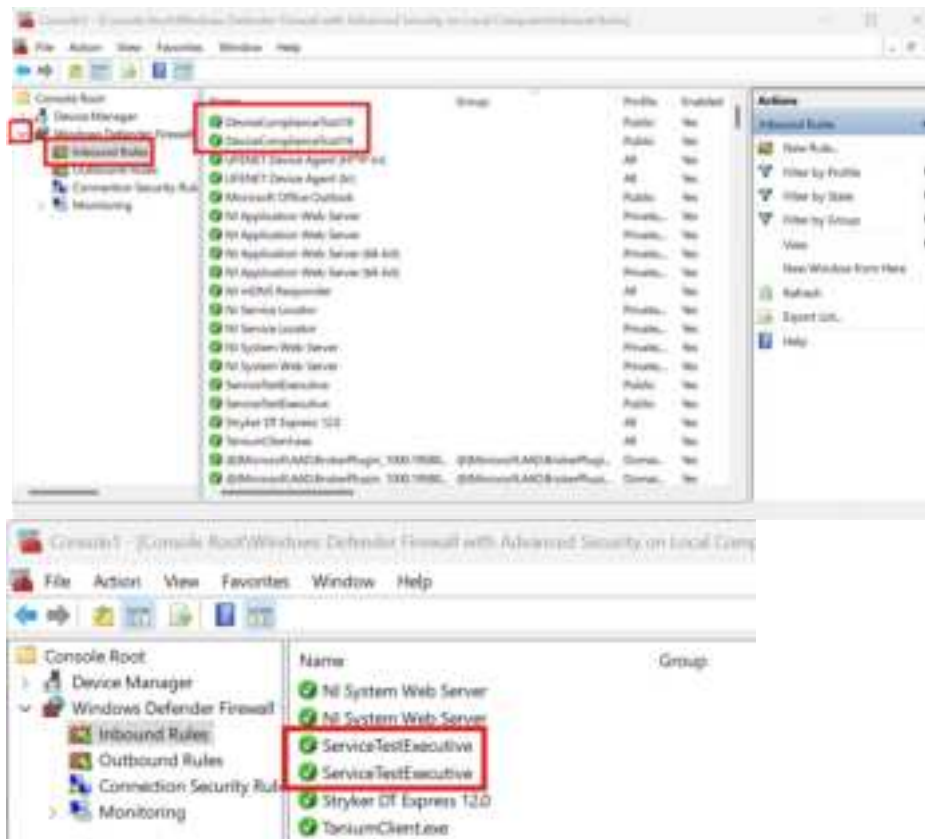
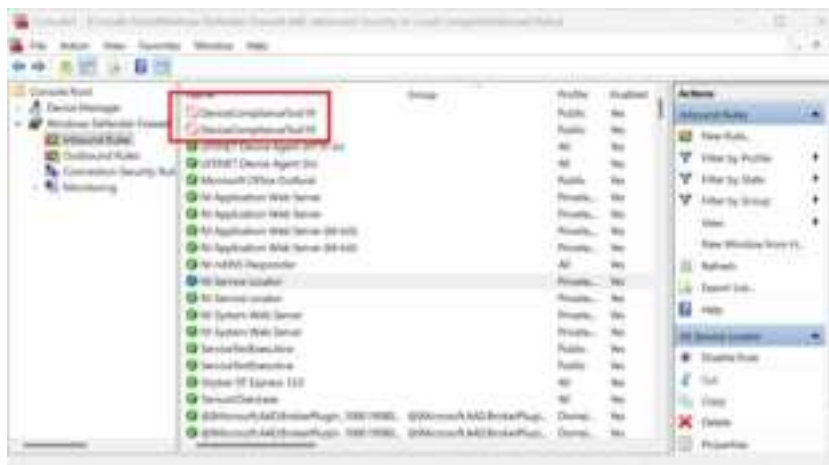
16. If DCT or STE have a red circle with a line through it Windows Firewall is blocking the connection, and it will need to be fixed.

17. Double click the blocked application to open it

18. Select Allow the Connection and click Apply
