**TECHNICAL INSTRUCTIONS**

**SPECIAL SERVICE CAMPAIGN K0B**

**MILLIMETER WAVE RADAR SENSOR**

**CERTAIN:**  
**2018 – 2019 TACOMA**  
**2018 – 2019 TUNDRA**

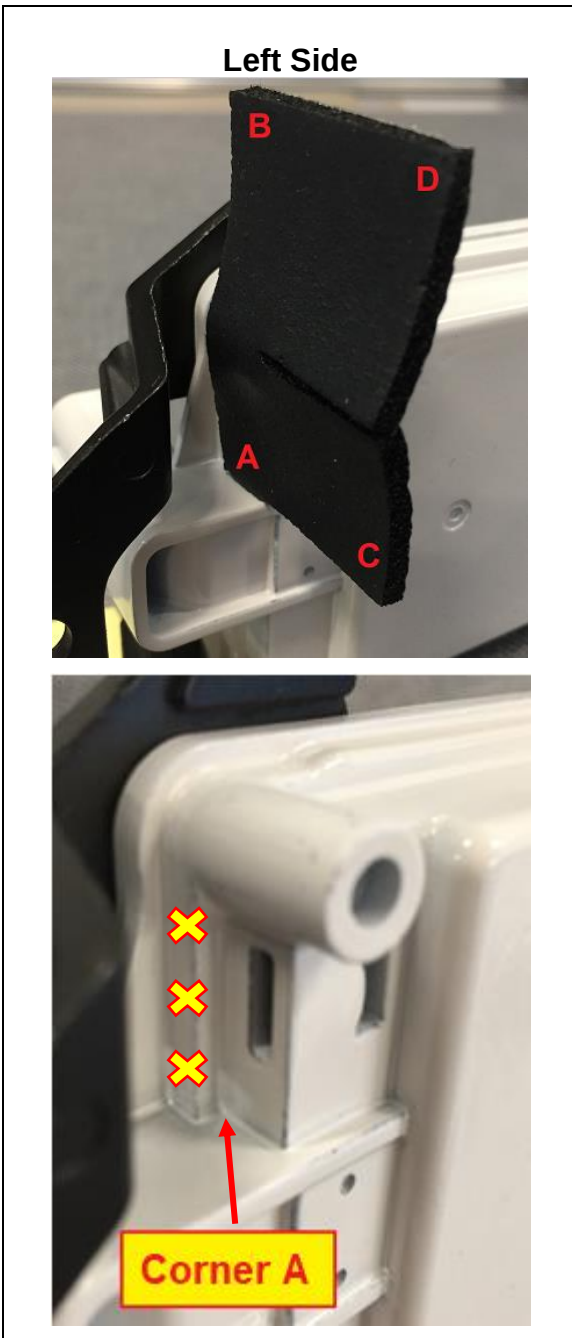
**Note:** The MWRS housing has been painted white in these photos to provide more contrast in the pictures. The actual MWRS housings will be black.

- Using general purpose cleaner, remove all traces of dust, dirt, and oils or grease from the application area (indicated within the red circle). Be careful not to get any liquids into the 2 vent holes.

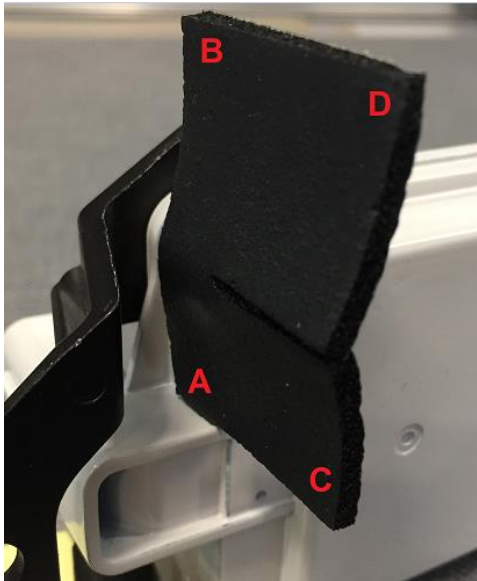
Left Side

- a. Using general purpose cleaner, remove all traces of dust, dirt, and oils or grease from the application area (indicated within the red circle). Be careful not to get any liquids into the 2 vent holes.

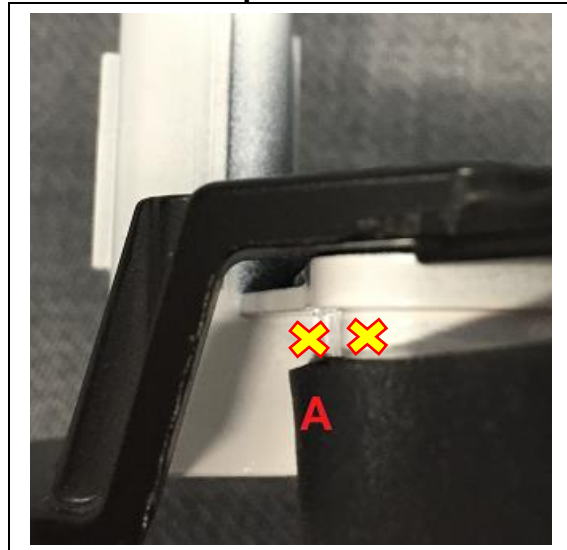
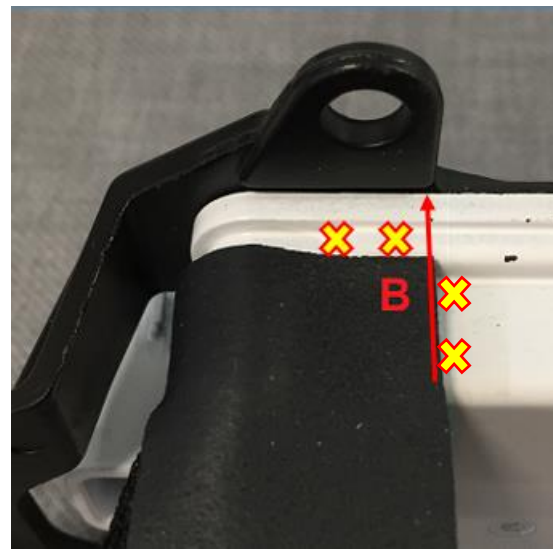
Top View

- a. Wear Nitrile Gloves to prevent adhesive contamination.
- b. Apply the EPT-Sealer to the left side of the MWRS to the following standard:
  - **Left Side View:** Corner "A" of the EPT-Sealer should be placed at the inner corner of the MWRS as indicated.
  - **Top View:** Place the EPT-Sealer on the surface of the side vent hole (it is ok to cover the side vent hole). **DO NOT place the EPT Sealer on top of the ridge**, as indicated with the yellow X's.

- c. Press the EPT sealer firmly into place in this area to seat it thoroughly. Use flathead screw driver or trim tool if necessary to reach the corner.

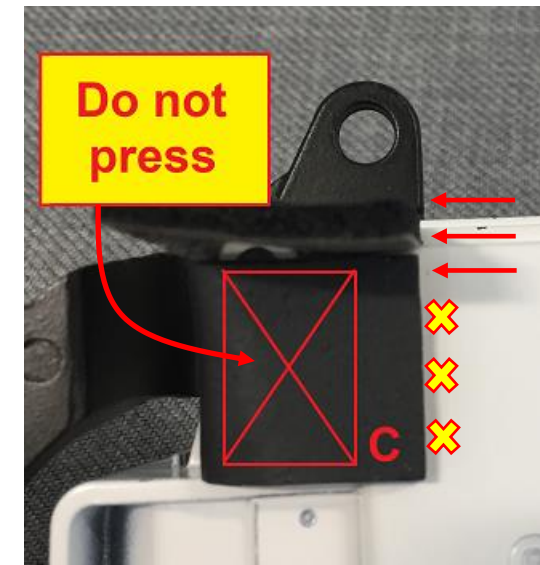
- d. Roll the EPT-Sealer Corner "B" onto the top edge of the MWRS sensor as shown, **aligning its edge with the end of the metal bracket. Be sure to keep the EPT-Sealer off the upper ridge.**
- e. Press the EPT sealer firmly into place in this area to seat it thoroughly.

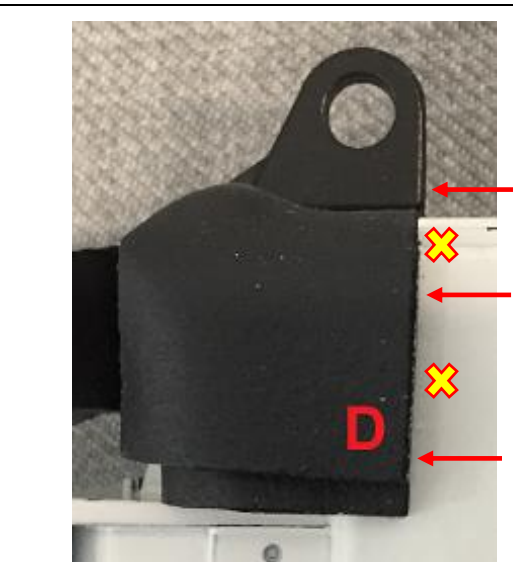
- f. Bend the lower flap (Corner "C") onto the face of the MWRS and align the edge with the edge of the upper flap and metal bracket.
- g. Press the EPT-Sealer into the face of the MWRS to seat it firmly. **DO NOT** press in the area indicated as it's critical there is an air gap for the vent.

| | <p><b>ONLY PRESS THE EPT SEALER ONTO THE FACE OF THE MWRS. DO NOT</b> press the EPT sealer into the vent hole. <b>It's critical that the vent hole remains open.</b></p> |

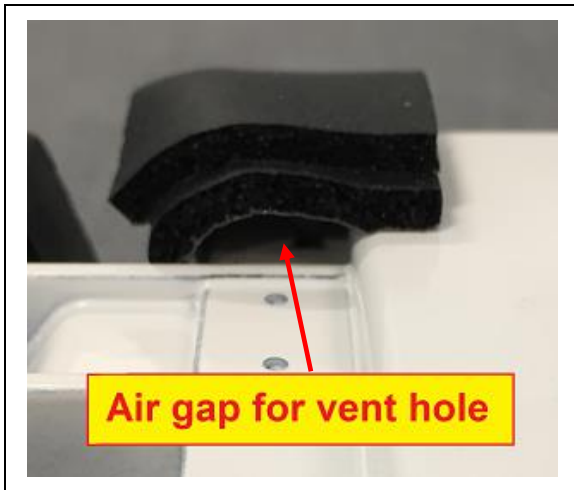
- h. Roll Corner "D" downward from the top, aligning the edge with the edge of the lower section and metal bracket.
- i. Press the EPT sealer into place, being careful to leave an airgap above the rear vent hole.
