1199 Panigale Safety Upgrades  
Models: MY 2012 and MY 2013 Panigale (All Versions)  
**Recall Bulletin RCL-12-006**

Date: Tuesday, August 7<sup>th</sup>, 2012  
To: Dealer Principal, Service Manager, North American Dealer Network  
From: Austin Gray, Technical Director; Jonathan LaForte, Technical Manager

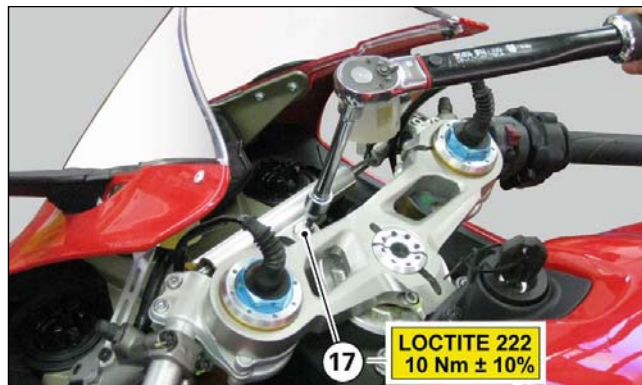
- C) **STEERING DAMPER RETAINING SCREWS** (all versions): The two steering damper retaining screws might loosen from their original tightening torque. It is necessary to re-tighten the screws and properly apply the specified threadlocker.

- 1) Remove the **central screw (17)** retaining the steering damper to the frame, remove any trace of threadlocker and thoroughly degrease the surface.
- 2) Tighten the **screw (17)** with **LOCTITE 222** to **10 Nm  $\pm$  10%**.
