## SERVICE BULLETIN

**APPLICABILITY:** 2020-22MY Legacy and Outback Models

**NUMBER:** 15-261-20R

**SUBJECT:** Reprogramming File Availability for Optimization  
 of Gen 4 Denso CP1 Infotainment Systems

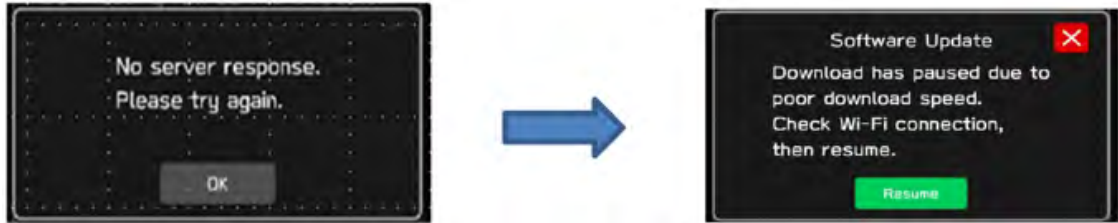
| Number | New Functions and Enhancements | | | | | | | | | | |
|---|---|---|---|---|---|---|---|---|---|---|---|
| 2 | Two ways of MOTA operations, i.e., by connect CCM to Wi-Fi or by transferring the downloaded map data to CCM via smart phone are executed simultaneously by error. | | | | | | | | | | |
| 3 | <p>"One of the Pop-up Error Messages displayed during the FOTA operation in case of weak Wi-Fi signal is not intuitive. Even if the customer tap "OK," it does not transit to another screen.</p>

<p>As the improvement for this inconvenience, the message is changed so that the customer finds the reason why the FOTA operation has been paused. Also a "Resume" button is prepared so that the customer can do the rest of operations after necessary action (moving the vehicle to another place with better Wi-Fi connection**, or tethering the CP1 to a mobile phone, etc.)</p> <p><b>Note**</b> The FOTA operation can be paused when the Wi-Fi indicator at the upper right corner of the CID is not in "Good" or "Excellent" as shown below."</p>

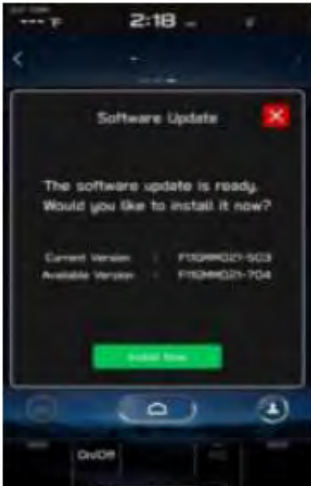
| Number | Symptoms to be Improved: |
|---|---|
| 1 | <p>System restarts itself during FOTA (Firmware Over The Air) update. FOTA operation is conducted in two processes: downloading (from the server to the Cockpit Control Unit via Wi-Fi) and installation (inside the Cockpit Control Unit). During the FOTA operation, after the new software has been downloaded to the Cockpit Control Unit (CCU) customer is to push “Install Now” on the Center Information Display (CID) to start installation of the software.</p> <p><b>FOTA Normal process</b></p> <p>The flowchart illustrates the normal FOTA process. It begins with 'IGN ON', followed by 'Start up' (120s), 'FOTA notice', 'Update Confirmation', 'Download' (5min ~ 30min), 'Install' (10min ~ 40min), 'Confirmation screen', and finally 'FOTA complete with restart'.</p> <p><b>However, in rare case, the CCU restarts itself* during installation.</b></p> <p><b>Linux reset occurs</b></p> <p>This flowchart shows the process when a Linux reset occurs during installation. It follows the same initial steps as the normal process but includes a 'Linux reset' event (CID Black screen, Max 30s) during the 'Install' phase. This is followed by a 'Restart', 'Install confirmation screen(Retry)', 'Restart Install', and 'Confirmation screen' before reaching 'FOTA complete with restart'. A note at the bottom states: 'Linux reset(CID black screen) may occur during FOTA installation' and 'If Linux reset occurred, CID will be black screen max 30s, after that CID will restart automatically'.</p> <p><b>Note*</b> Even if this symptom occurs, after approximately 2 minutes, the system resumes, and the CID comes back to the below screen. Customer can then push the “Install Now” to proceed with the installation.</p> <p>The image shows a screenshot of the 'Software Update' screen on the CID. The screen displays the message: 'The software update is ready. Would you like to install it now?'. It also shows the 'Current Version' as 'F030M02H-903' and the 'Available Version' as 'F030M02H-704'. A green 'Install Now' button is visible at the bottom.</p> |

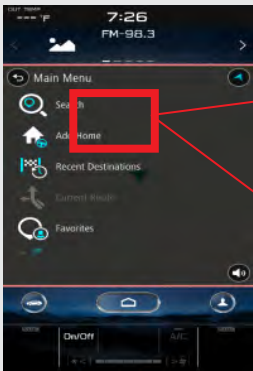
| Symptom # | Description of Symptom: |
|---|---|
| 2 | <p>After an extended period of usage, some white blinking dots appear on the display.</p> <div> <p>White Blinking Dots</p> </div> |
