# MULTIMEDIA REPAIR GUIDE

### Touch 2 & Touch 2 with Go

This document is intended to help technicians to solve issues related to the multimedia system Touch 2 (with Go) only.

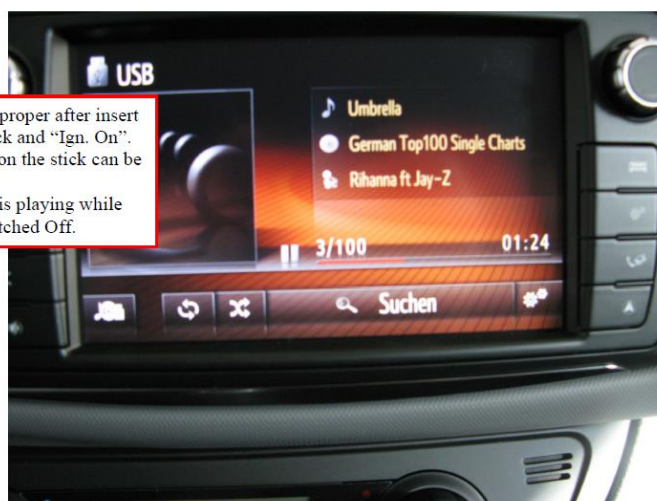
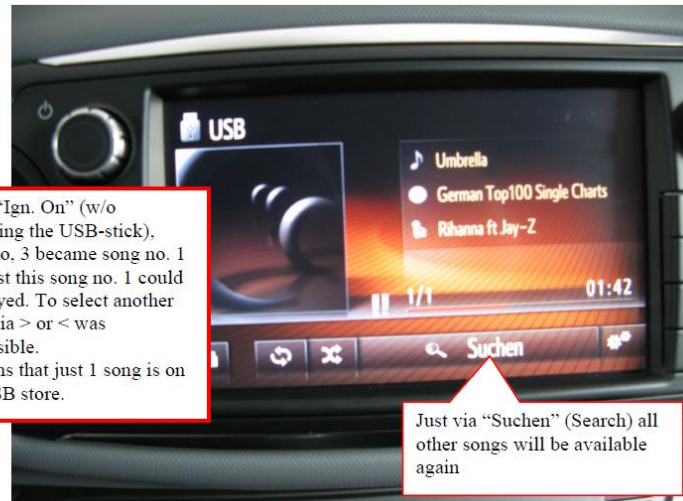
If the customer tried to change the tracks used buttons UP and DOWN, the system switched only between the track which shown on the display (current situation 1 of 1 track).

This phenomenon can occur on the following vehicles (see table) on DA software lower than mentioned in below table.

For using all tracks from USB stick, the customer needs to push overview button on the touch screen, then choose any track from the list -> system again recognized all tracks on USB stick.

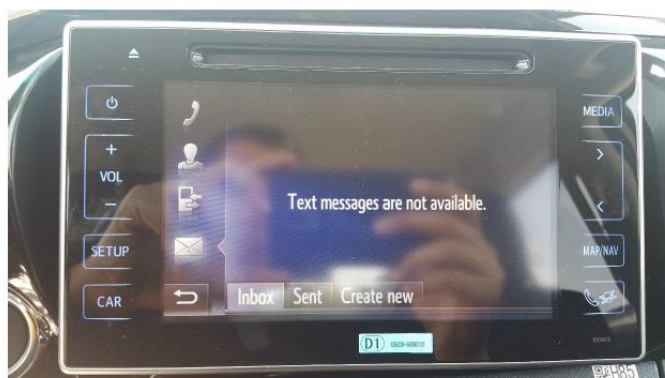
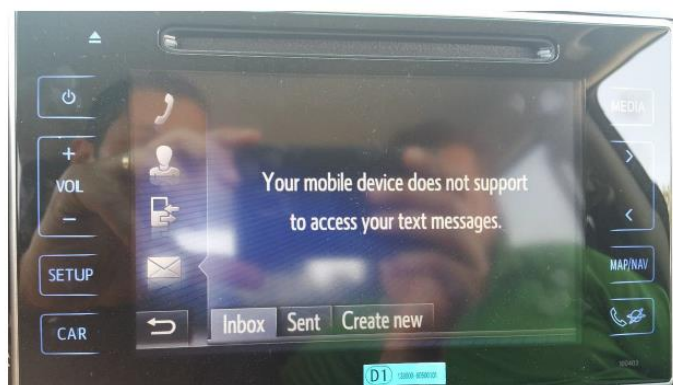
The phone is easily connected over B/T. The phone book and calls are synchronized, but SMS text messages cannot be retrieved.

**Supplier:** Fujitsu Ten / Denso Ten

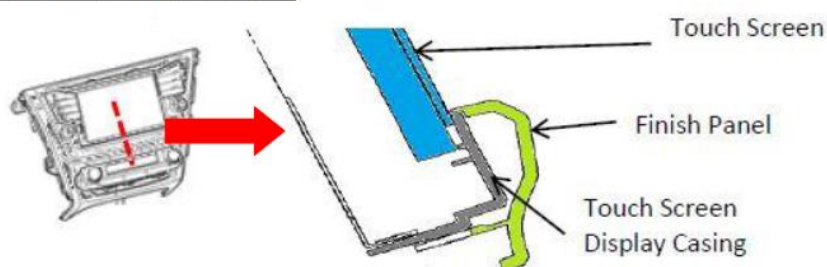
#### Concern area – cross section

Please follow the Repair Procedure to confirm whether the customer claim can be resolved without replacing the actual Display Audio-unit.

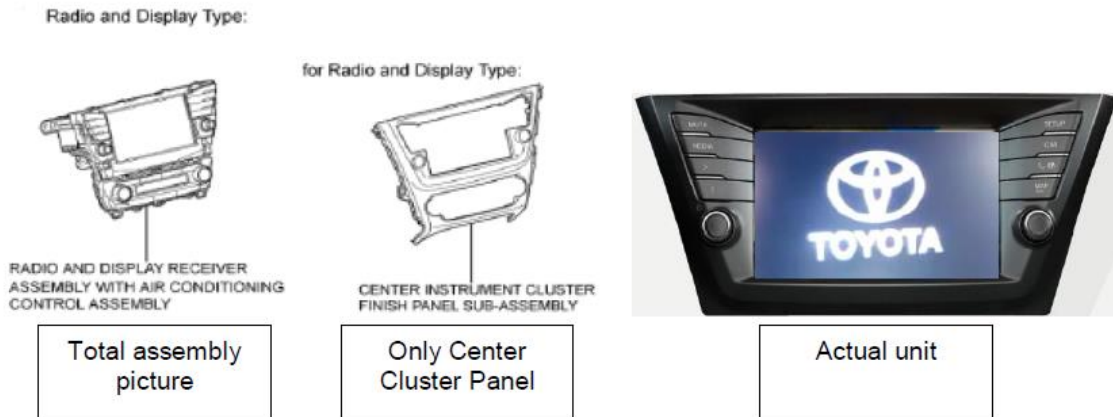
### STEP 1: TSB Applicability check.

This bulletin is only applicable for Avensis MY2015 equipped with one of the above listed part numbers and which corresponds to below pictures:

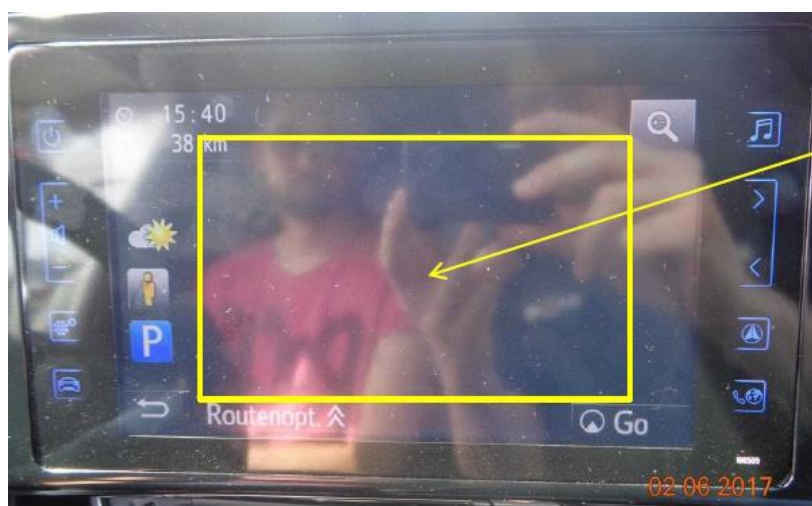
After updating the navigation software the dealer notices that the system will freeze after inputting a destination location, however this only happens when the destination is a long distance from the start location (150+ miles).

The start location is the dealer address = Fish Brothers Toyota, Penzance Drive, Swindon, SN5 7RX, United Kingdom.

This phenomenon can occur on Extension Box software lower than mentioned in below table. The problem has been resolved as from the software version shown below table or higher.

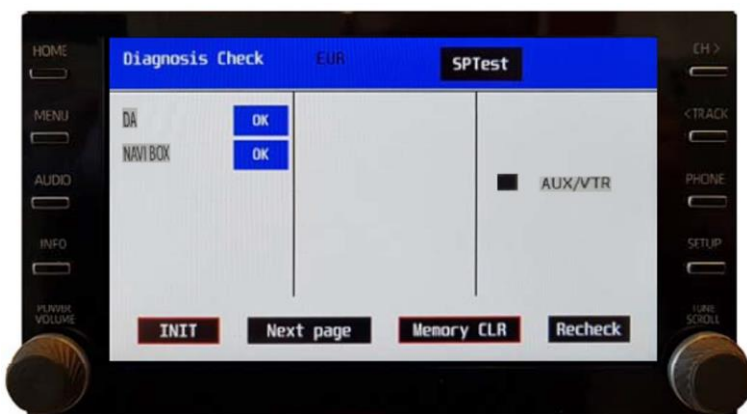
<b>OK</b>	No problem detected
<b>DEL</b>	Memory was cleared, please recheck again
<b>NRES</b>	No response
<b>GPS</b>	Problem with GPS-antenna
<b>NCON</b>	Not connected (previously detected item)
<b>ANT</b>	GPS/DAB-antenna problem
<b>NG</b>	Problem other then mentioned here

- a) If a complete malfunction like non boot-up (pwr-connections, internal power loss) then **Diag System-Check from DA to TEB will show – NG (Not Good). At this point, replace the TEB.**

Replace TEB
