## GENERAL T.I. BULLETIN INDEX

| T.I. No. | Issue | Subject | Products Affected | Date |
|---|---|---|---|---|
| Gn 001 | 1 | Tappet Adjustment | Perkins 1000 Series Engines | Mar. 90 |

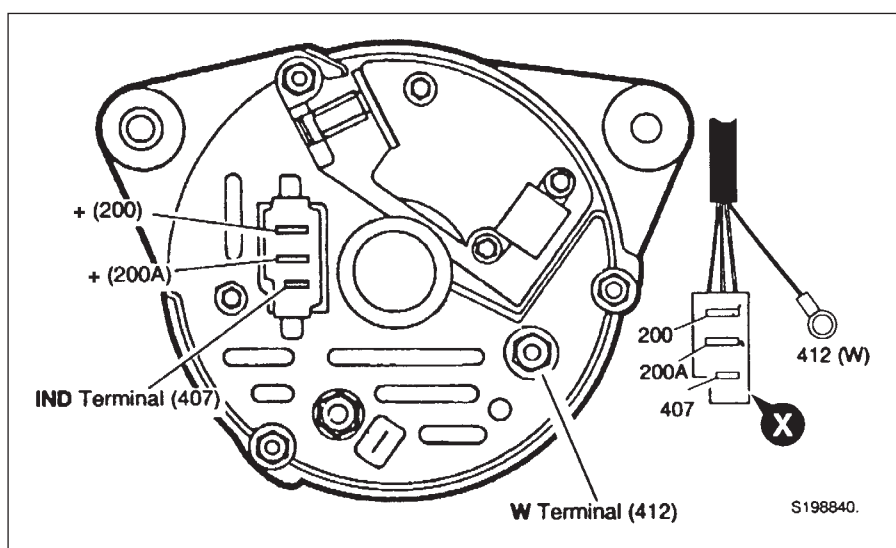
FIG 1

Two types of alternator connectors have been supplied. The alternator 'euro plug' connector (item **X** - FIG 1) is no longer supplied. Instead, a ring terminal and lucar connector (item **Y** - FIG 2) are now supplied.

If the harness has a 'euro plug' connector (item **X**) fitted, install the harness as shown in FIG 1. If the harness has a ring terminal and lucar connector (item **Y**) fitted, install the harness as shown in FIG 2.

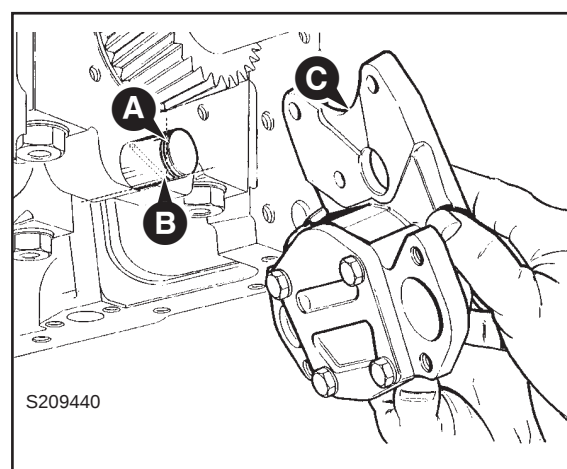
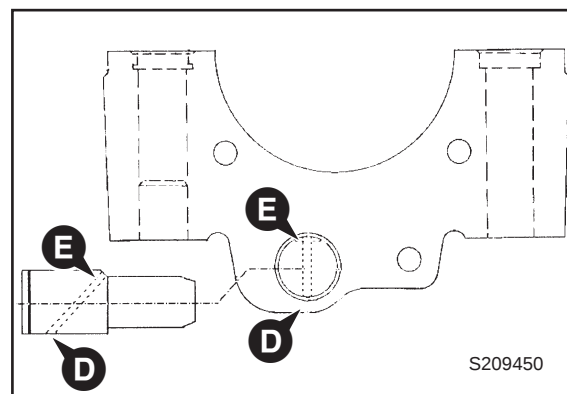
It has been found in service that excessive wear can occur to the bush for the idler gear of the lubricating oil pump. This wear may occur on four and six cylinder engines.

If it is found in service that more lubrication is necessary for the bush of the idler gear, renew the bush, part # 02/290006. Fit the new idler shaft part # 02/201131 and the new lubricating oil pump, part # 02/201050 (four cylinder engines) or 02/201130 (six cylinder engines).

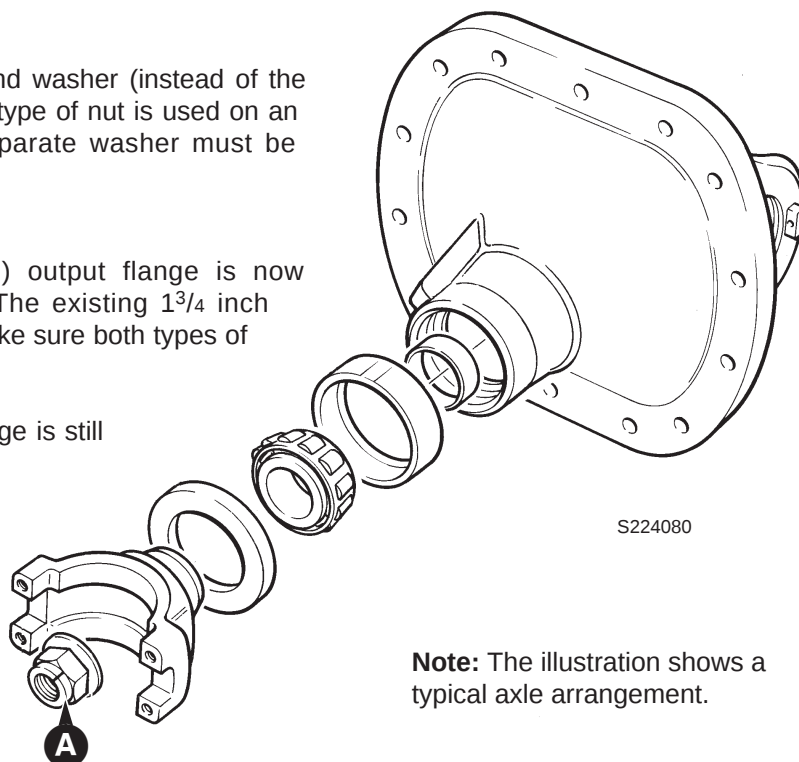
The axle flanges and transmission output flanges are now hardened (at the sealing area). The hardened flanges prevent possible oil leaks and loss of bearing pre-load by reducing the risk of fretting and subsequent loosening of the flanges.

In the event of a flange becoming loose or wearing, a new hardened type flange and new seal should be fitted. Apply a small bead of Loctite 936 around the shaft spline. Full details for removing and replacing output flanges are given in the relevant Workshop Manual.

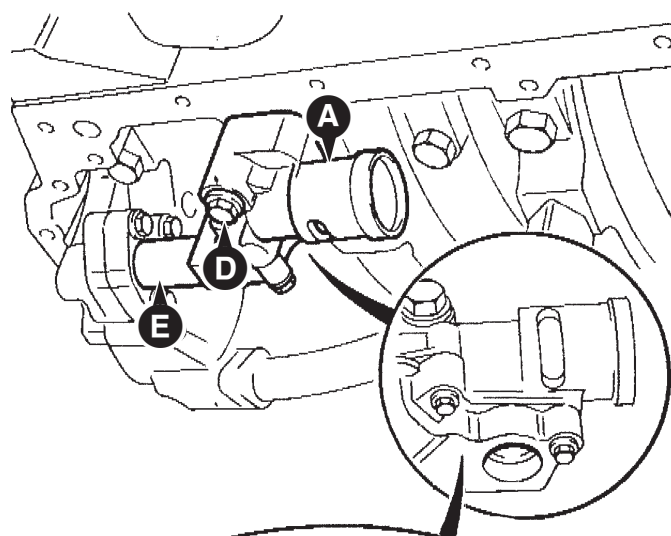
The possibility exists that engine relief valve housing **A** may fail. The relief valve controls the engine lubricating system oil pressure, therefore a failure of the housing could result in the loss of engine oil pressure and cause subsequent damage to the engine.

- 5** Provide a support for the sump and remove the sump retaining bolts. Lower the sump and remove the sealing gasket.
- 6** Inspect the relief valve housing:
- 6.1** Look at the side of the relief valve housing **A** for the manufacturer's number.
- 6.2** If the number has a '1' below it as shown at **B**, then the housing is made to the correct specification, move to step **9**.
- 6.3** If the number has a '2' below it as shown at **C**, then the housing is made to the wrong specification and must be replaced with a new one, move to step **7**.

- 7** Remove the relief valve housing retaining bolt **D**, and then remove the relief valve housing **A**.
- 8** Fit a new replacement relief valve housing, torque tighten the retaining bolt to 22 Nm (16 lbf ft). Make sure that the 'O' ring at each end of tube **E** are in good condition and securely in place before tightening the retaining bolt.
- 9** Refit the engine sump together with a new gasket. Tighten the sump retaining bolts to 22 Nm (16 lbf ft). Fit the sump drain plug together with a new 'O' ring, torque tighten the plug to 34 Nm (25 lbf ft). Refit the dipstick and dipstick tube.
- 10** Using the engine oil drained at step **3** refill the engine sump, make sure that the engine oil reaches the 'MAX' mark on the dipstick, top up as required.

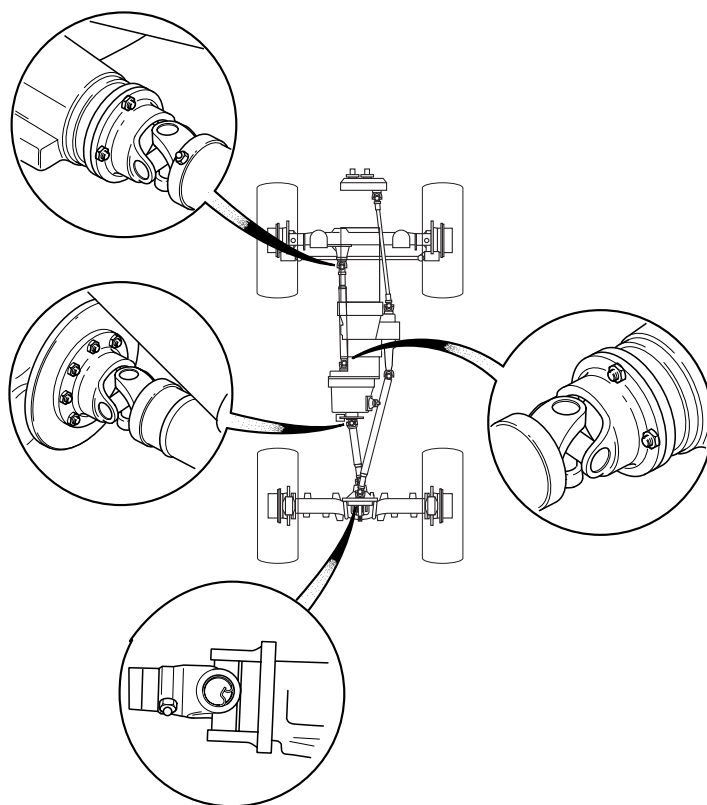
Failure to protect the propshafts adequately may result in damage to oil seals, propshafts and other transmission components.

When working in loose straw or grass it is important that an undershield is fitted to the machine to prevent material wrapping around the propshafts.

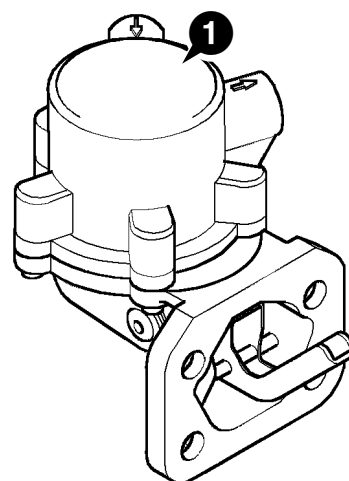
**IMPORTANT: The fuel strainer can be damaged and fuel flow can be restricted if the fuel pipe is inserted too far into the inlet connection. This should be checked if a fuel restriction is suspected.**

- 1 Allow the engine to cool. Remove the fuel filler cap to vent the system and reduce loss of fuel. Disconnect the fuel inlet pipe to the lift pump.
- 2 Unscrew the fuel filter **A**. Remove strainer **2** and O-ring **3**.
- 3 Clean the strainer in clean diesel fluid and dry with low pressure compressed air. Renew the strainer and O-ring if damaged.
- 4 Fit the strainer into the fuel inlet connection. Fit the fuel filter **A** and tighten to 20Nm (15 lbf ft). Fit the fuel inlet pipe carefully to prevent damage to the strainer, and tighten the union nut.

Make sure the olive on the fuel inlet pipe is in good condition and forms an effective seal. Renew the olive or pipe if necessary to prevent air entering the fuel system.

- 5 Fit the tank cap and prime the fuel system. Start the engine and check for fuel leakage.

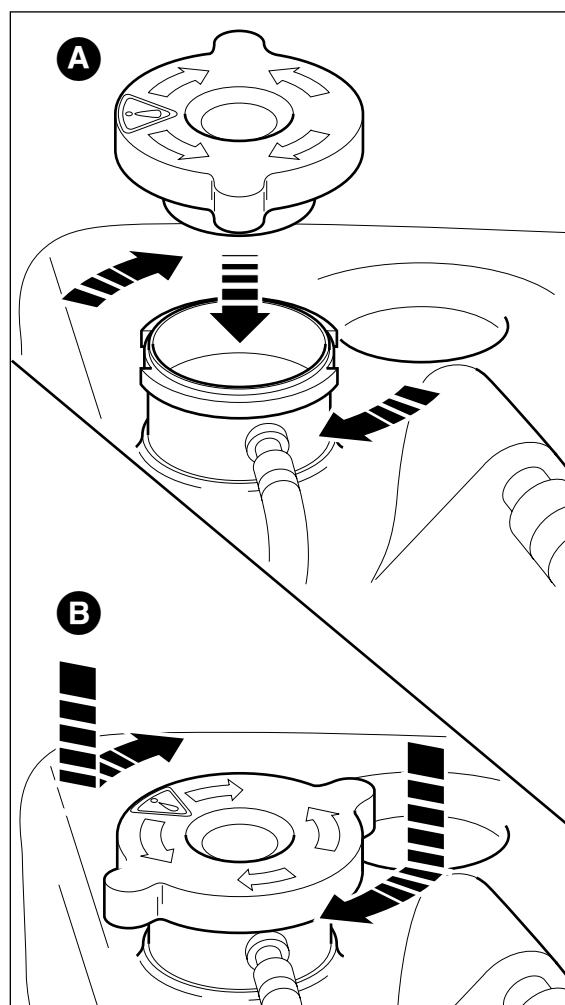
Some instances of overheating have been reported which were caused by the engine coolant filler cap not being correctly fitted. This results in the coolant system failing to pressurise, so reducing its efficiency.

When fitting the filler cap, ensure that the cap is correctly fitted. Fit and turn the cap to the first notch, as shown at **A**, then PRESS DOWN and continue turning FULLY clockwise, as shown at **B**, until the end stop is met. Failure to do this will result in inefficient cooling and may result in injury when the cap is removed.
