# SK® 62TE

Fits: 62TE 2007-17

## Corrects / Prevents / Reduces

TCC Slip/Shudder, Overheating, Drainback,  
Delay or No Forward or Reverse, Coasting  
6-5 UD Apply Clunk or 4-2 L/R Apply Clunk

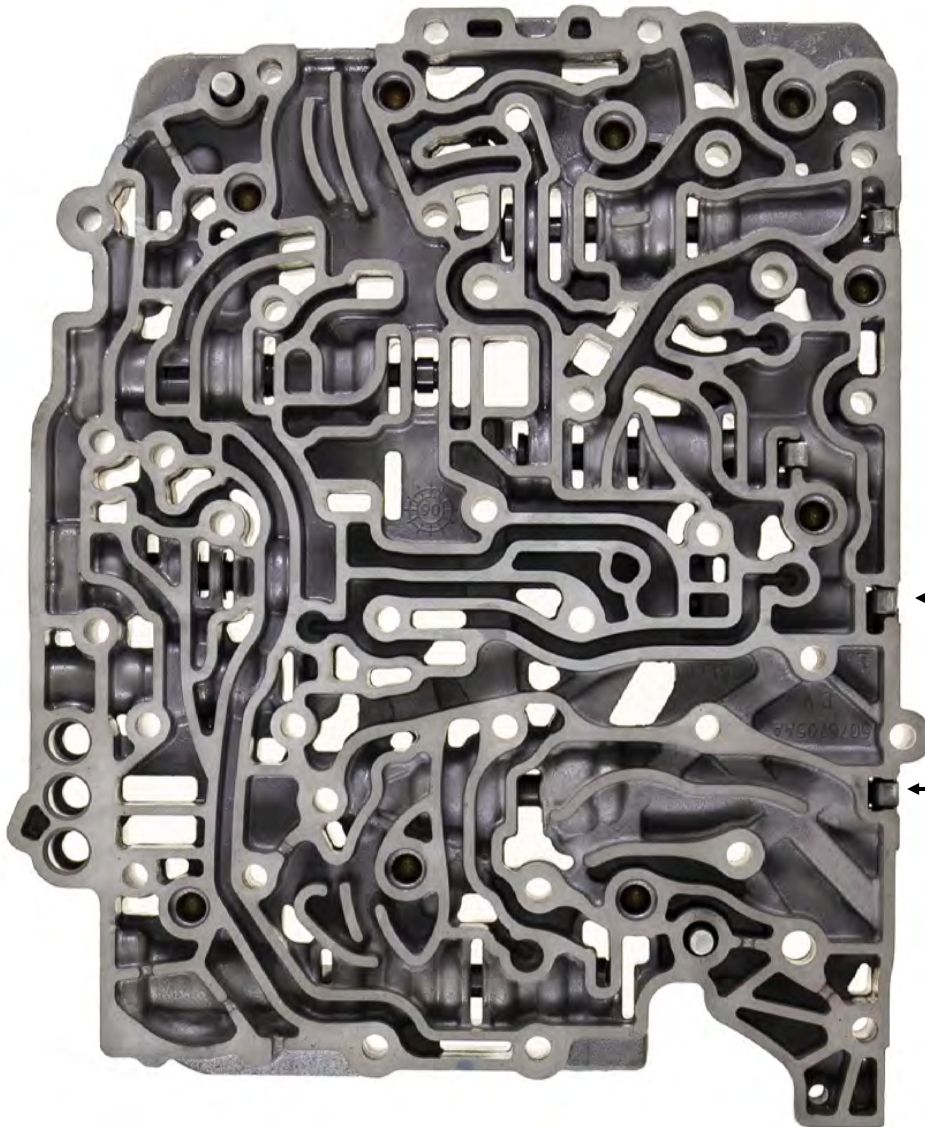
# Valve Body Repairs

The repair work on this page will improve the overall **stability** of the **main pressure system** to **reduce shift complaints** as well as **correct** the malfunctioning Torque Converter Regulator to **improve** lubrication, cooling and **prevent** drainback from bore wear. An easy and effective **drop-in** solution. Saves \$\$\$ and time. We love it! You and your customer will too.

## Step 1.

Install **New TC Regulator Valve** checking that it travels freely then **New Orange Spring** & reuse retainer.

## Step 2.

Install **New PR Valve** checking that it travels freely then **New White PR Spring**. Re-use Retainer.

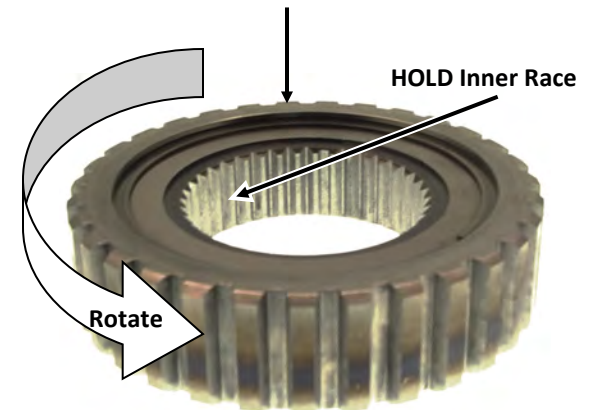
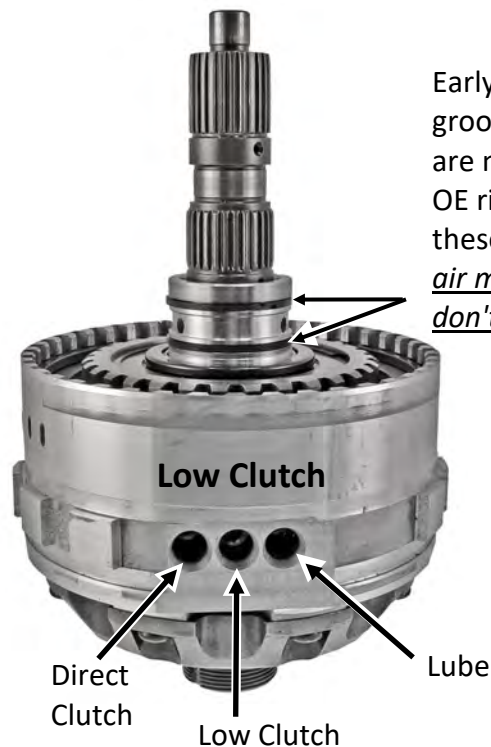
### Compounder One-Way Clutch

Early rotating rings usually destroy the ring grooves on low clutch housing. Later housings are notched for non rotating rings 05078800AB OE rings air check great and work excellent in these notched housings. 20-25 psi of regulated air must apply direct clutches on the bench, don't assemble unit until they do!

The **stepped side** of the outer race faces **into** the Low Drum. When sprag assembly is installed in the Low drum, the Outer **Race** must rotate Counter Clockwise while the drum held stationary.

*Flat side of outer race faces up when installed in Low Drum*
