2020S Firmware Update Procedure for ACOM Amplifiers

FIRMWARE UPDATE PROCEDURE FOR ACOM 2020S AMPLIFIERS

This instruction describes the firmware update procedure for ACOM 2020S amplifier (CPU module firmware).

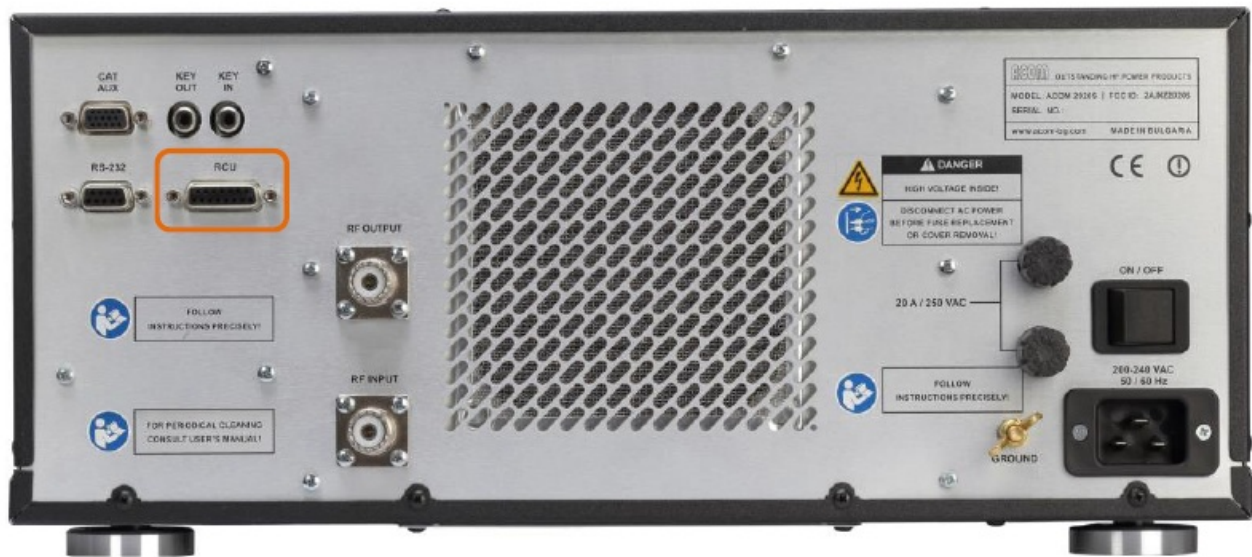
Figure 1-1 | Amplifier rear panel - Connections

Figure 1-1 | Amplifier rear panel – Connections

- The ACOM Terminal S software (installed on your PC) communicates with the amplifier via a special cable (see Figure 1-2 | Special cable for ACOM 2020S firmware update) connected to the RCU connector (see Figure 1-1 | Amplifier rear panel – Connections).

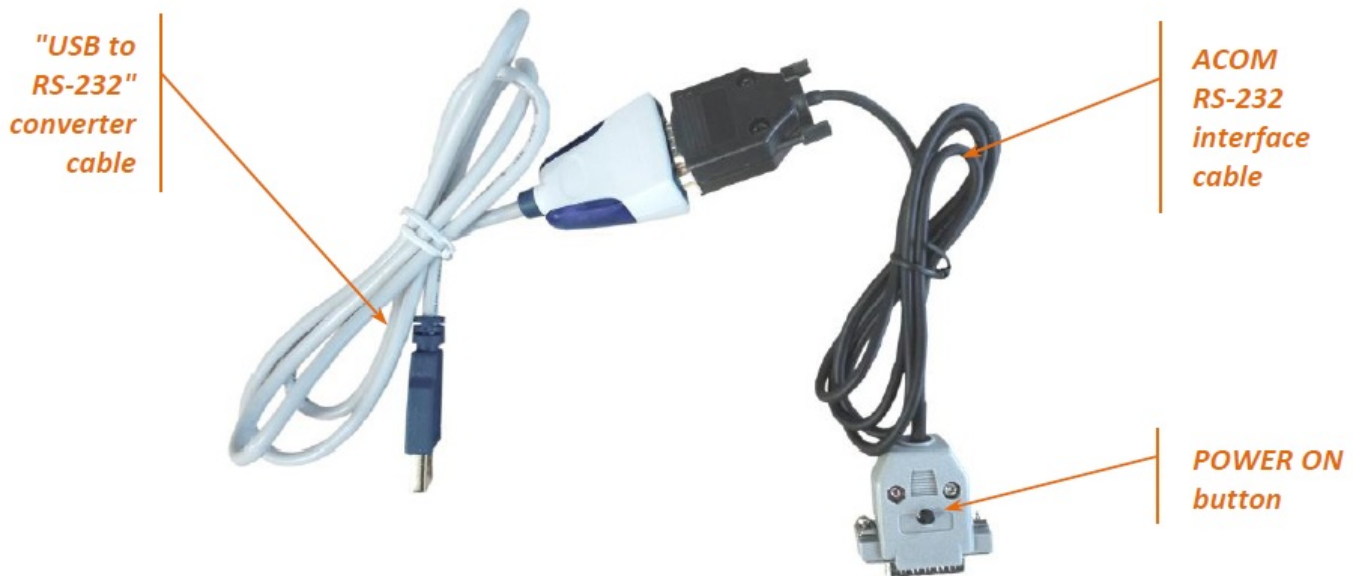
Figure 1-2 | Special cable for ACOM 2020S firmware update

In fact, the above special cable consists of 2 separate parts:

- “USB to RS-232” converter cable;
The ACOM recommends using “USB to RS-232” converters produced by FTDI (www.ftdichip.com) or based on an FTDI chip.
- ACOM RS-232 interface cable with POWER ON button (cable made by ACOM).
For all owners of ACOM 2020S with firmware versions earlier than V1.9 (in-factory installed), ACOM company will provide the special cable (as shown on Figure 1-2) for firmware updates free of charge. Please, contact your dealer for cable availability and delivery.

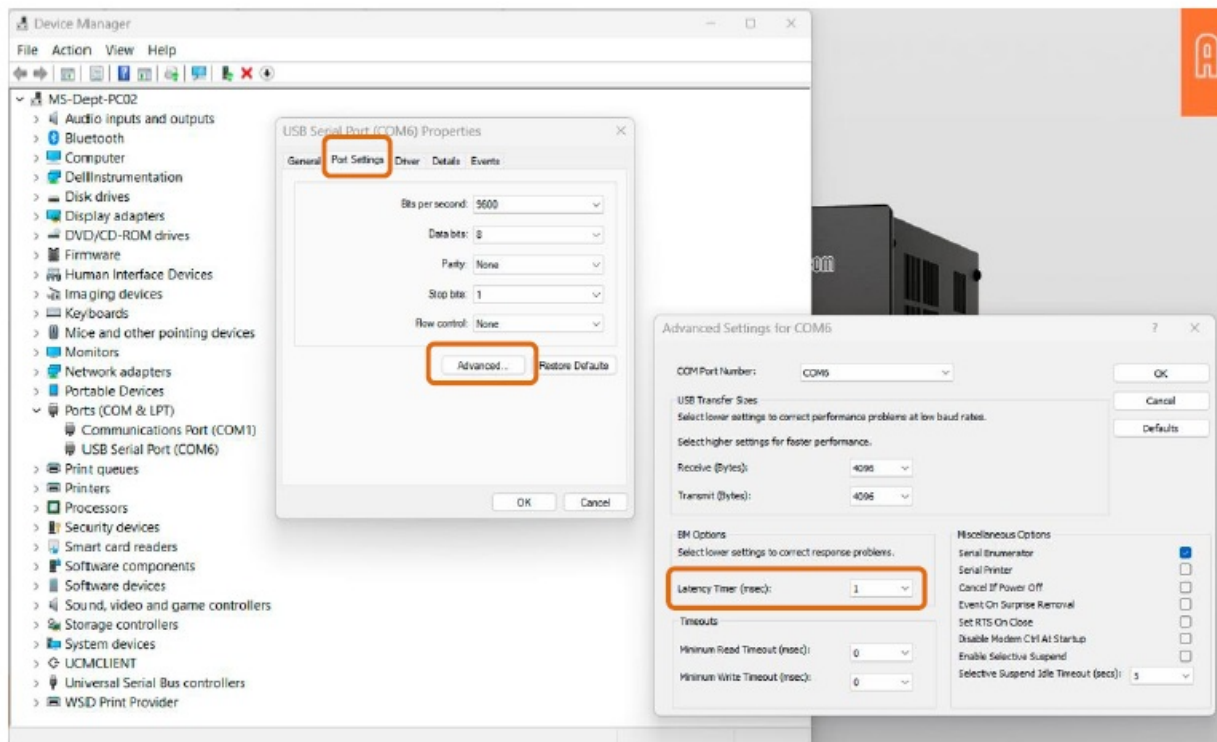
Figure 1-5 | PC Device Manager -> USB Serial Port properties

- Go to Port Settings tab -> Advanced tab and change Latency Timer parameter to 1 msec.

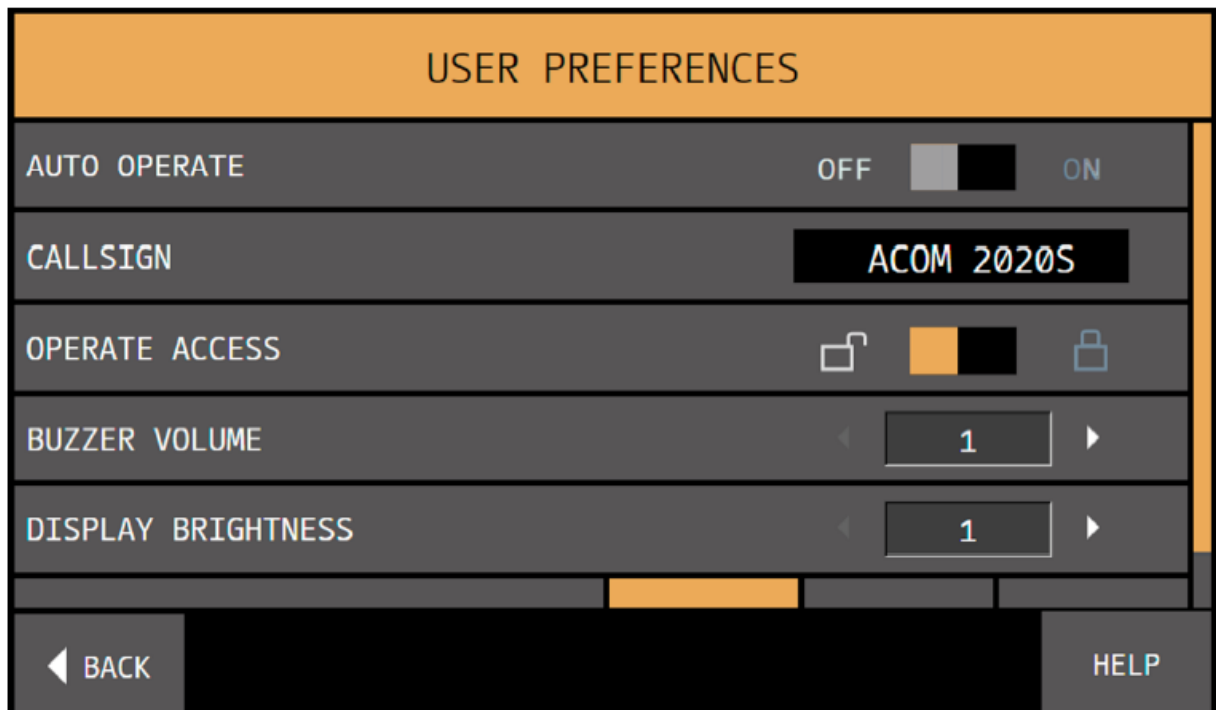
Figure 1-7 | Menu USER PREFERENCES

When the amplifier is turned on, check the menu USER PREFERENCES -> AUTO OPERATE. The status must be OFF. This is a necessary condition for a successful start of Firmware Update Procedure.

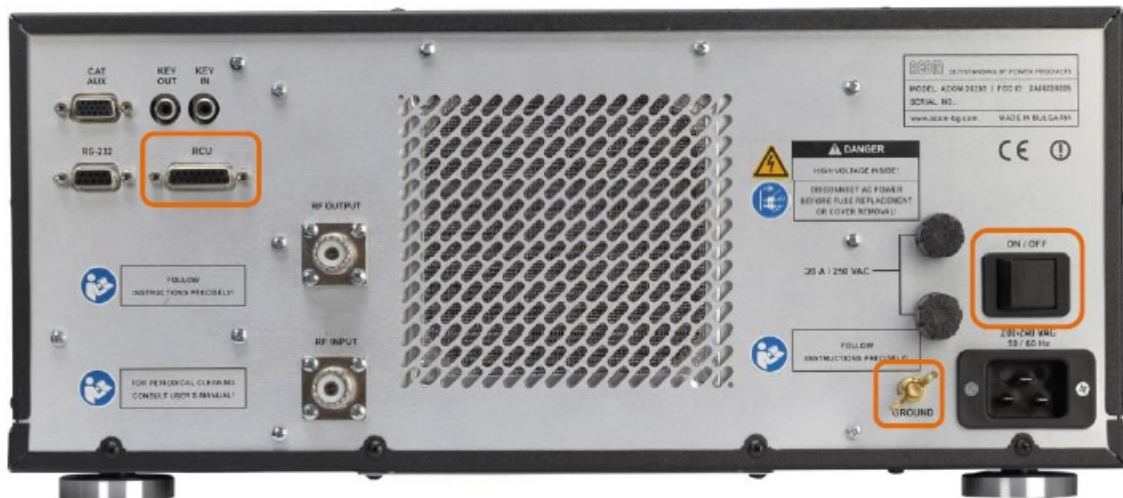
Figure 1-8 | Rear panel

- When the amplifier is turned on, push the POWER button on the RCU rear panel to turn off the amplifier (back to low-energy STANDBY mode);
- Switch off the amplifier via Main Power Switch (see Figure 1-8 | Rear panel);
- Make sure the Main Power Switch is in OFF position;
- Pull the amplifier's line (mains) plug out of the outlet;
- Do not disconnect GND connection;
- Disconnect all cables (except GND connection) from the rear panel of the amplifier – RCU, transceiver, antenna, etc.

Remove the **GND** connection last (see [Figure 1-8 | Rear panel](#)) and wait 30 minutes for safety.

- Connect the special cable's connector (D-sub, 15-pin, male) to the amplifier's RCU connector (see Figure 1-8 | Rear panel);
- Check whether the amplifier rear panel Main Power Switch (marked ON/OFF) is turned off (must be). Insert the amplifier's mains plug into the wall outlet;
- Switch on the amplifier via Main Power Switch (see Figure 1-8 | Rear panel);
- Push and hold for 1-2 seconds the POWER ON button on the special cable (see Figure 1-9 | Special cable for ACOM 2020S firmware update) to start the amplifier in the STANDBY mode.

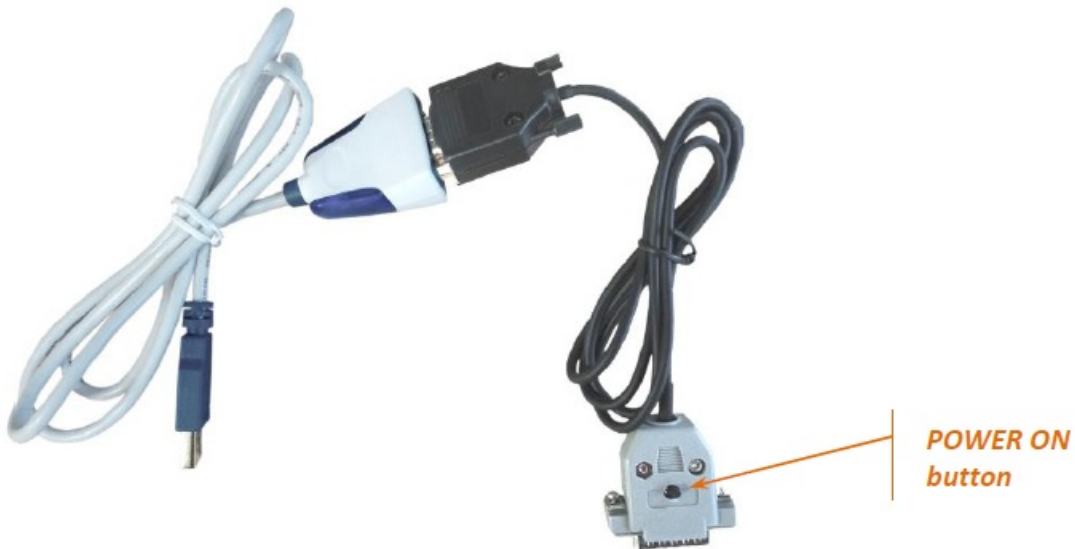
Figure 1-9 | Special cable for ACOM 2020S firmware update

If the amplifier starts normally there will be a couple of beeps from the amplifier.

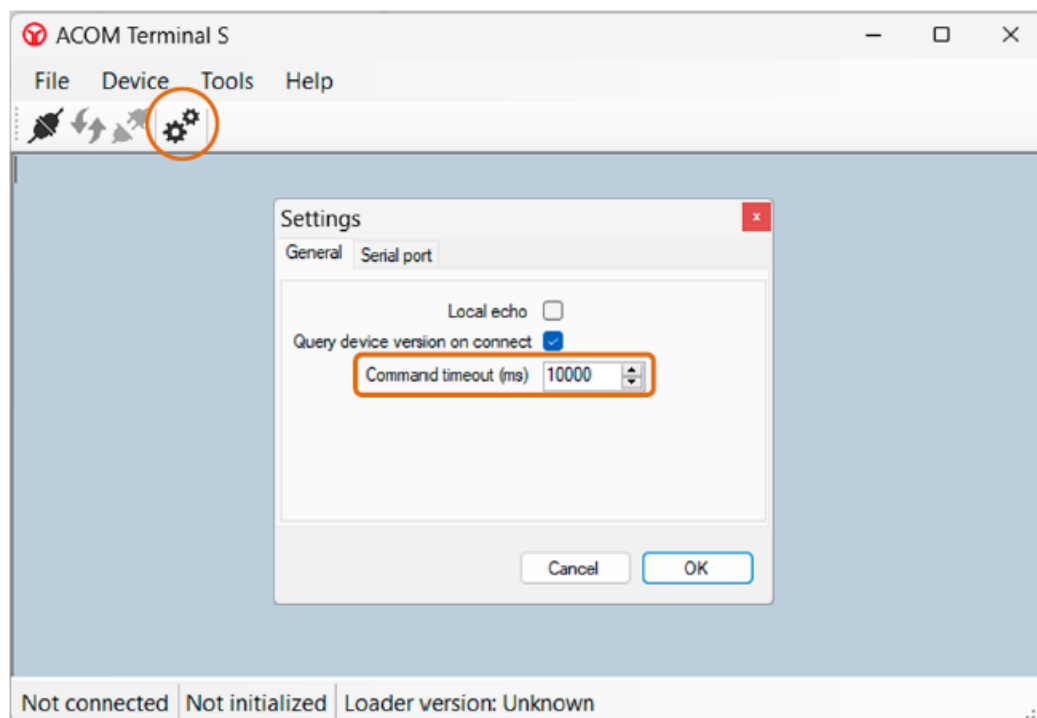
Figure 1-11 | Terminal S – Tools -> Setting -> General menu

- Open the Settings window by clicking on the Settings icon (two gears) or use Tools -> Settings from the menu bar. In the Settings window -> tab General, configure the settings as shown in Figure 1-11 | Terminal S – Tools -> Setting -> General menu: – Command timeout (ms) 10000;
- In the Settings window -> tab Serial port, configure the settings as shown in Figure 1-12 | Terminal S – Tools -> Setting -> Serial port menu. For actual serial port number see STEP 1 – RS-232 Interface Settings on your PC:
 - – Serial port settings 9600, 8, None, 1;

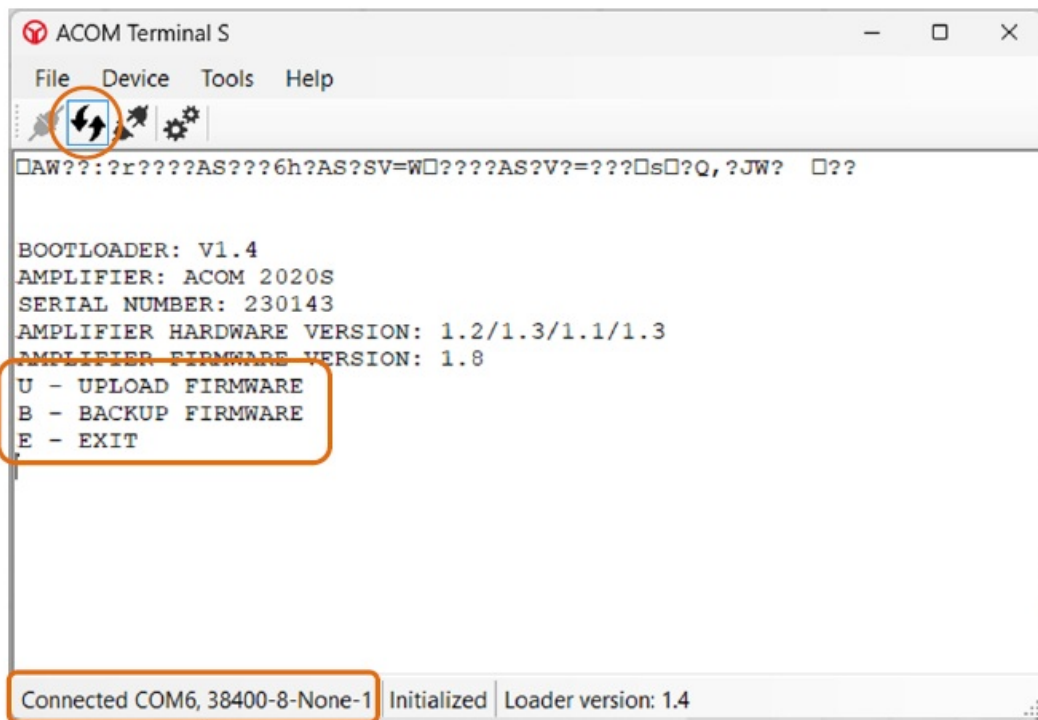
Figure 1-18 | Terminal S – Bootloader menu

- When connected click on the Firmware Upload/Download icon (two arrows in opposite directions) or use Device -> Firmware upload/download from the menu bar to activate the bootloader. A Bootloader menu will appear in the text box as shown below;

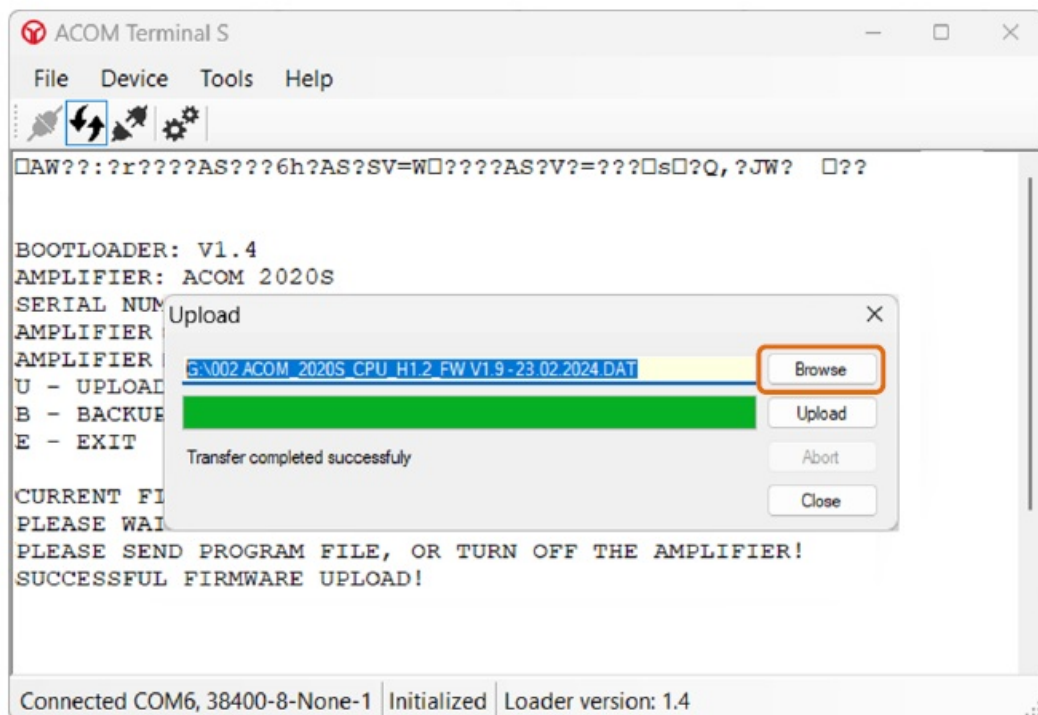
Figure 1-19 | Terminal S – Upload firmware process

- A new dialog box will open asking for the new firmware file name and location. Open the folder that contains the new firmware file (*.dat), select the file, and press the Upload button (We assume that you downloaded the newest firmware from www.acom-bg.com and unzipped it on your PC);

- The Upload firmware process may take approx. 3-6 minutes.
- Press the B letter from your keyboard to activate the Firmware Backup process. A new dialog box will open prompting you to enter a name and location for the new backup file. Press the Download button to start the process;

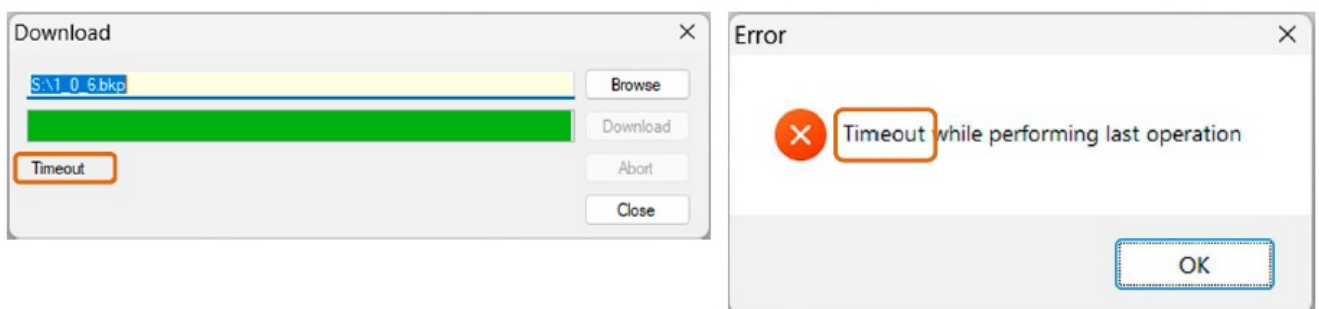
Figure 1-23 | Terminal S – Error Timeout

- If you see an error message related to Timeout, please check:

- Command timeout parameter as described in Section 1.3 Firmware Update Procedure (STEP 3 –Using Terminal S software for Firmware Update).
- **The other possible reasons for Timeout error could be, for example:**
Windows Device Manager -> USB Serial Converter Properties -> Advanced Below are shown the recommended settings (VCP = Virtual Com Port):
