Allison DTC U0010 CAN 1 Bus Counter Overrun Instructions

DTC U0010 CAN 1 Bus Reset Counter Overrun

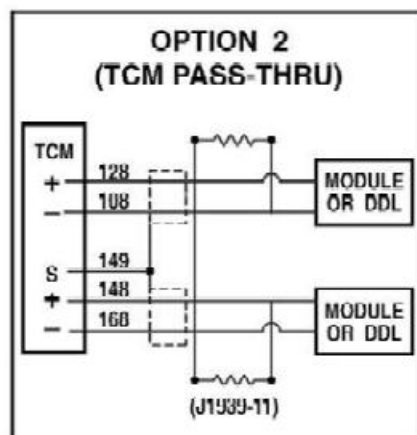
Circuit Description

The Controller Area Network (CAN) defined by SAE J1939 allows the integration of various vehicle components into an overall vehicle system by providing a standard way of exchanging information between the various

DTC U001 O sets when the Transmission Control Module (TCM) detects no communication on the CAN backbone harness for 3 seconds or more. This indicates that the CAN communication has reset due to a short-to-ground or power on wire 108 or 128.

This setup allows communication directly to TCM. If no communication is available replace the TCM with a known good module. Test again (refer to Figure 5-5 for complete ‘T’ harness hook-up information).

4. Connect Allison DOC® For PC-Service Tool interface device at J-42455 Load Box.
5. This configuration should allow communication directly with the TCM, if no communication is available replace the TCM with a known good module. Test again. Refer to Figure 5-5 for complete 'T' harness hook-up information.
