Beijer ELECTRONICS X2 HMI Panels User Guide

Beijer ELECTRONICS X2 HMI Panels

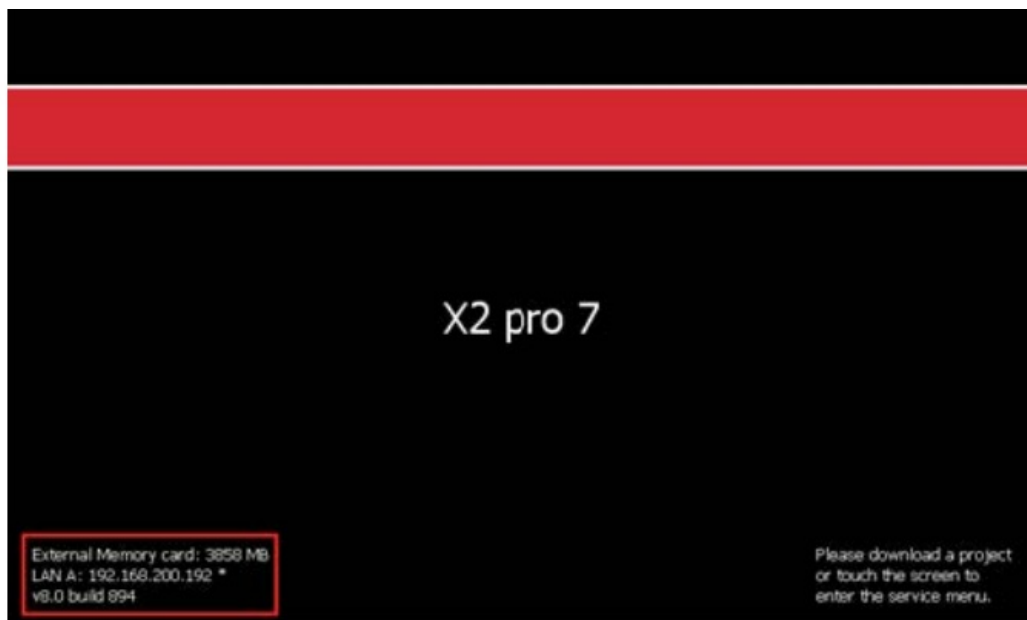
On an X2 extreme HMI panel with an image version older than v. 2.0, we recommend updating the Image Version Using a Recovery SD Card. That means that the iX Developer project and IP settings need to be copied from the HMI panel before the image is updated, see Copy iX Developer Project and IP Settings. On panel startup, in the welcome screen, it is possible to see the image version. Certain USB memories are not recognized at startup on specific units. Use other devices or methods for updating in such cases. The welcome screen for an X2 pro 7 panel.

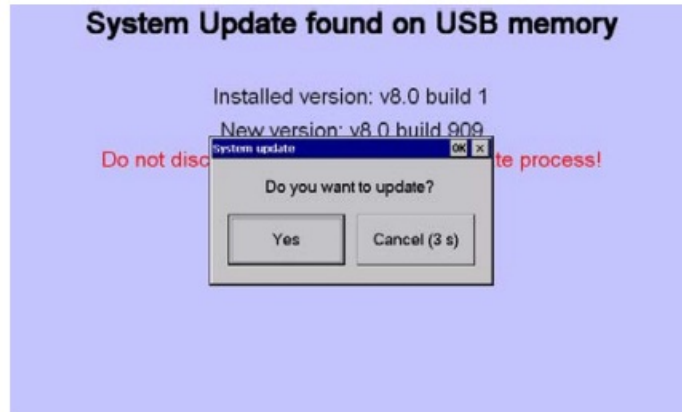
1. Download your image from Beijer Electronics SmartStore.
2. Unzip the downloaded file and start the Image Loader application.
3. Connect a USB flash drive or SD card to the computer.

4. In Select Drive: choose the connected USB flash drive or SD card.
5. Click Create.
6. When finished, eject the USB flash drive or SD card.

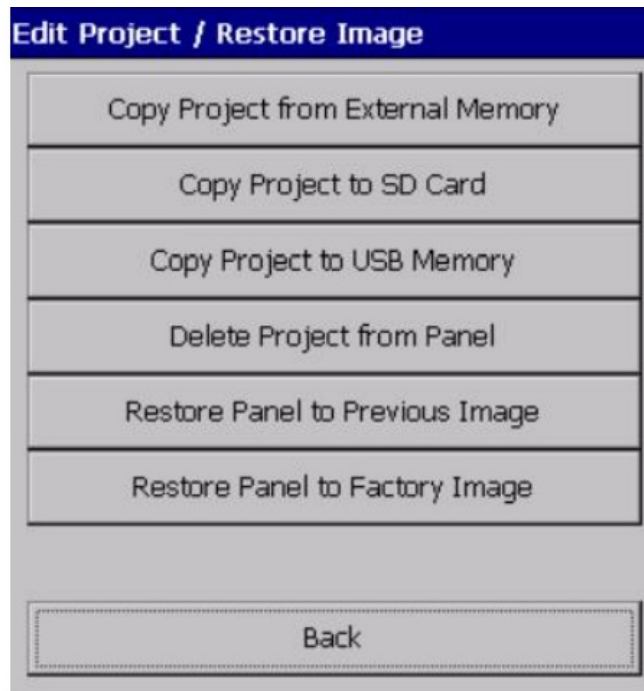
3. Tap the screen once again to enter the service menu.
4. If the service menu is password protected, you will be prompted for a PIN code. Enter the PIN code.
5. IP settings are found in the "IP settings" dialogue. Please write down the IP settings for LAN A and LAN B for future use before proceeding.
6. The iX Developer project is copied in the Edit Project / Restore Image dialog.

You can choose to export the project to an SD card or USB.

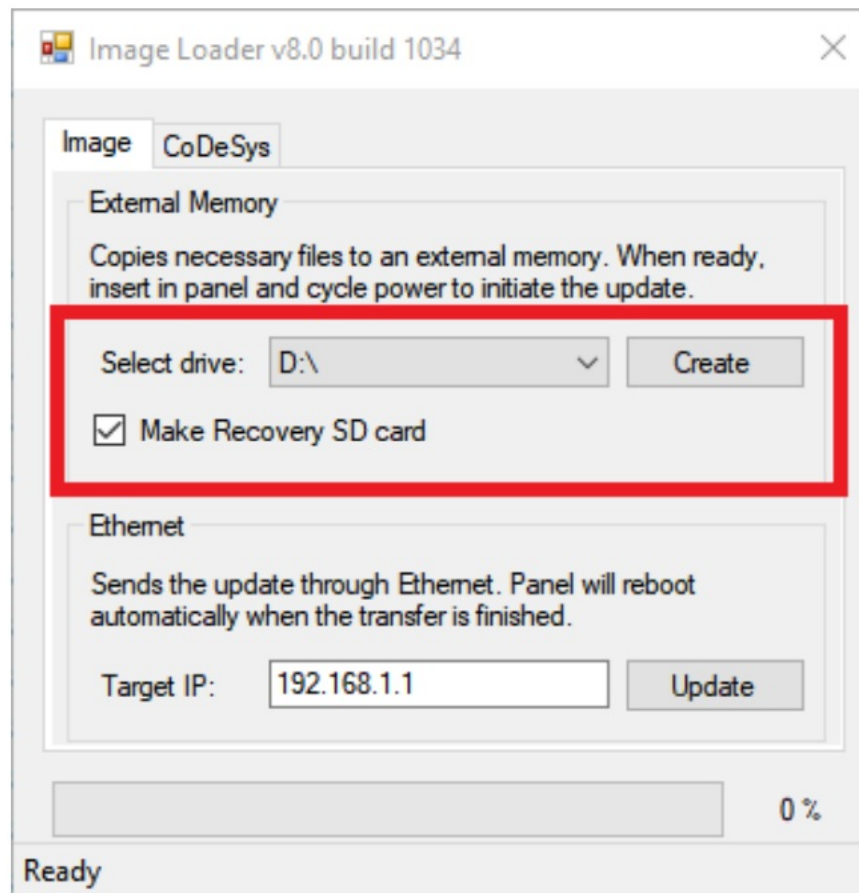
2. Unzip the downloaded file and start the Image Loader application.
3. Connect an SD card to the computer.
4. In Select Drive: choose the connected SD card. Make sure to check the Make Recovery SD card checkbox.
5. Click Create.
6. When finished, eject the SD card.
7. Connect the SD card to the powered-off unit and power it back on.
8. In the dialogue that opens, select Yes to confirm the Update.
9. The update is now completed.

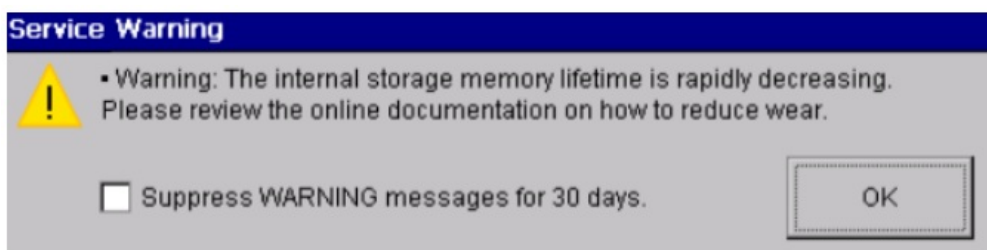
1. Enter the service menu.
2. Enter diagnostics.
3. Enter settings.

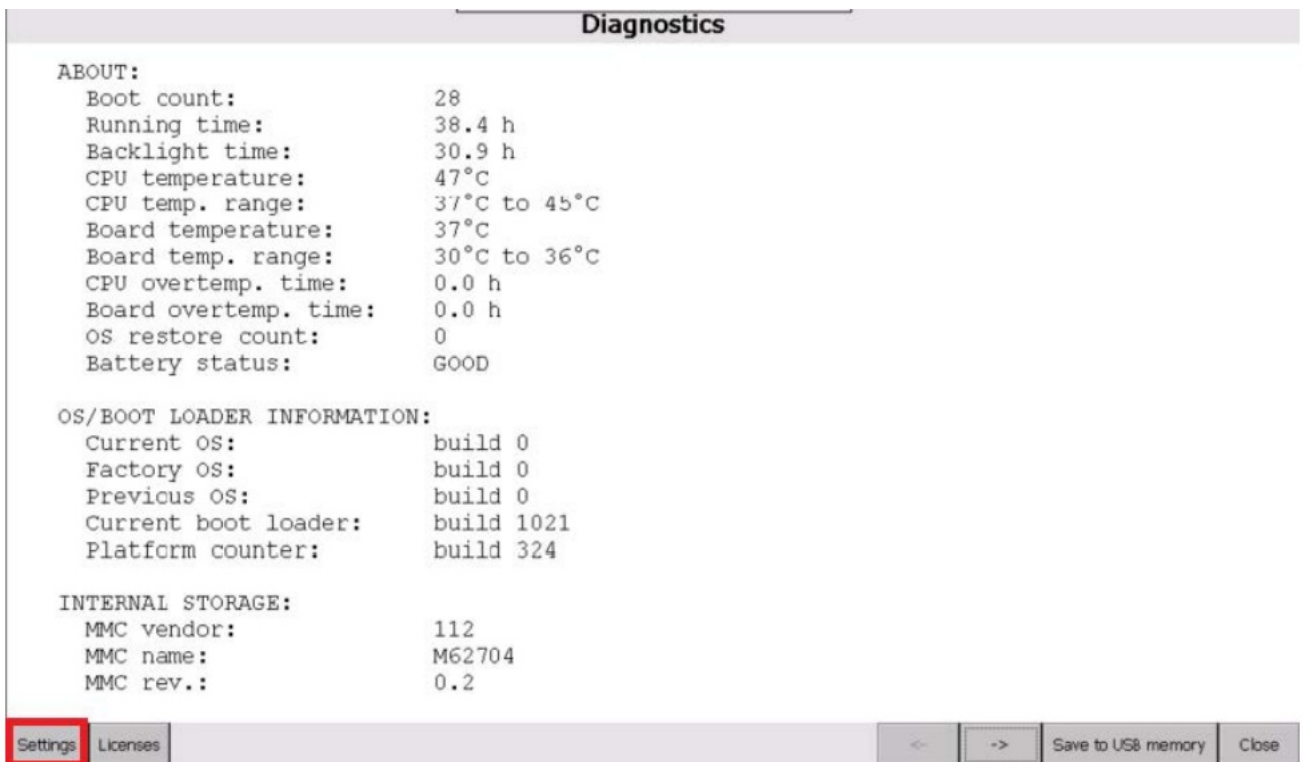
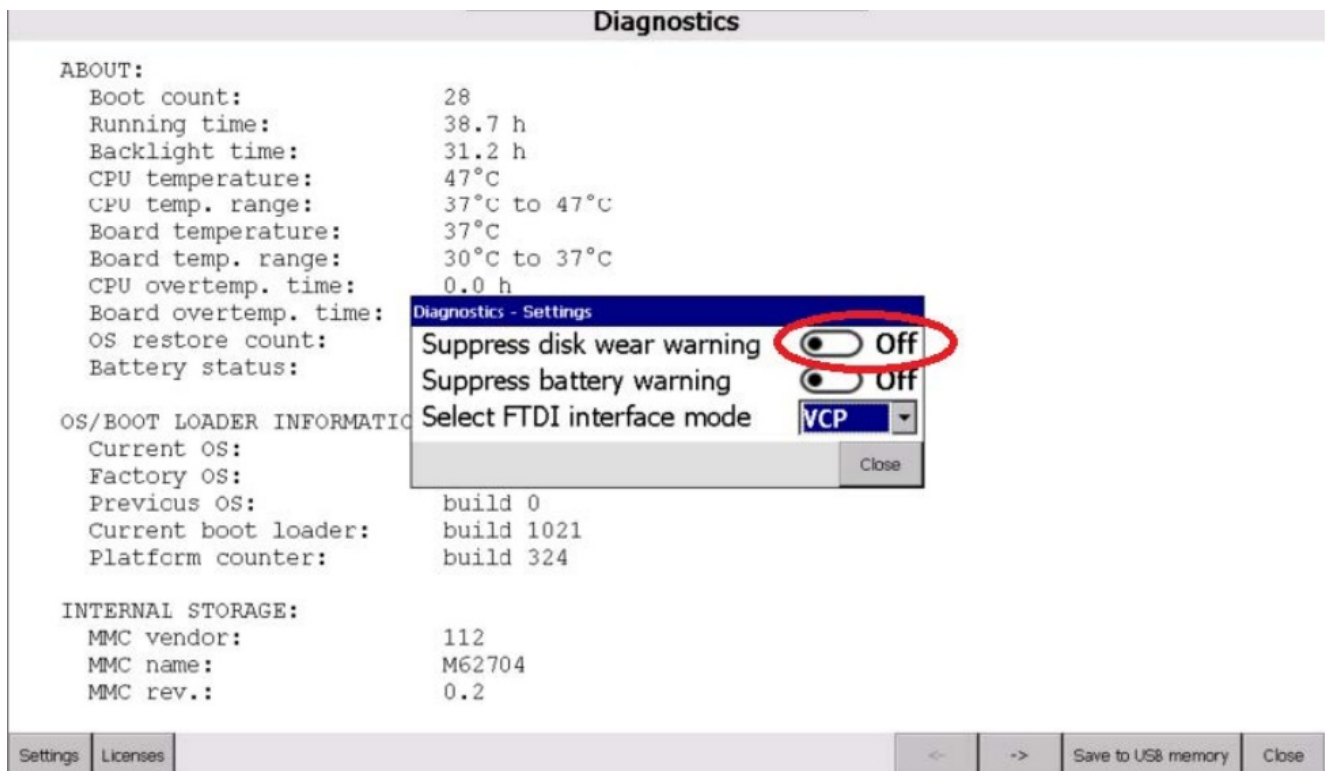
4. Suppress disk wear warning

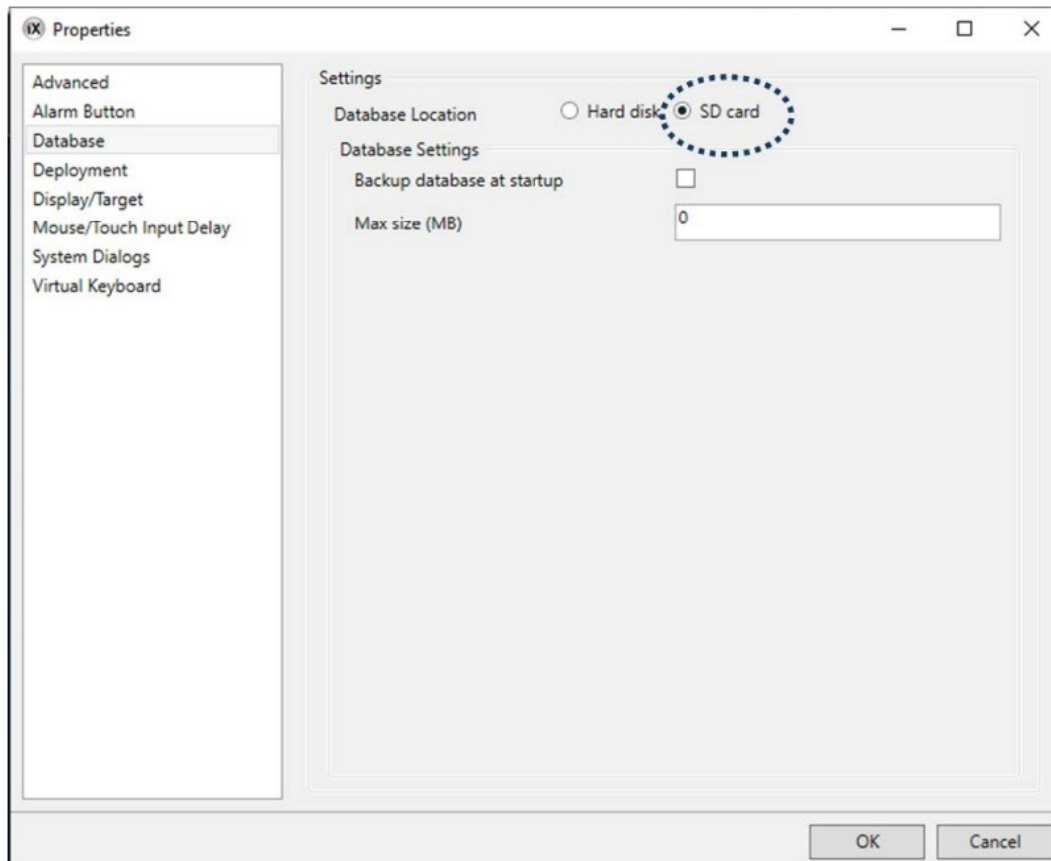
2. Go to Project/Settings. Select Database and select SD Card in the dialogue.
3. Click on the OK Button to confirm the new settings.
4. When the location of the database is changed from flash to SD card (or vice versa) in an existing application, the database will be automatically copied to the new location once the project is transferred to the panel. This will be started immediately after the project transfer has taken place and hence a somewhat slower project start-up time can be noticed.
