Emerson 2.20F03 Update Advisory Supervisory Control Platform Firmware Instruction Manual

Update Advisory Supervisory Control Platform
Firmware 2.20F03
Release Notes

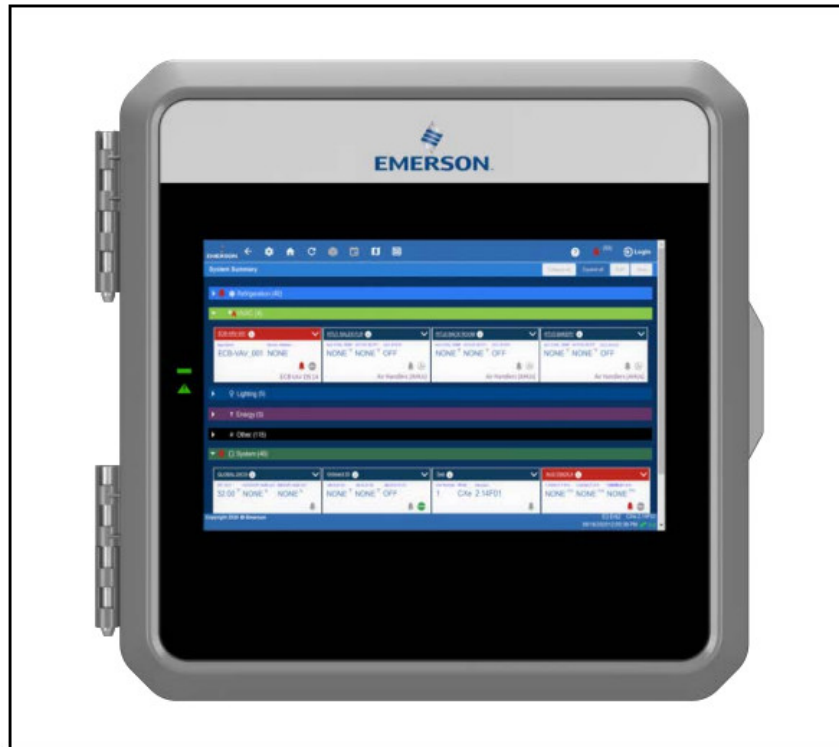
Figure 1 - E3 Controller

1. For E3 firmware upgrades, be sure to use the _Display_Update file.
2. Reset or power cycle an upgraded E3 approximately 10 minutes after the upgrade is complete.
