**ESAB®**  
**PAB**  
**System**  
**Software**  
**Tutorial**

## ESAB PAB System Software Tutorial Instruction Manual

### System software upgrade/downgrade PAB units

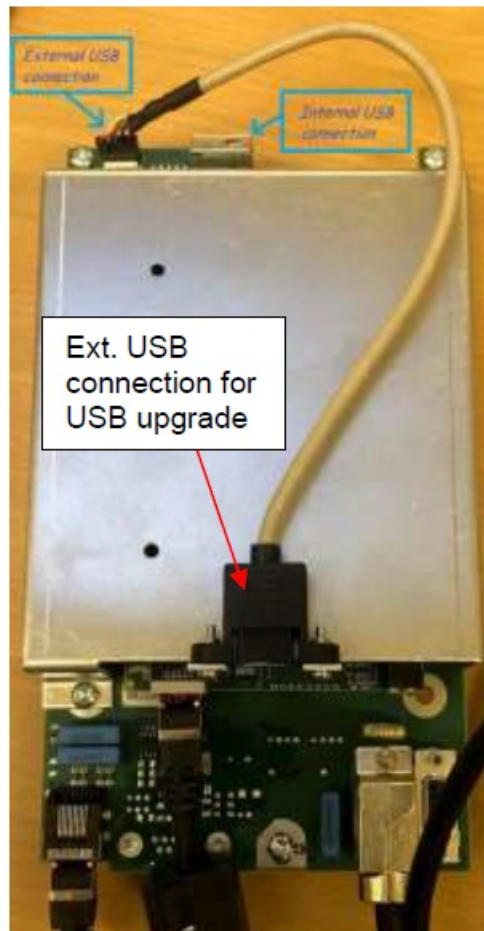
Picture 1.

- Check PAB hardware version. Old PAB with hardware version 10 (only one USB connector) will not work with software 5.00A and newer.
- Upgrade the software from the external USB connector on new PAB, see picture 1.

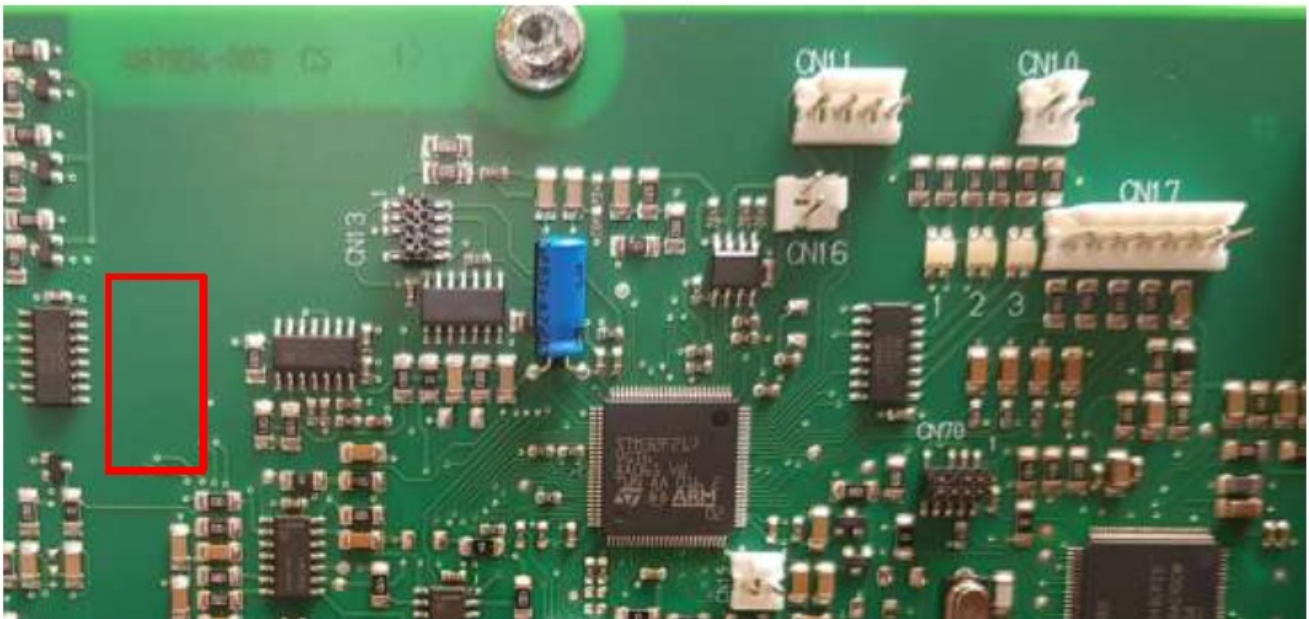
Picture 2. New version of Aristo 1000 control board **without** CN 65.

- Upgrade/downgrade to system software version older than 1.39A: The PAB USB structure has to be replaced manually. The config.xml file must not be replaced.
- The new version of Aristo 1000 AC/DC control board, see picture 2, will require new software (version 3.xxx) and is not compatible with older software of the old control board.

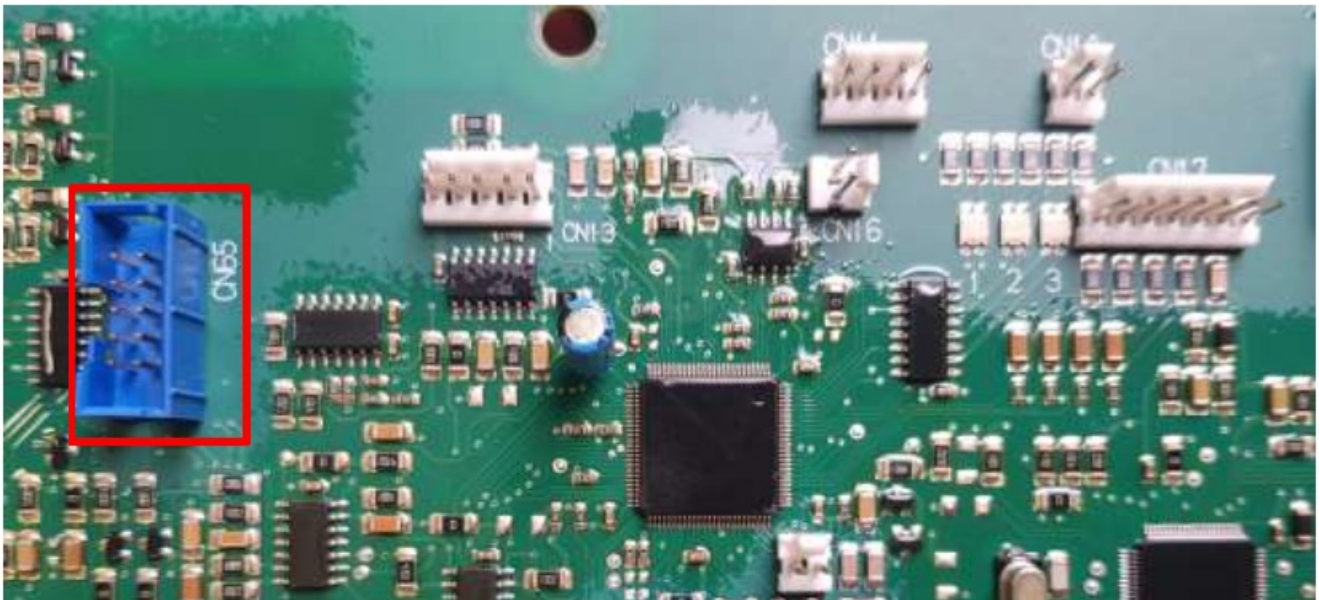
Picture 3. Old version of Aristo 1000 control board **with** CN 65.
