Espressif ESP32-C6 Series SoC Errata User Manual

This document describes known errata in ESP32-C6 series of SoCs.

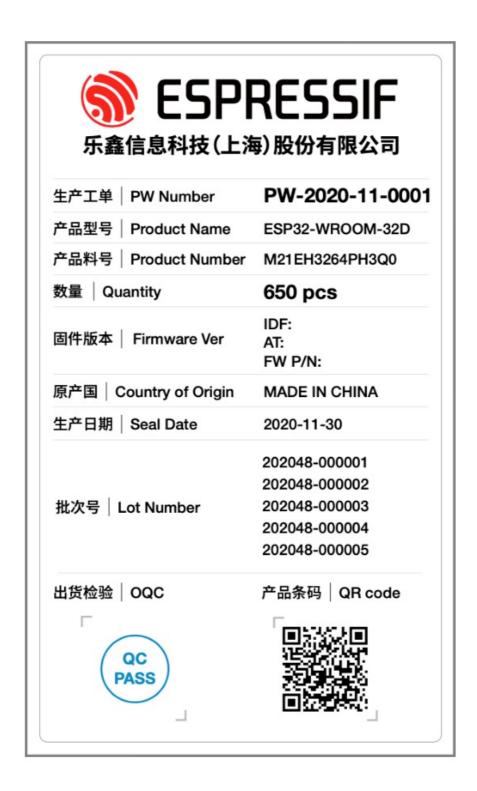
Figure 3: Module Product Label

Modules built around the chip may be identified by PW Number in product label (see Figure 3). For more information, please refer to **Espressif Module Packaging Information**.

Please note that **PW Number** is only provided for reels packaged in aluminum moisture barrier bags (MBB).
