UD-3900C4 Firmware Update Guide

The following procedure describes how to update the Synaptics VMM5200 DisplayPort MST chipset firmware to version **Ver5_06_106** within a [Plugable UD-3900C4 docking station](#) using a Windows host PC.

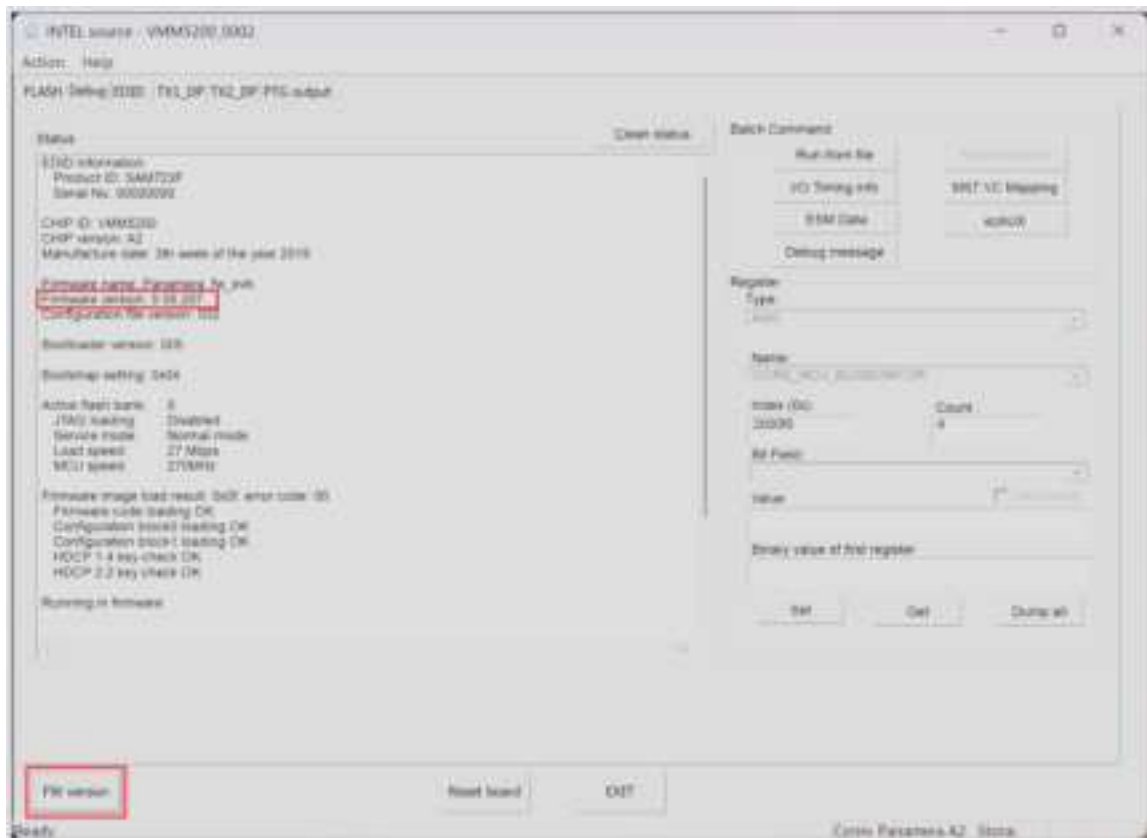
- **Do not** attempt to run the update application from within the .ZIP file; it must be extracted first.
 - The update application **should not** be run over a network shared drive; please ensure that the file is extracted to the host system **locally**.
6. Run the “VmmDPTool64.exe” update application that was extracted from the .ZIP file earlier. When/if prompted by Windows UAC (User Account Control) to run the application, please allow.
 7. Once the update application is open, click the “Debug” tab, then click on the “FW version” button at the bottom left. Within the “Status” window, we should see that the current dock firmware version will be read:

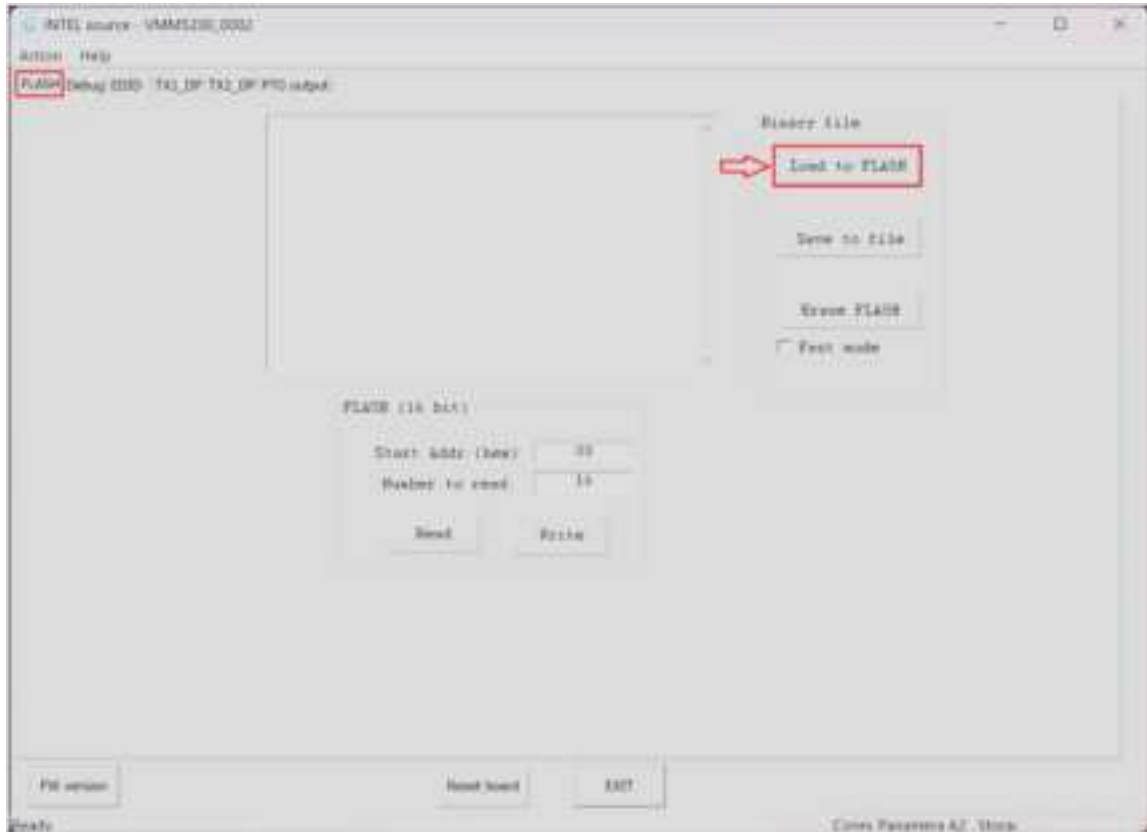
8. Click the “FLASH” tab, then click “Load to FLASH” to the right:

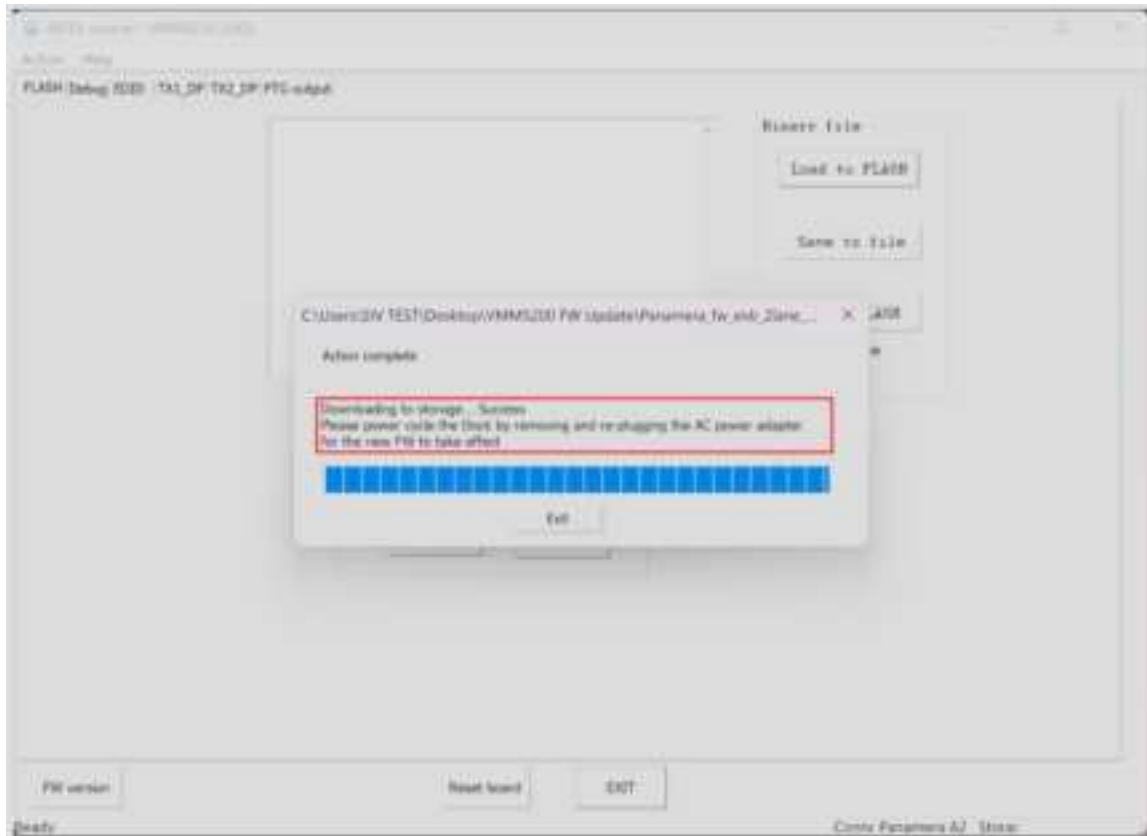
9. You must now select the firmware file to be flashed. Navigate to the files that were extracted from the .ZIP file earlier, then select the “Panamera_fw_evb_2lane_Ver5_06_106.fullrom” file and click “Open”:
