# **Aurora Reference Design**

**AN5864**

This document provides instructions for using the Aurora 8B/10B IP on the PolarFire Evaluation Board. The PolarFire high-speed transceiver (PF\_XCVR\_ERM) must be configured in PCS 8B10B mode along with the Aurora 8B/10B IP. The AURORA\_TX\_GENERATOR and AURORA\_RX\_CHECKER modules are used to generate and verify data through the AXI4-Stream interface.

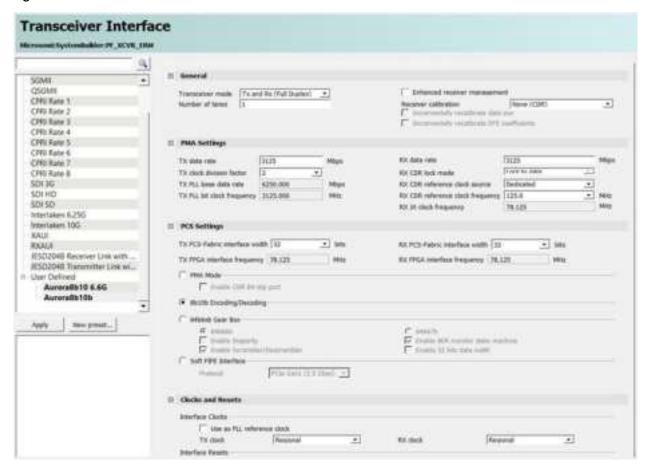
Figure 3-5. Transceiver Interface

- 2. Configure PF\_XCVR\_ERM for full-duplex operation with a single lane and a data rate of 3.125 GHz.
- 3. Configure the PCS interface width to 32 bits with 8B/10B encoding and decoding.

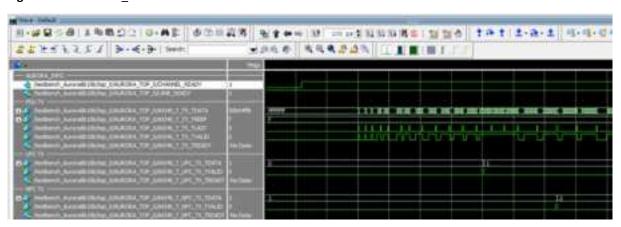
Figure 5-3. CHANNEL\_READY is Asserted

• The TX\_GENERATOR module starts transmitting test patterns to Aurora 8B/10B IP after CHANNEL READY is asserted.
