## **Cisco ONS 15454 DWDM Troubleshooting Guide, Release 9.2**

Text Part Number: 78-19394-02

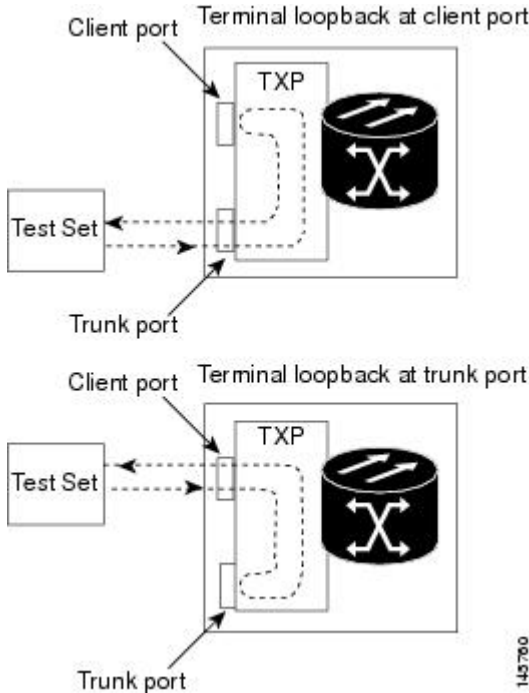
A terminal loopback tests a circuit path as it passes through a TXP, MXP, or ADM-10G card and loops back. For example, as shown in [Figure 2: Terminal Loopback on a TXP Card, on page 6](#), there are two types of terminal loopbacks shown for a TXP card.

This test verifies that the terminal circuit paths are valid, but does not test the LIU on the TXP card.

**Figure 2: Terminal Loopback on a TXP Card**

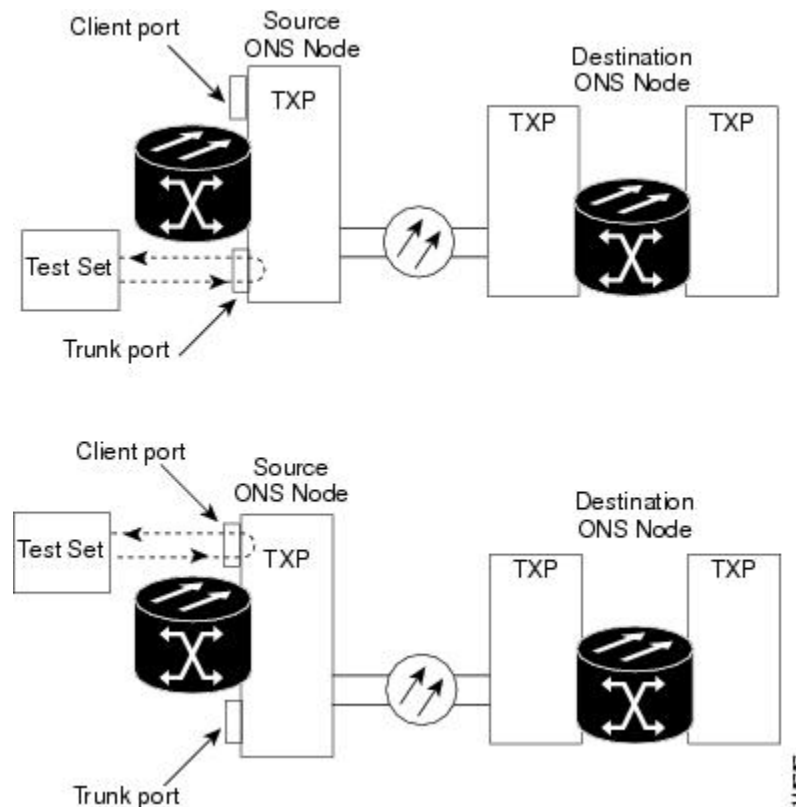
This facility loopback test is performed on the node source port in the network circuit. In the testing situation used in this example, the source muxponder, transponder, xponder, or ADM-10G port under test is located in the source node. Facility loopback can be performed at the trunk port or at a client port. Completing a successful facility loopback on this port isolates the source MXP, TXP, XP, or ADM-10G port as a possible failure point. [Figure 3: Facility Loopback on a Circuit Source MXP or TXP Port, on page 9](#) shows the facility loopback examples on source ONS node TXP ports (client and trunk).

**Figure 3: Facility Loopback on a Circuit Source MXP or TXP Port**

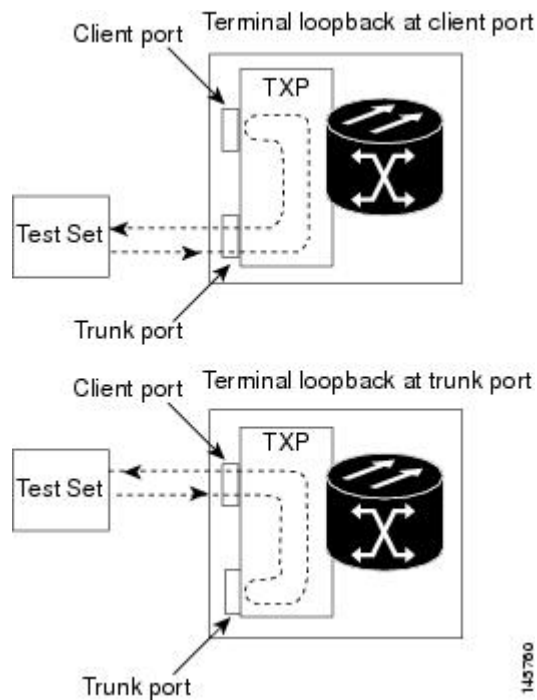
The terminal loopback test is performed on the node source MXP, TXP, XP, or ADM-10G port. For the circuit in this example, it is the source TXP trunk port or a client port in the source node. Completing a successful terminal loopback to a node source port verifies that the circuit is through the source port. [Figure 4: Terminal Loopback on a Source-Node MXP or TXP Port](#), on page 12 shows an example of a terminal loopback on a source TXP port and a client TXP port.

**Figure 4: Terminal Loopback on a Source-Node MXP or TXP Port**

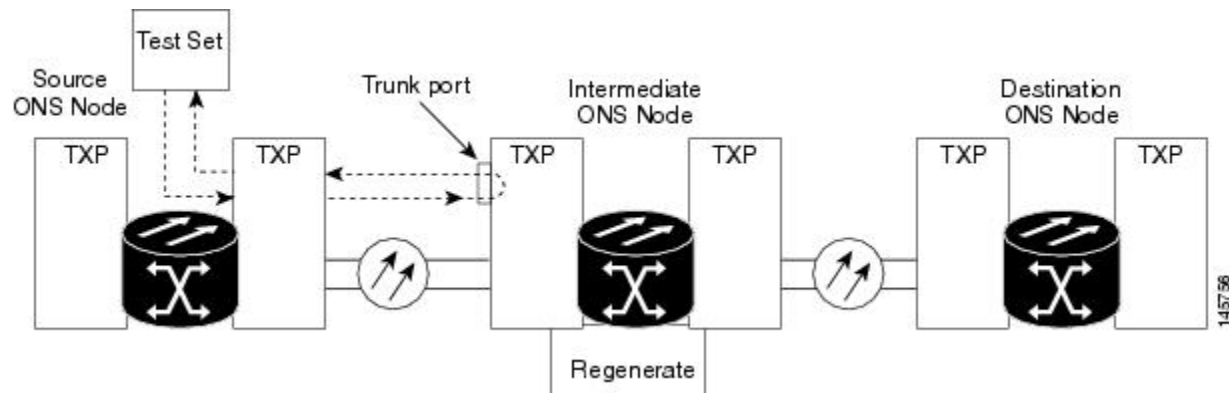
Performing the facility loopback test on an intermediate port isolates whether this node is causing circuit failure. In the situation shown in [Figure 5: Facility Loopback on an Intermediate-Node MXP or TXP Port, on page 15](#), the test is being performed on an intermediate MXP or TXP port.

**Figure 5: Facility Loopback on an Intermediate-Node MXP or TXP Port**

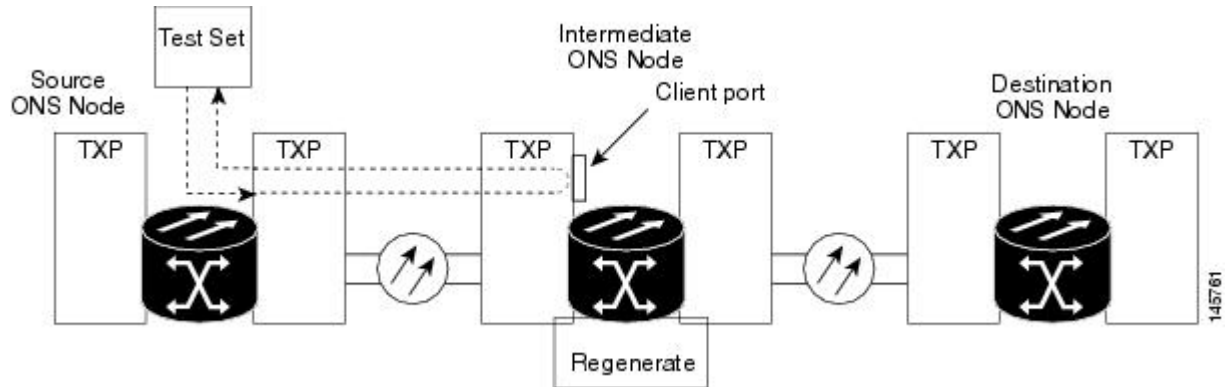
In the next troubleshooting test, you perform a terminal loopback on the intermediate-node port to isolate whether the intermediate client or trunk port is causing circuit trouble. In the example situation in [Figure 6: Terminal Loopback on an Intermediate-Node MXP or TXP Port](#), on page 18, the terminal loopback is

performed on an intermediate MXP or TXP port in the circuit. If you successfully complete a terminal loopback on the node, this node is excluded from possible sources of circuit trouble.

**Figure 6: Terminal Loopback on an Intermediate-Node MXP or TXP Port**

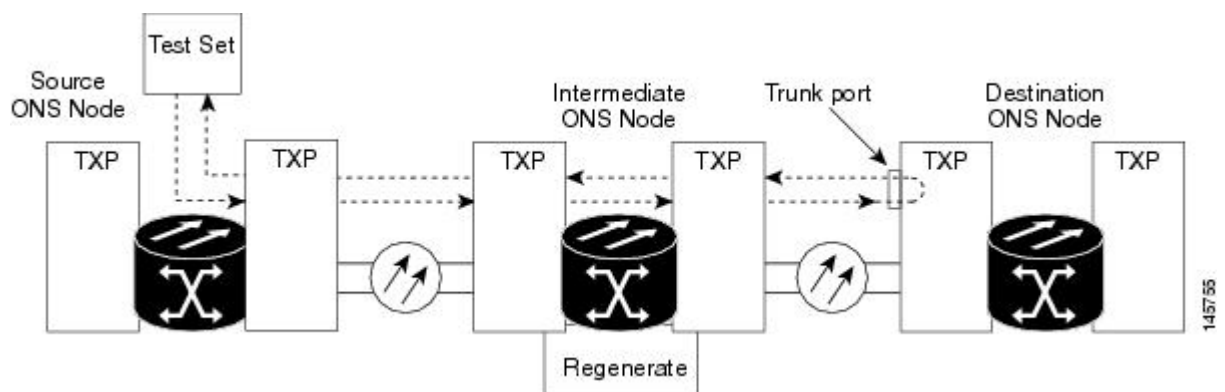
You perform a facility loopback test at the destination port to determine whether this local port is the source of circuit trouble. The example in [Figure 7: Facility Loopback on a Destination-Node MXP or TXP Port](#), on page 20 shows a facility loopback being performed on a TXP client or trunk port at a destination node.

**Figure 7: Facility Loopback on a Destination-Node MXP or TXP Port**

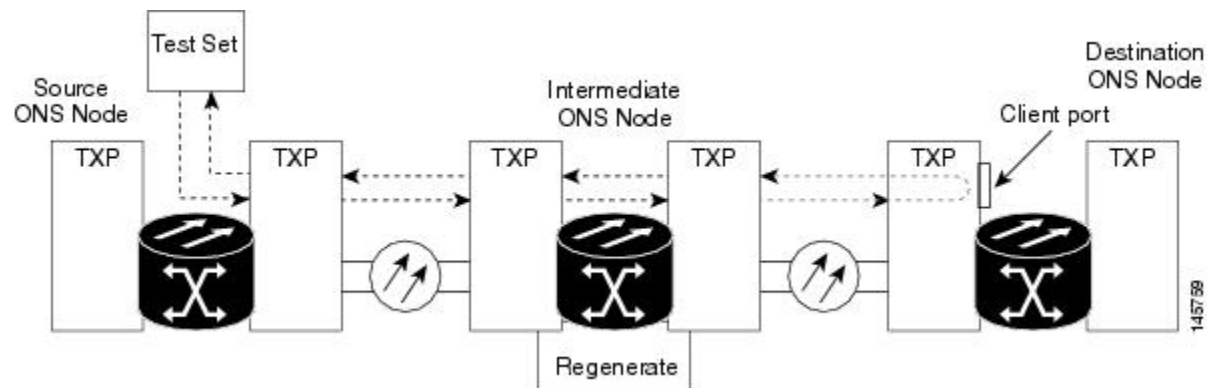
The terminal loopback at the destination-node port is the final local hardware error elimination in the circuit troubleshooting process. If this test is completed successfully, you have verified that the circuit is good up to the destination port. The example in [Figure 8: Terminal Loopback on a Destination-Node MXP or TXP Port](#), on page 23 shows a terminal loopback on an destination node TXP port.

**Figure 8: Terminal Loopback on a Destination-Node MXP or TXP Port**

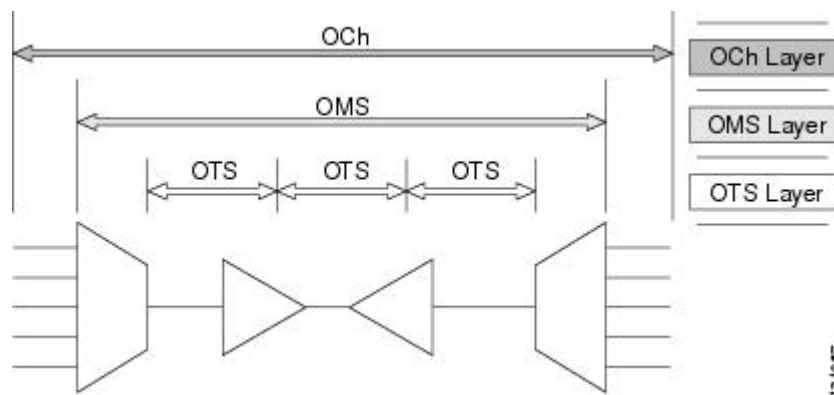
Like traditional SONET networks, ITU-T G.709 optical networks have a layered design ([Figure 9: Optical Transport Network Layers, on page 26](#)). This structure enables localized monitoring that helps you isolate and troubleshoot network problems.

**Figure 9: Optical Transport Network Layers**

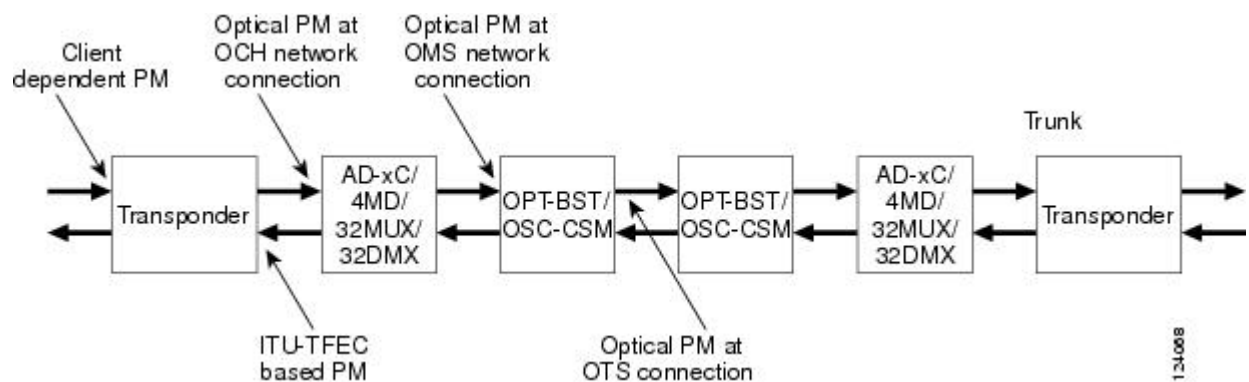
Different PM count parameters are associated with different read points in a network. [Figure 10: Performance Monitoring Points on ONS DWDM](#), on page 28 illustrates the PM read points that are useful in identifying DWDM circuit points of failure. The Performance Monitoring chapter in the *Cisco ONS 15454 DWDM Reference Manual* lists all PM parameters and provides block diagrams of signal entry points, exit points, and interconnections between the individual circuit cards. Consult these specifications to determine which PM parameters are associated with the system points you want to monitor or provision with CTC or TL1. The monitoring points might vary according to your configuration.

**Figure 10: Performance Monitoring Points on ONS DWDM**

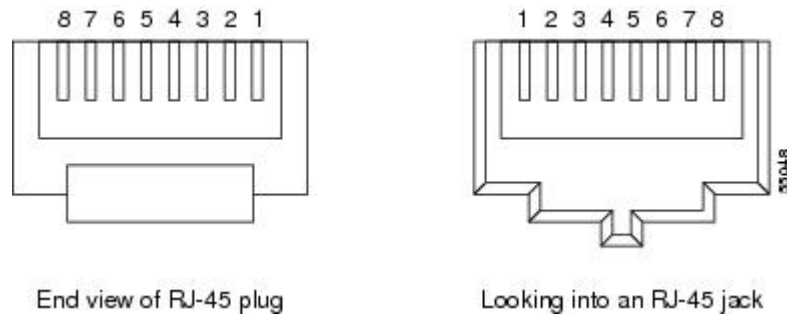
You can crimp your own LAN cables for use with the ONS 15454. Use a cross-over cable when connecting an ONS 15454 to a hub, LAN modem, or switch, and use a LAN cable when connecting an ONS 15454 to a router or workstation. Use CAT-5 cable RJ-45 T-568B, Color Code (100 Mbps), and a crimping tool. [Figure 11: RJ-45 Pin Numbers](#), on page 58 shows the wiring of an RJ-45 connector. [Table 9: LAN Cable Pinout](#), on page 58 [Figure 13: Cross-Over Cable Layout](#), on page 59 shows a LAN cable layout, and [Table 9: LAN](#)

**Figure 11: RJ-45 Pin Numbers**

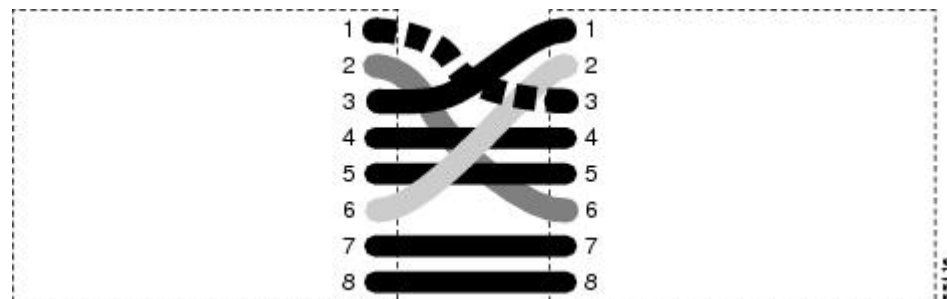
**Figure 12: LAN Cable Layout**

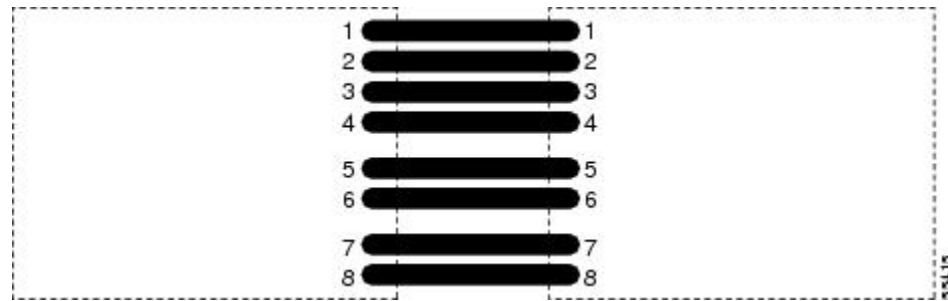
[Cable Pinout](#), on page 58 shows the cable pinouts. [Figure 13: Cross-Over Cable Layout](#), on page 59 shows a cross-over cable layout, and [Table 10: Cross-Over Cable Pinout](#), on page 59 shows the cross-over pinouts.

**Figure 13: Cross-Over Cable Layout**

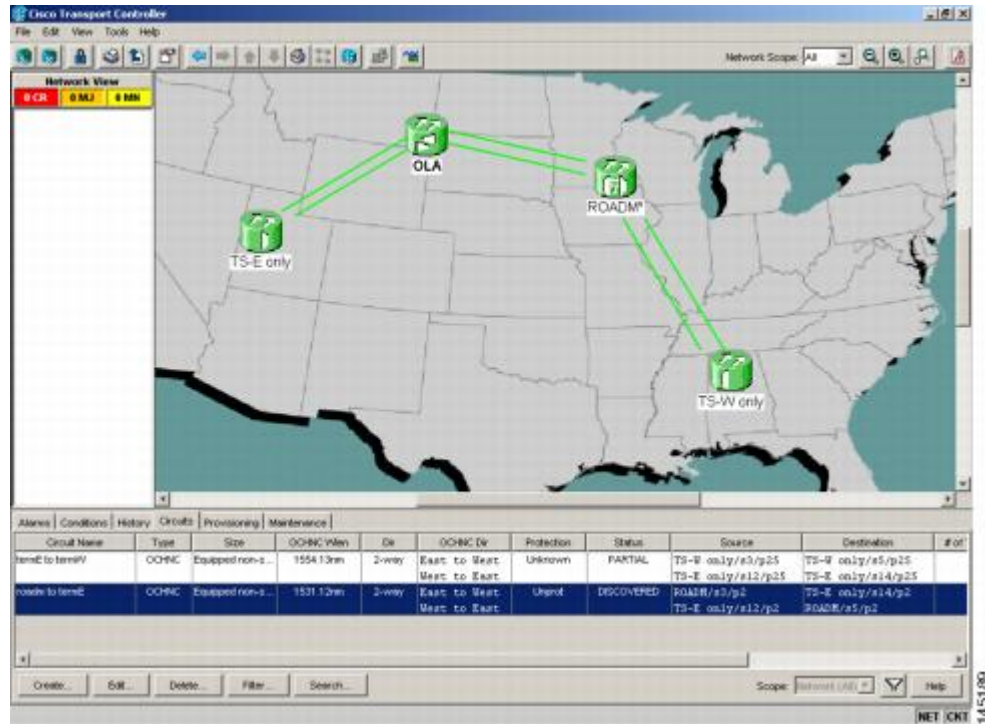
Different symptoms and scenarios can occur, depending on the network ALS settings. Consider the linear network (four nodes) in [Figure 14: Linear Network, With No Fiber Cut](#), on page 64 as a reference. The scenarios are presented after the figure.

**Figure 14: Linear Network, With No Fiber Cut**

The symptoms of the possible span loss scenarios (except for span loss decrease) are described in the following paragraphs. Refer to the linear network in [Figure 14: Linear Network, With No Fiber Cut](#), on page 64 during the discussion of the scenarios.

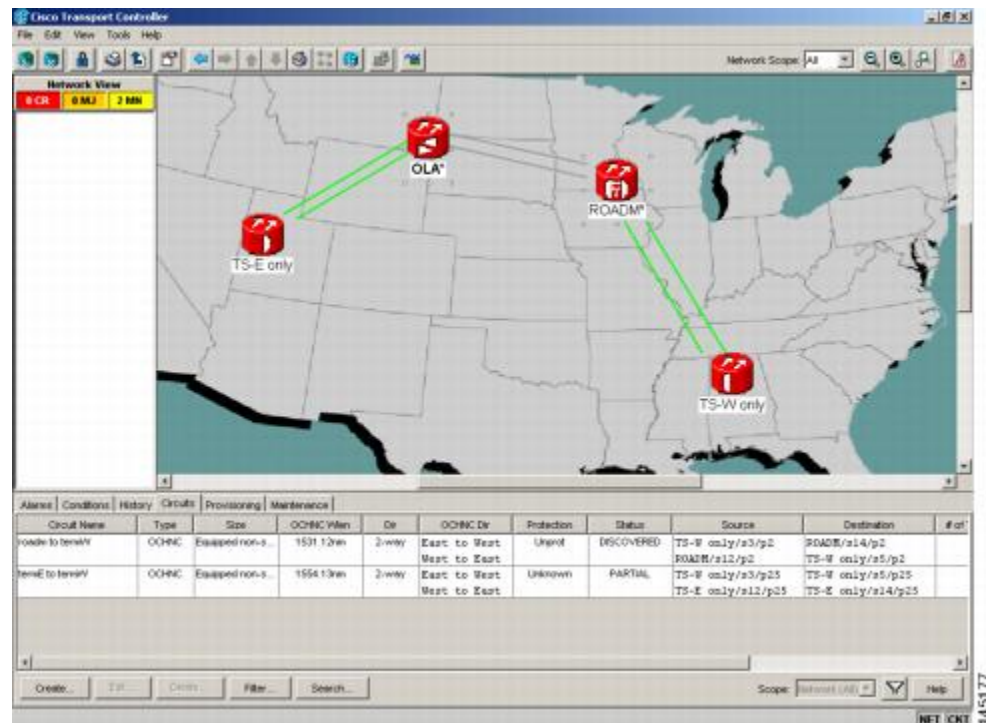
The final fault condition of the network is shown in [Figure 15: Fiber Cut with ALS MODE = Auto Restart](#), on page 65.

**Figure 15: Fiber Cut with ALS MODE = Auto Restart**

In network view, both of the lines representing the span were formerly green and have now changed to gray. Notice also that the status of all the OCHNC circuits on the broken span have changed from Discovered to Partial.

The basic assumption is that the network ALS feature (for feature details, refer to the Network Optical Safety—Automatic Laser Shutdown section in the Network Reference chapter of the *Cisco ONS 15454 DWDM Reference Manual*) is active (ALS Mode = Auto Restart on the OPT-BST, OPT-AMP-x-C, [+ OSCM] and OSC-CSM). Given this assumption, the starting condition is as shown in [Figure 15: Fiber Cut with ALS MODE = Auto Restart](#), on page 65.

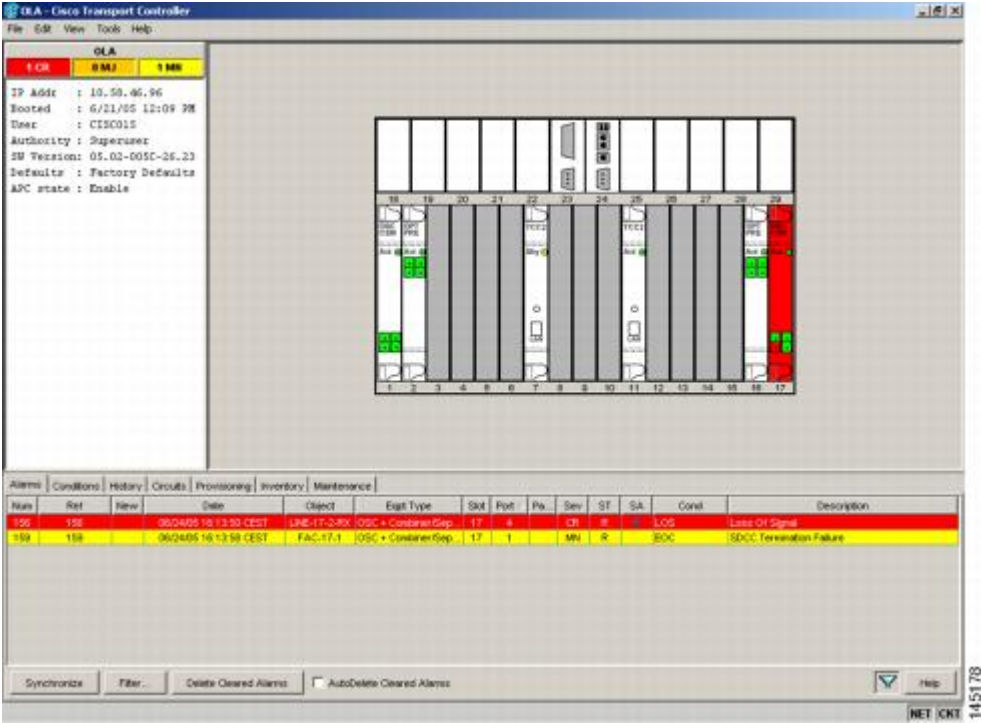
In node view (single-shelf mode) or shelf view (multishelf mode), the alarm panel of the two nodes (reconfigurable optical add/drop multiplexing [ROADM] and optical line amplification [OLA] in the example) show the LOS (AOTS) alarm on Port 4 of the OSC-CSM (see [Figure 16: LOS Indication on the ROADM](#)

Figure 16: LOS Indication on the ROADM Node OSC-CSM

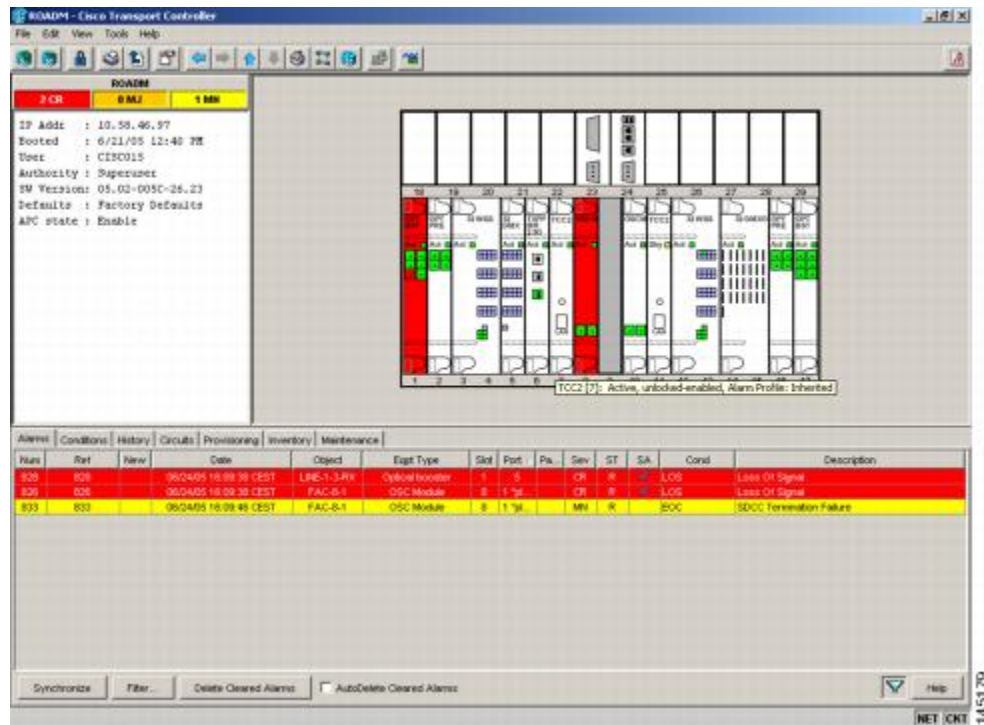
Node OSC-CSM, on page 66) and the LOS (OTS) on Port 5 of the OPT-BST (see Figure 17: LOS Indication on the OLA Node OPT-BST, on page 66).

Figure 17: LOS Indication on the OLA Node OPT-BST

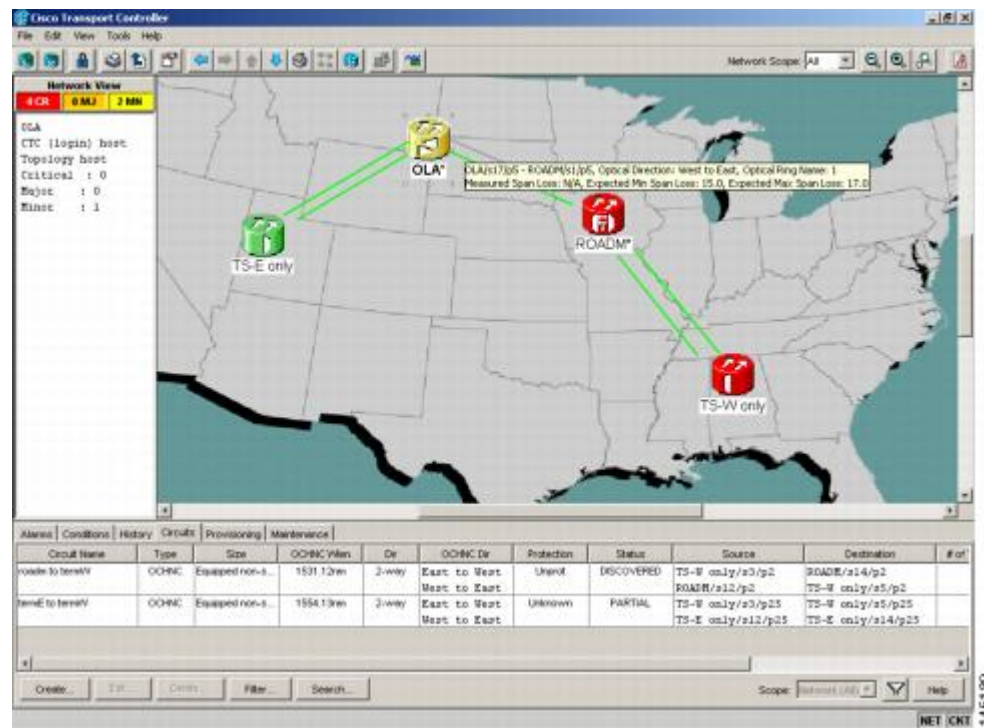
The LOS (OTS or AOTS) alarm is raised by the ROADM-RX node that was receiving the signal coming from the broken fiber. The final fault condition of the network is shown in [Figure 18: Network View Fault Condition for Fiber Cut with ALS Mode Disabled](#), on page 68.

**Figure 18: Network View Fault Condition for Fiber Cut with ALS Mode Disabled**

In network view ([Figure 18: Network View Fault Condition for Fiber Cut with ALS Mode Disabled](#), on page 68), only the actual affected fiber becomes gray, whereas the traffic (and OSC signal as well) on the good fiber is active and fault identification is immediate.

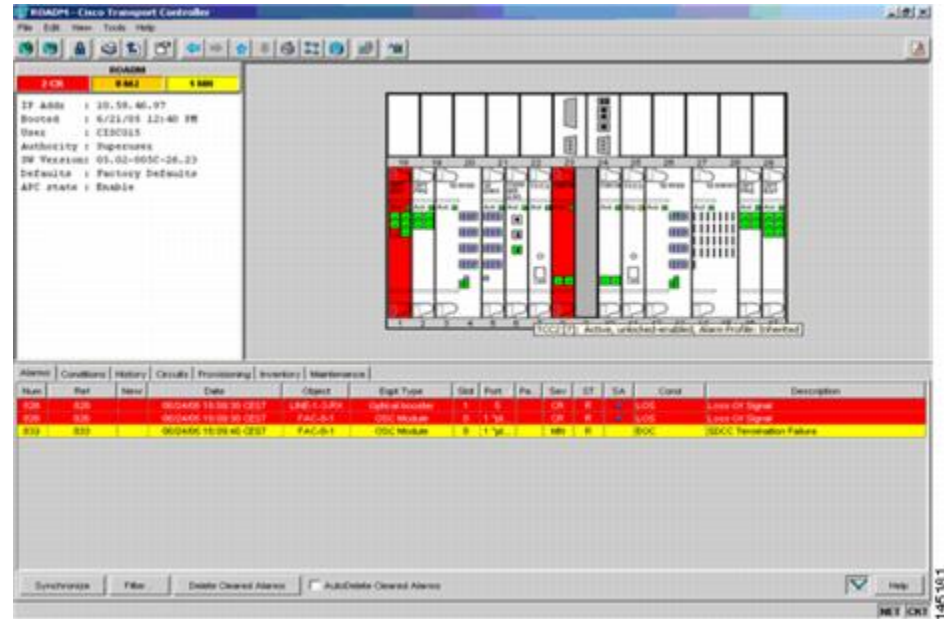
In node view (single-shelf mode) or shelf view (multishelf mode) ([Figure 19: ONS 15454 SDH ROADM Node View with Fault Condition for ALS MODE Disabled](#), on page 69 and [Figure 20: ONS 15454 SDH OLA Node View with Fault Condition for ALS MODE Disabled](#), on page 69), the alarm panel of the receiving

node (ROADM in this example) reports the LOS (OTS), while the transmitting node (OLA) reports only an EOC alarm.

**Figure 19: ONS 15454 SDH ROADM Node View with Fault Condition for ALS MODE Disabled**

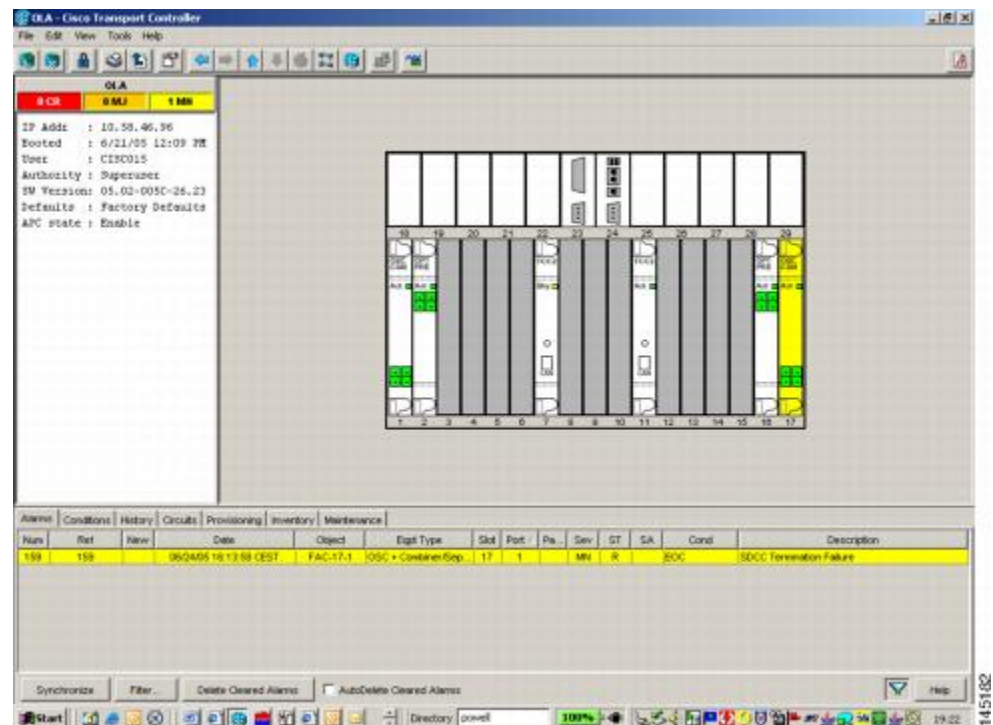
**Figure 20: ONS 15454 SDH OLA Node View with Fault Condition for ALS MODE Disabled**

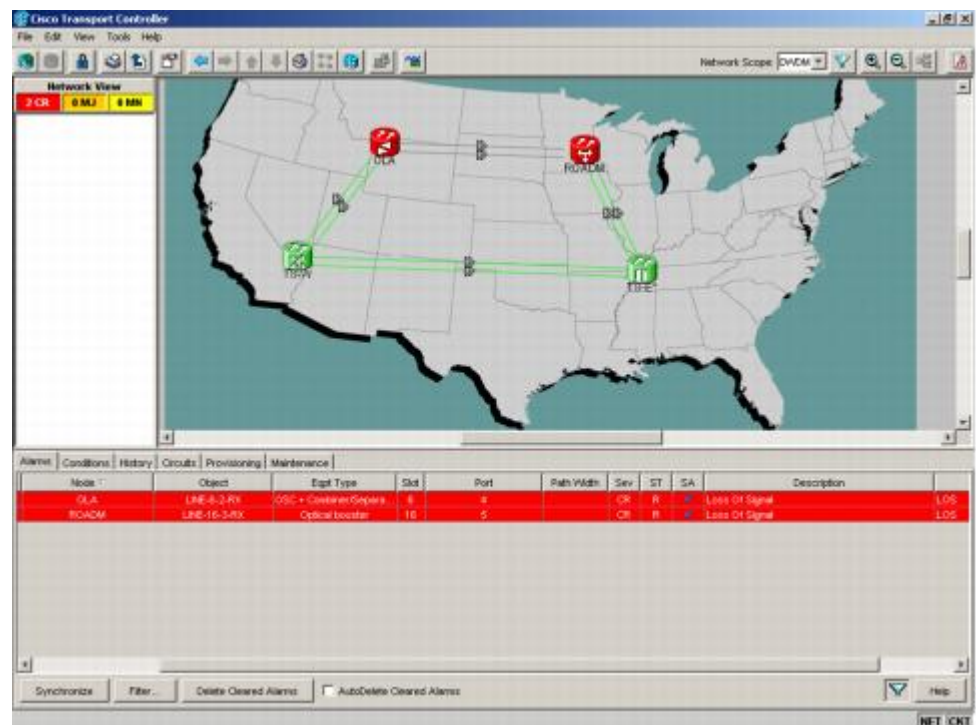
This change is due to the fact the physical optical power value received by the OSC transceiver is above the sensitivity limit (-42 dBm) and consequently, the OSC optical link can be rebuilt, allowing the restoration of the Section DCC (SDCC) or multiplex section DCC (MS-DCC). The network view for this condition is shown in [Figure 21: Network View for Span Loss Change > 5 dBm and OSC Power Value at Receiver > -42 dBm](#), on page 74.

**Figure 21: Network View for Span Loss Change > 5 dBm and OSC Power Value at Receiver > -42 dBm**

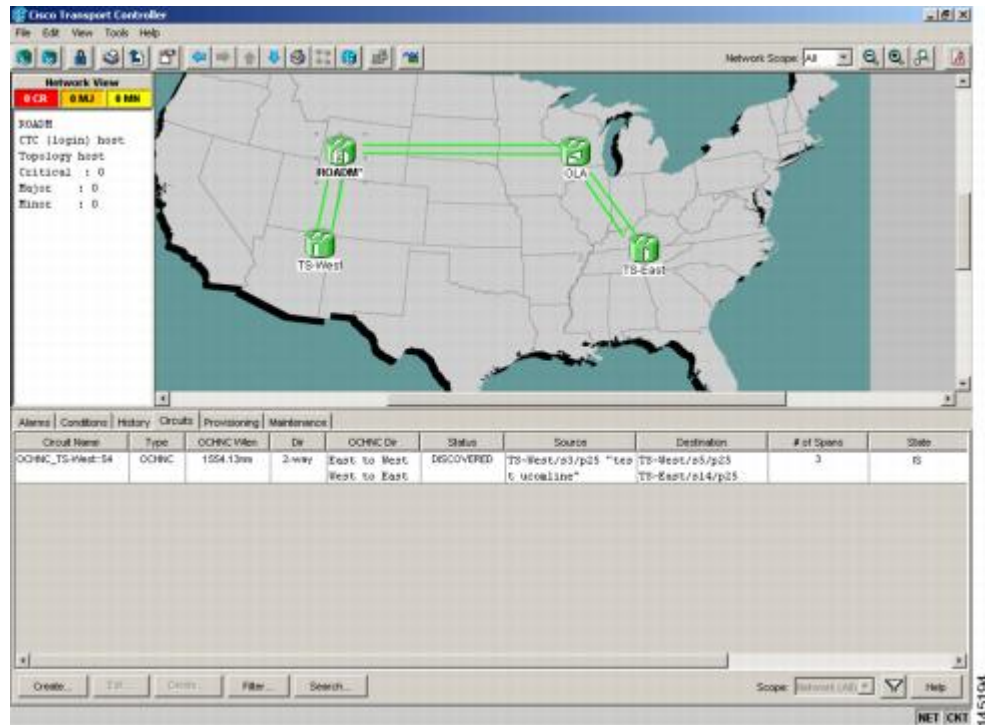
OCHNC circuit creation is successfully completed when the CTC circuit table reports the situation shown in [Figure 22: OCHNC Circuit Successfully Completed](#), on page 82.

- Circuit State reports IS (or unlocked).

**Figure 22: OCHNC Circuit Successfully Completed**

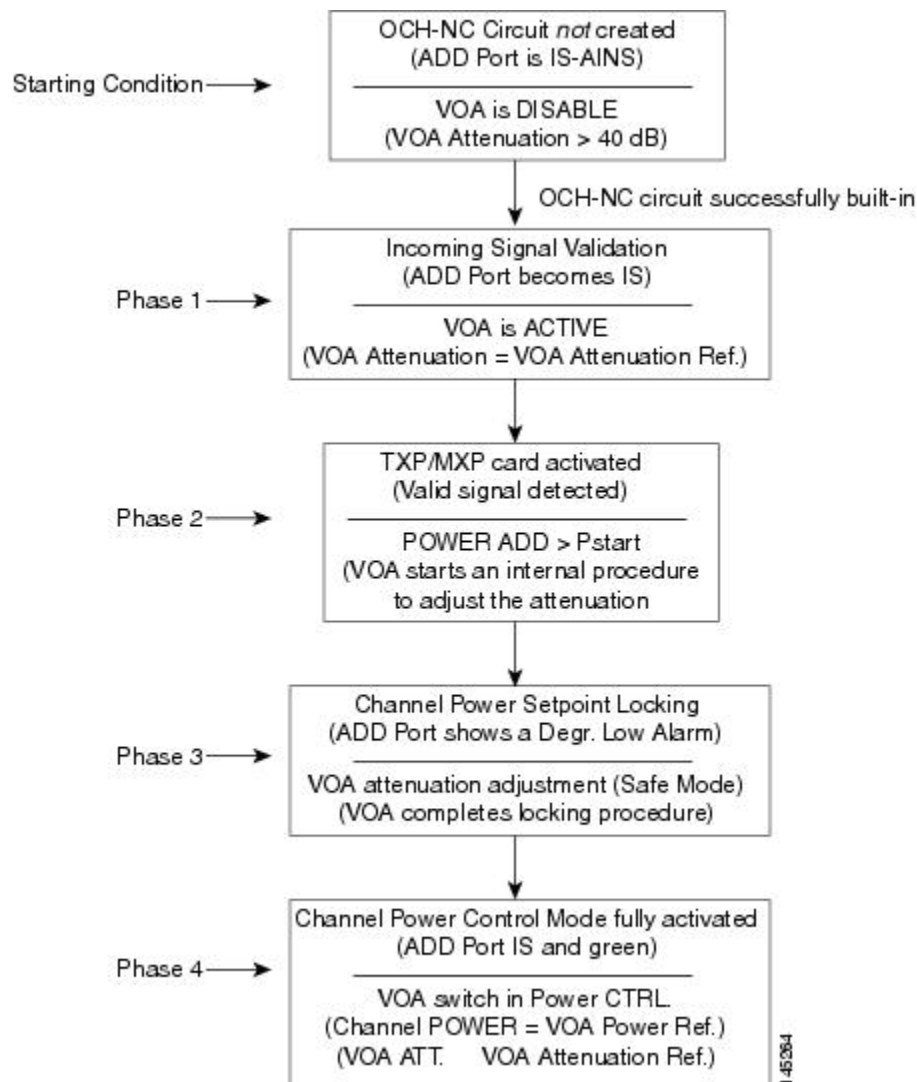
The final VOA condition is achieved through a startup procedure divided into the four sequential phases shown in [Figure 25: VOA Startup Procedure, on page 85](#).

**Figure 25: VOA Startup Procedure**

Until the VOA has completed all the phases shown in [Figure 25: VOA Startup Procedure, on page 85](#), the power control mode is not fully activated.

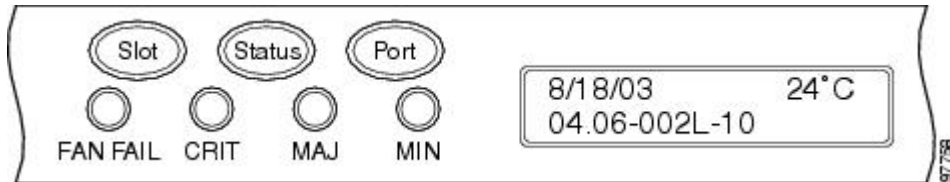
- Step 1** View the temperature displayed on the ONS 15454 LCD front panel (Figure 28: Shelf LCD Panel, on page 238).  
Figure 28: Shelf LCD Panel, on page 238 shows the shelf LCD panel.

**Figure 27: Shelf LCD Panel**

- Step 1** View the temperature displayed on the ONS system LCD front panel. For example, the ONS 15454 front panel is illustrated in [Figure 28: Shelf LCD Panel](#), on page 238.

- 
- Step 1** Check for any outstanding alarms that were raised against the active and standby TCC2/TCC2P/TCC3 and resolve them.
- Step 2** If the alarm does not clear, determine whether the LCD display on the fan tray ([Figure 28: Shelf LCD Panel, on page 238](#)) is blank or if the text is garbled. If so, proceed to [Step 8, on page 253](#). If not, continue with [Step 3, on page 252](#).
