Best Practice Image Update X2 HMI Panels

MAEN361B
2023-06

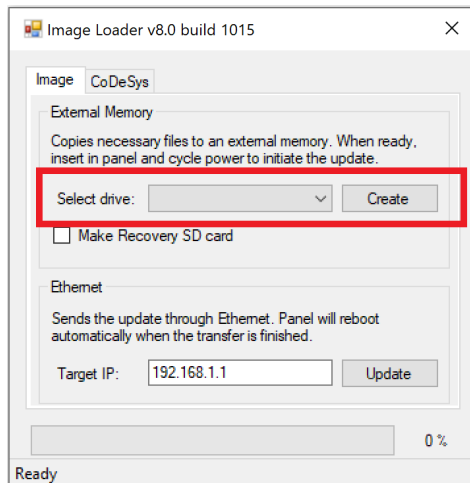
1. Download your image from Beijer Electronics [SmartStore](#).
2. Unzip the downloaded file and start the Image Loader application.
3. Connect a USB flash drive or SD card to the computer.
4. In **Select drive:**, choose the connected USB flash drive or SD card.

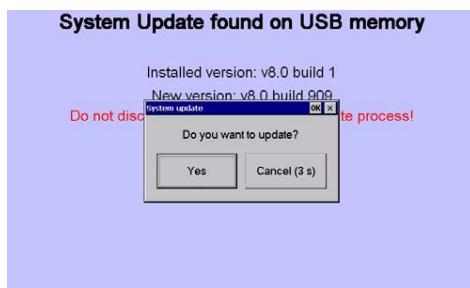
5. Click **Create**.
6. When finished, eject the USB flash drive or SD card.
7. Connect the USB flash drive or SD card to the powered off unit and power it back on.
8. Select **Yes** to confirm the Update.

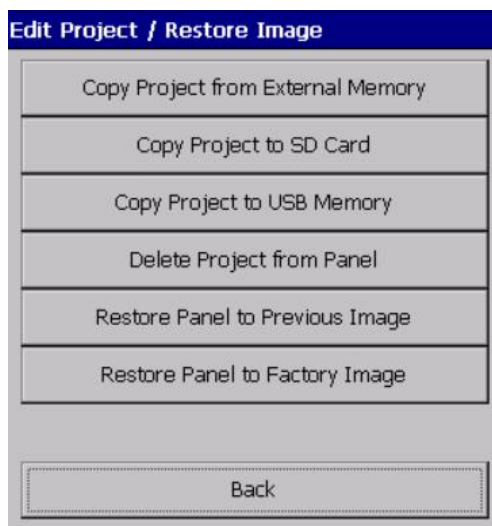
The iX Developer project is copied in the **Edit Project / Restore Image** dialog.

You can choose to export the project to an SD card or USB.

1. Connect the USB flash drive or SD card that should be used for the backup to the panel.
2. Select **Edit Project / Restore Image**.
3. Select **Copy Project to SD Card** or **Copy Project to USB Memory**.

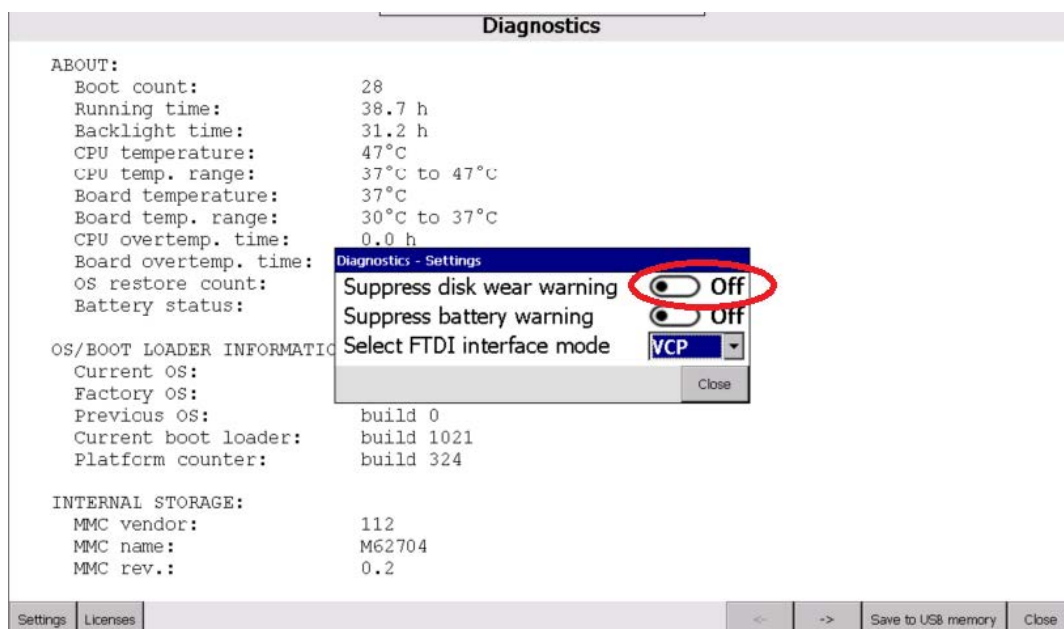
4. Suppress disk wear warning.
