# IBM System Storage SAN Volume Controller Troubleshooting Guide

*Version 6.2.0*

GC27-2284-01

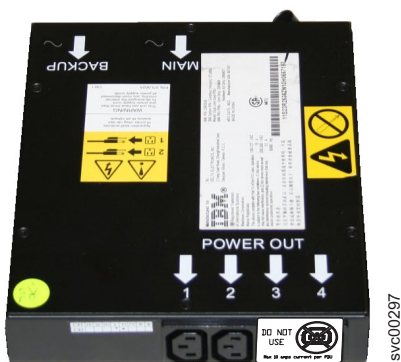
Figure 47 shows a redundant ac-power switch.

Figure 47. Photo of the redundant ac-power switch
